**FINAL REPORT**

**ACCIDENT INVESTIGATION**

**9N-AME (CRJ 200LR, MSN 7772) Aircraft**

Saurya Airlines Pvt. Ltd.

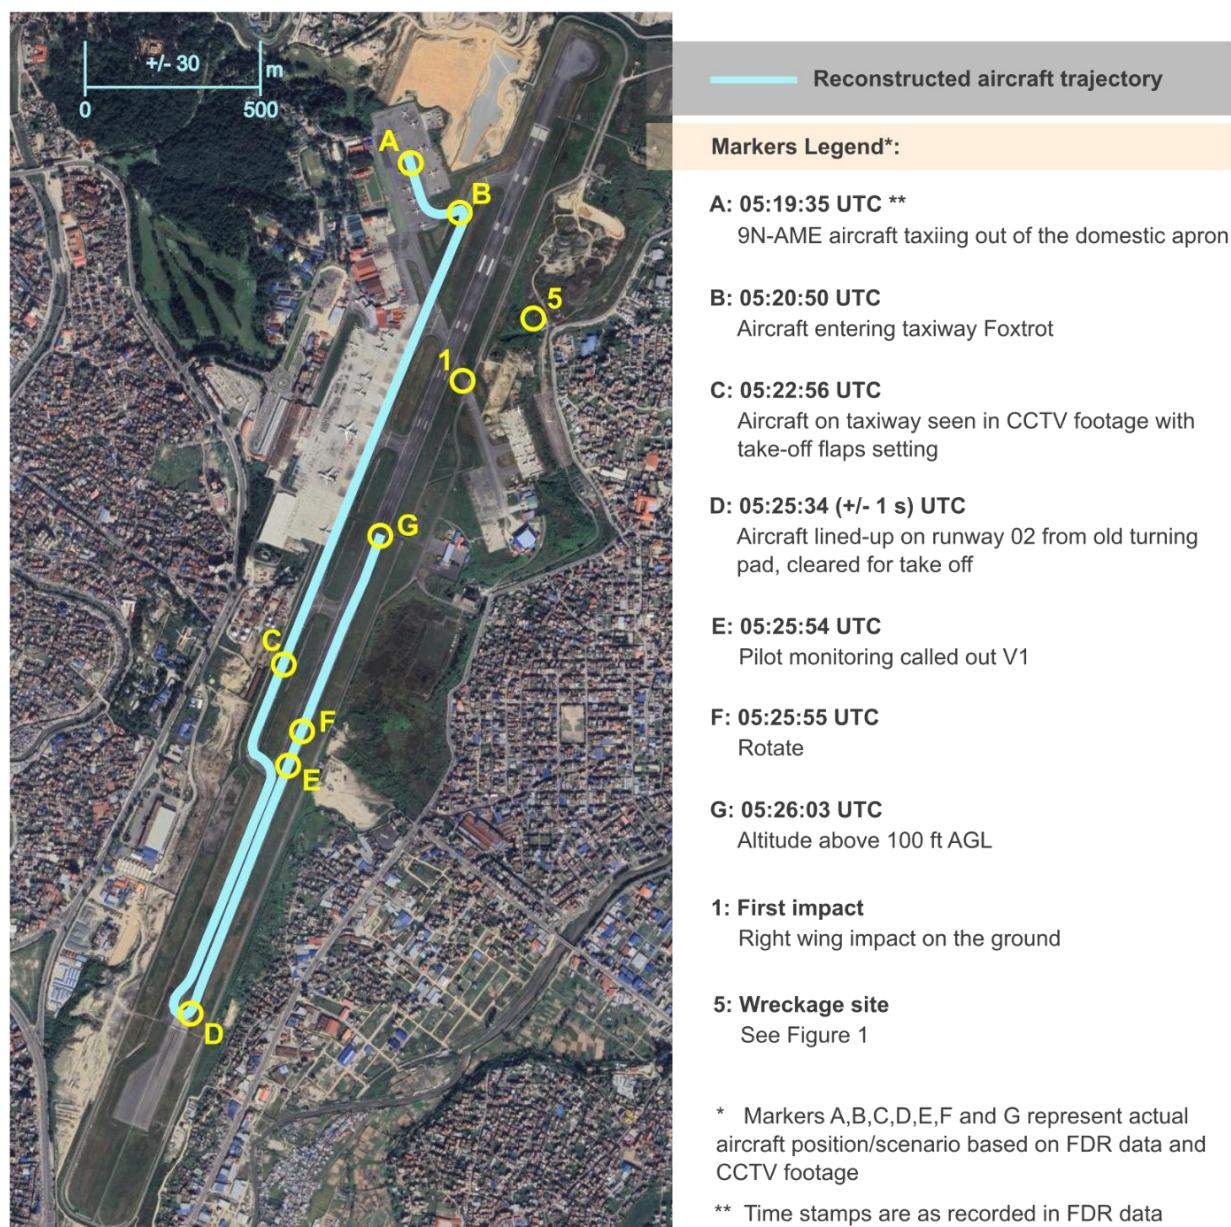
**Figure 1: Flight path and event markers**

The reconstructed path of the aircraft is shown in Figure 1. The figure includes the marking on the flight path significant to the comparative observation of the aircraft based on FDR data, CCTV footages, significant CVR audio information, and terrain references. Figure 2 shows the markers C and F as seen in the CCTV footage, while Figure 3 shows the unusual attitudes of the aircraft after take-off leading to the accident. The aircraft underwent a right, left and right bank before the right wing impacted on the ground at '1'.

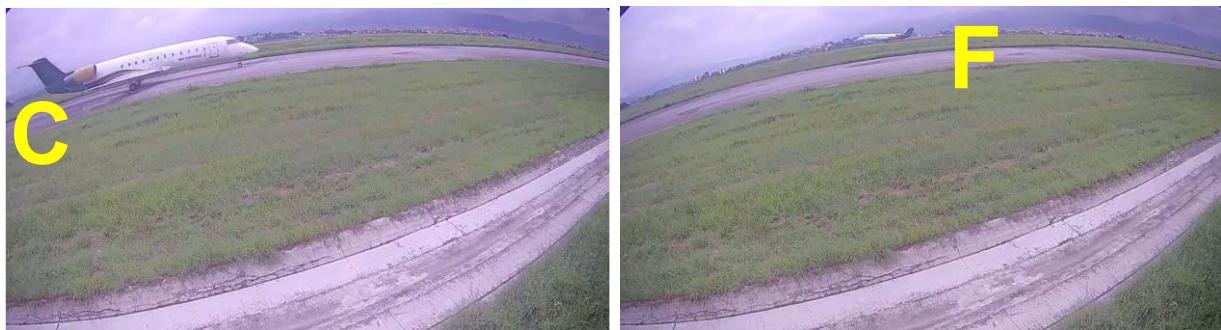
**Figure 2:** CCTV footage view of the events marked **C** and **F** in Figure 1

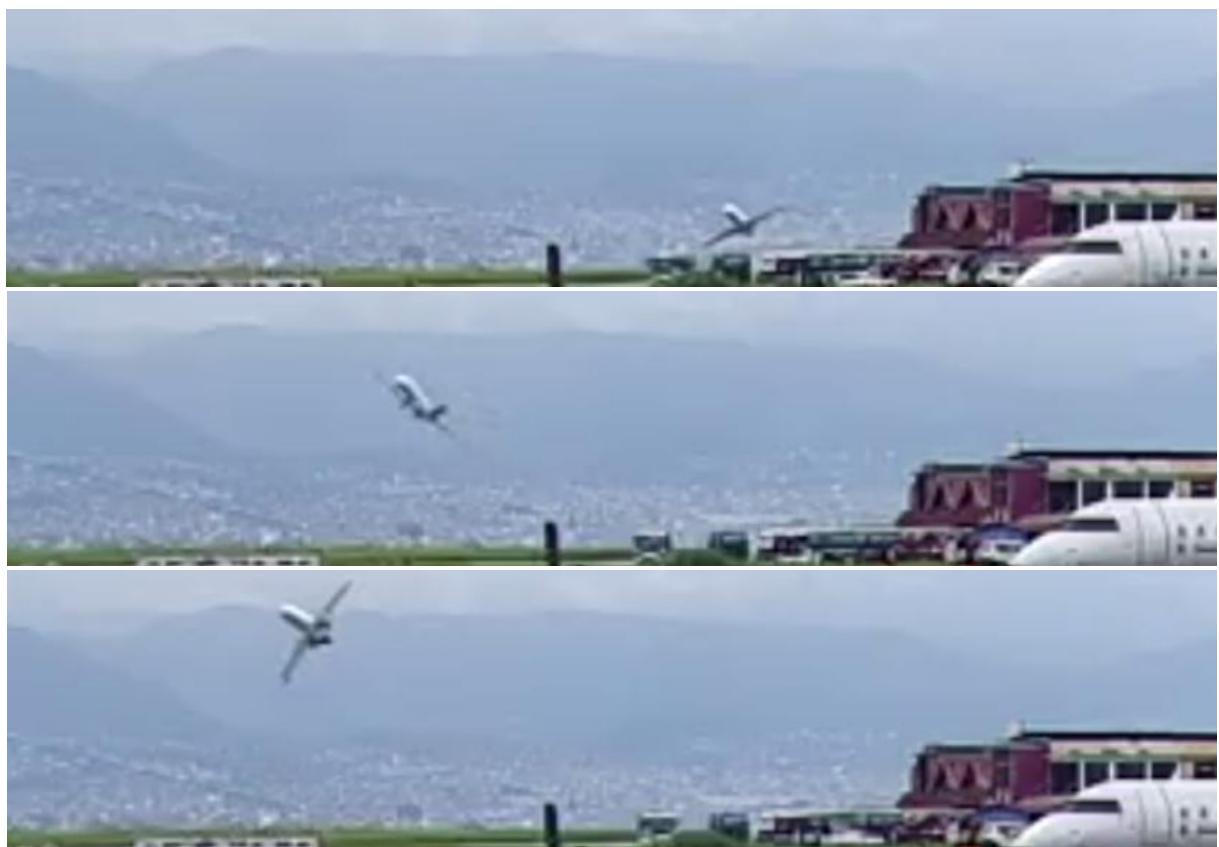
**Figure 3:** Event sequence with unusual attitudes leading to the accident, captured by a CCTV camera

After rotation for takeoff at 05:25:55 UTC, the aircraft attained a height of 50 ft above ground level (AGL) within around 5 seconds. Based on the height computed from inertial data, the aircraft attained a height of slightly above 100 ft AGL by 05:26:03 UTC (marked 'G' in Figure 1). At 'G', the aircraft was at 94.6° roll angle with a heading of 24.7°, veering right of Runway 02.

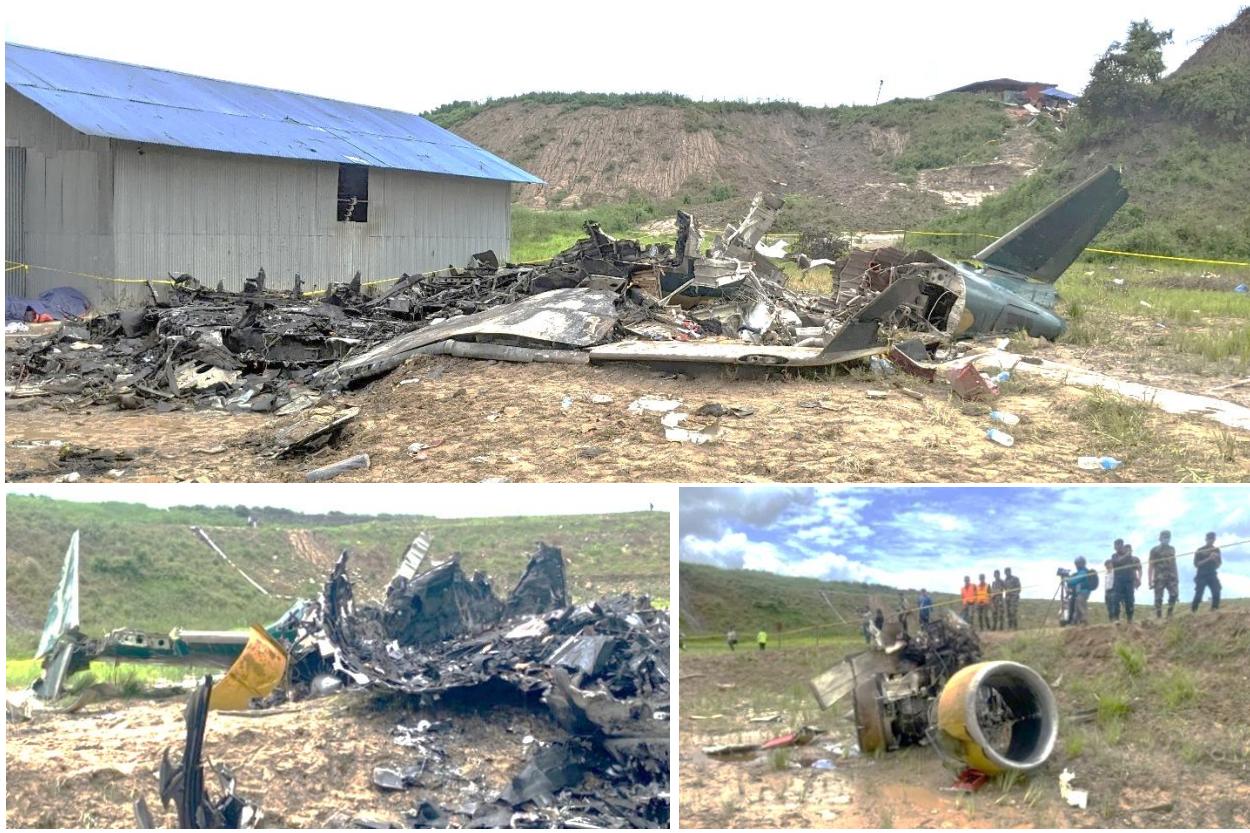
The aircraft was destroyed due to high velocity impact, and post impact fire as seen in Figure 4. The aircraft also collided with the container and shed of Air Dynasty Heli Services Pvt. Ltd. The cockpit portion was stuck on the Air Dynasty container on the eastern side of the airport. Most of the fuselage structure and its components were damaged due to fire.

**Figure 4:** Top: scene at the main wreckage site, bottom: burnt fuselage and empennage sections, and the detached left engine. Images were taken on July 24 and 25, 2024.

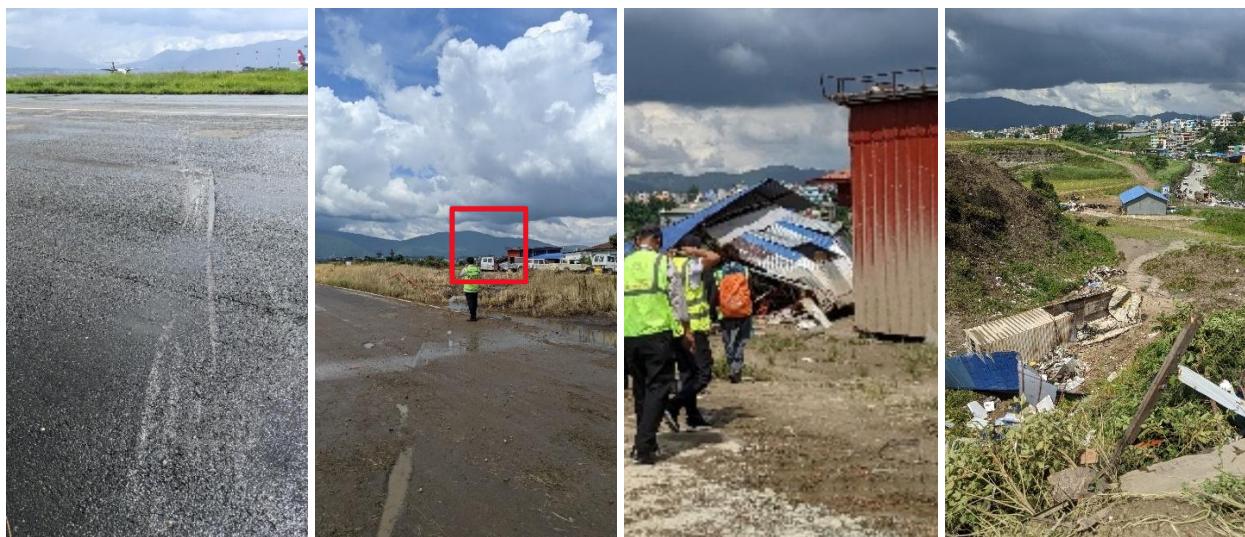
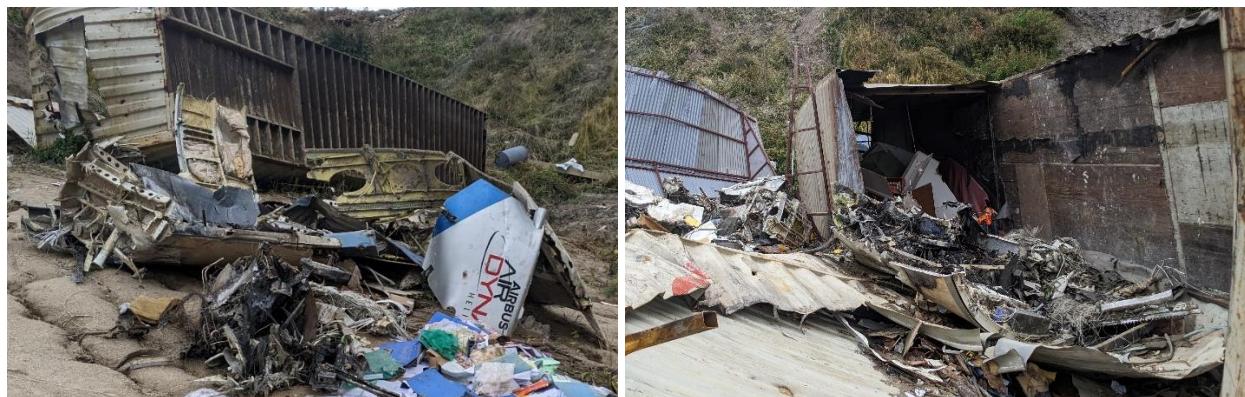
The collision of 9N-AME with the container and shed of the Air Dynasty Heli Services Pvt. Ltd. led to damage of Air Dynasty properties. Mainly, a container of Air Dynasty was dragged from its initial installation site on the eastern side of the airport. It was partly destroyed during the impact and further taken apart during the rescue efforts from the 9N-AME cockpit. A shed at the Air Dynasty site was also damaged. The airport ground infrastructure along the aircraft's distraction track was also damaged during the impact of the right wing and subsequent fire. Images of this damage are shown in Figure 5.

The components of the 9N-AME aircraft cockpit and other systems and avionics were scattered in the vicinity of the Air Dynasty container site. These areas had a mixed wreckage from the 9N-AME aircraft and components of an Air Dynasty helicopter. These components can also be seen in Figure 5.

**Figure 5:** Accident site photos, taken on July 25, 2024, tracing the damage that occurred during the accident. [**Top-left:** location of first impact by the right-wing east of runway-02 top-left; **top-center-left:** trail left by the right-wing as the aircraft plummeted towards the Air Dynasty shed area seen in the background; **top-center-right:** destroyed shed of Air Dynasty, beside the red container; **top-right:** crash site looking downhill of the location of the Air Dynasty shed area; **bottom-left:** Air dynasty container dragged down-hill by the aircraft upon impact; **bottom-right:** the container where the 9N-AME cockpit was stuck, showing the wreckage remaining after RFF team had taken apart the cockpit during rescue.]

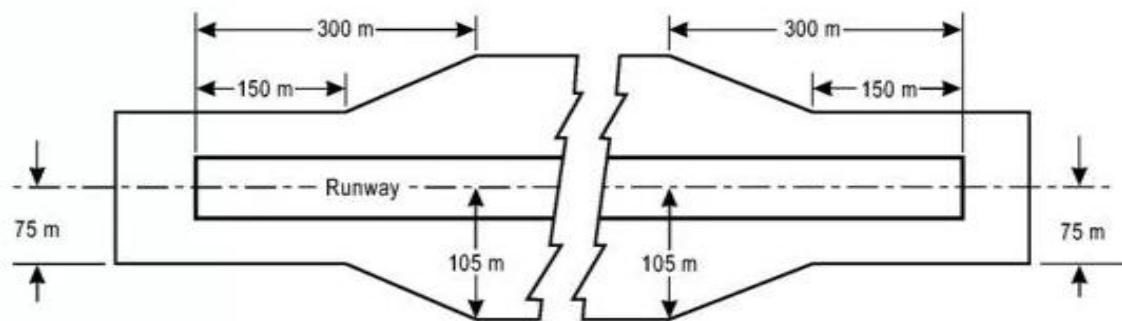
Annex-14, Volume-1, Chapter 3, 3.4.8, recommends that the portion of a strip of an instrument runway within at least 75 m from the centre line should be graded where the code number is 3 or 4. For a precision approach runway, it may be desirable to adopt a greater width where the code number is 3 or 4. Figure 6 shows the shape and dimensions of a wider strip that may be considered for such a runway. This strip has been designed using information on aircraft running off runways. The portion to be graded extends to a distance of 105 m from the centreline, except that the distance is gradually reduced to 75 m from the centreline at both ends of the strip for a length of 150 m from the runway end.

**Figure 6:** Graded portion of a strip including a precision approach runway where the code number is 3 or 4. [Source: ATCEP, CAAN]

In the AIP Nepal published by CAAN on November 3, 2022 (AMDT 08/2022), the runway strip is mentioned to be 280 m, which is as per the ICAO Annex 14 Volume-1 standard. However, at the site the runway strip the width was observed be only around 150 m, which is not sufficient.

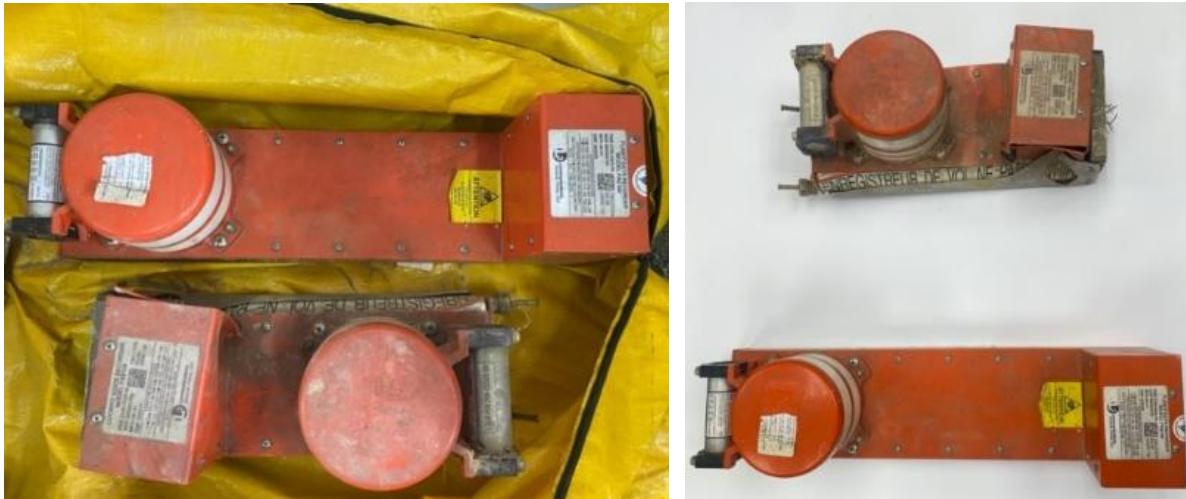
**Figure 7:** Condition of recorders as received by AAIC (left), and after being transported to TSIB, Singapore (right)

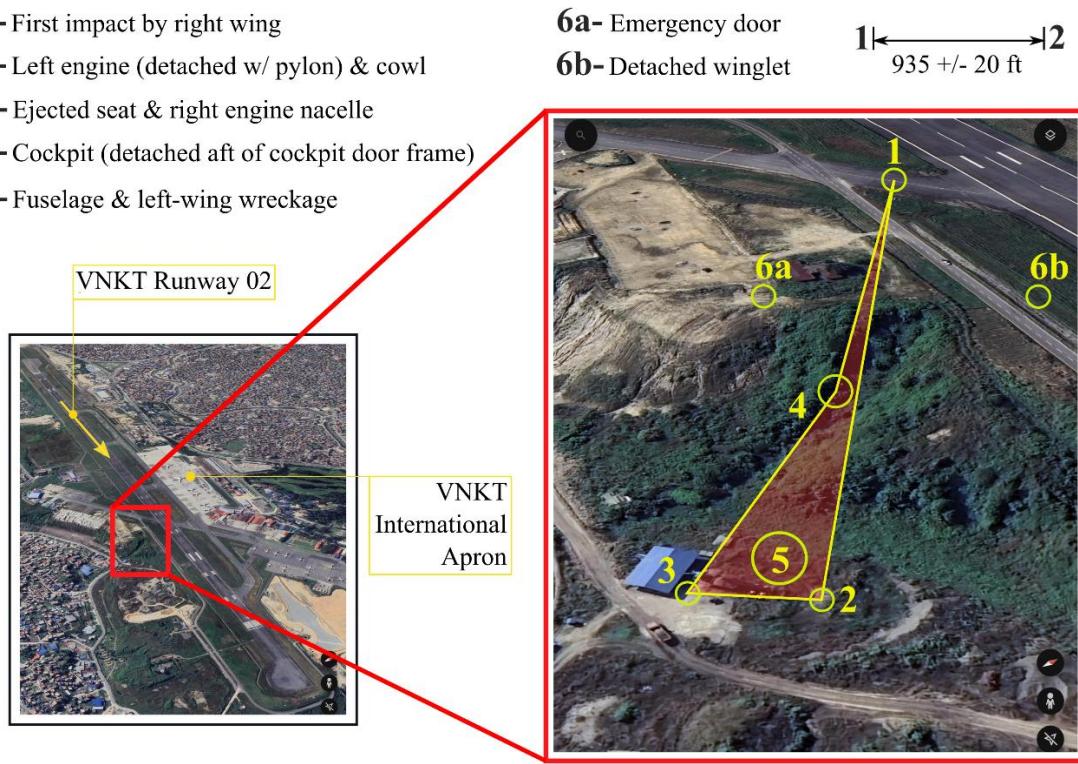
- 1- First impact by right wing
- 2- Left engine (detached w/ pylon) & cowl
- 3- Ejected seat & right engine nacelle
- 4- Cockpit (detached aft of cockpit door frame)
- 5- Fuselage & left-wing wreckage

**Figure 8:** Site corners showing the initial impact and distribution of the crashed aircraft

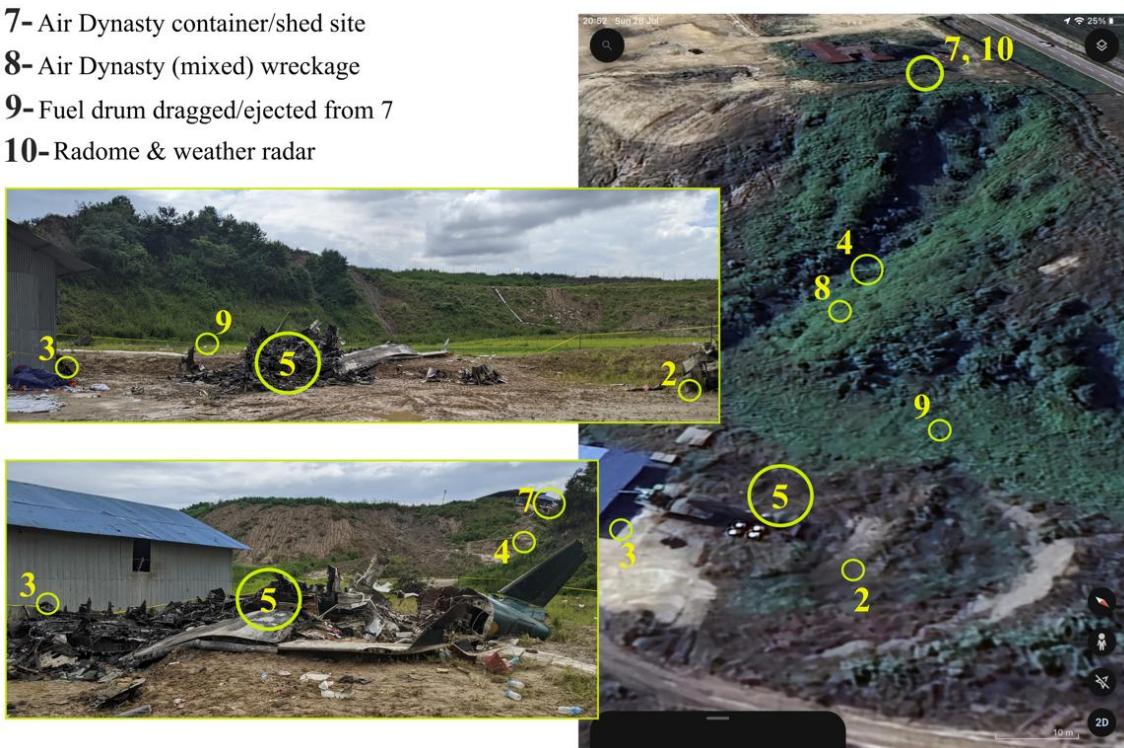
The layout of the wreckage distribution as identified on site visit is depicted in Figure 9. It is to be noted that some parts of the wreckage may have been moved during the rescue operations.

- 7- Air Dynasty container/shed site
- 8- Air Dynasty (mixed) wreckage
- 9- Fuel drum dragged/ejected from 7
- 10- Radome & weather radar

**Figure 9:** Overall distribution of the wreckage (see Figure 8 for markers '1' to '5')

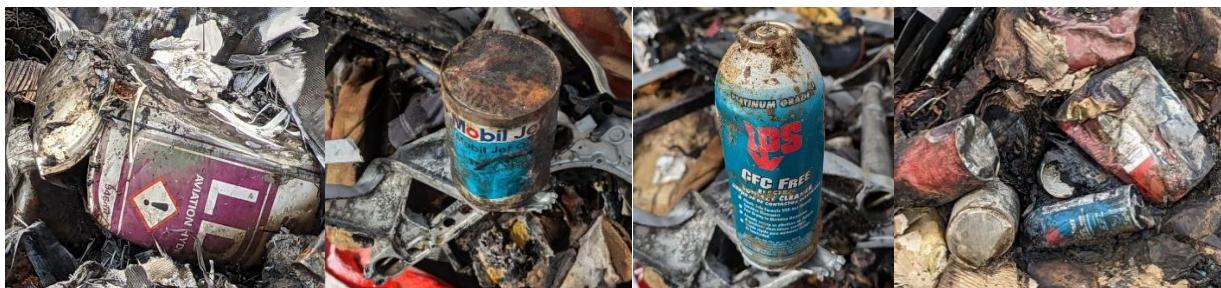
Notably, flammable fluids and other dangerous goods were also found among the wreckage. These included lubricants, hydraulic fluid, engine oil, contact cleaner, etc. Figure 10 shows the items found at the wreckage site. The LPS contact cleaner was identified as a dangerous good (UN1950; hazard class: 2.1; aerosols; flammable).

**Figure 10:** Hydraulic fluid and some flammable items found at the wreckage site

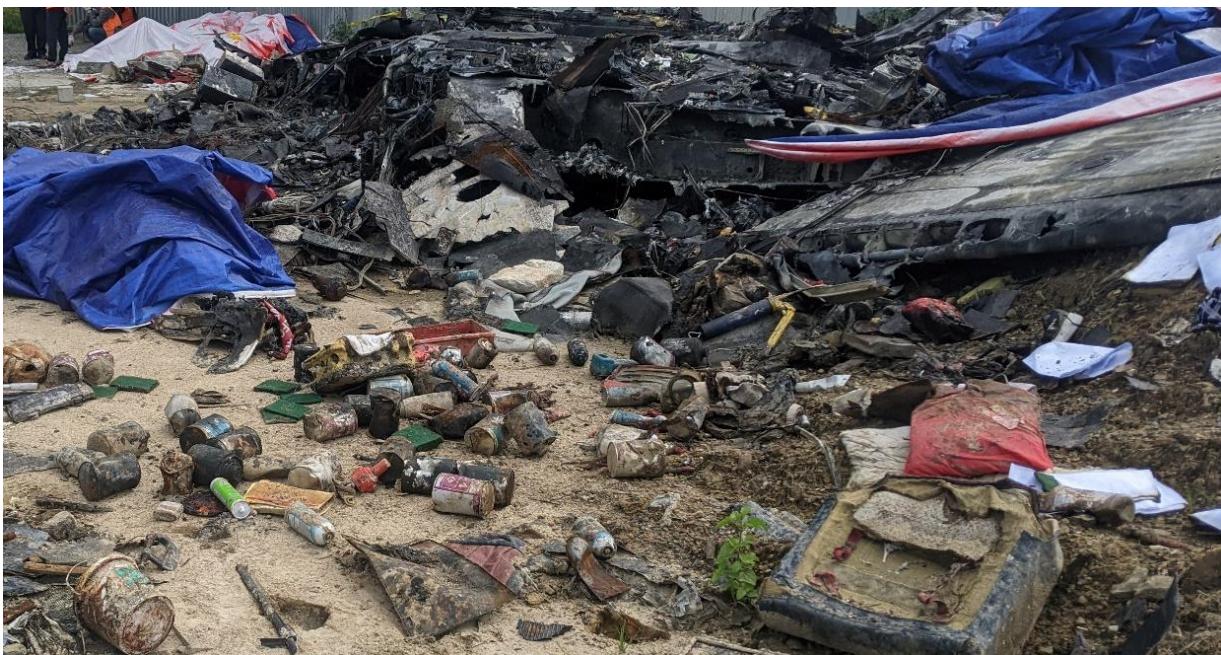
**Figure 11:** Wreckage site at marker '5', with recovered containers of fluidic items

were not present in the cabin during the event flight cannot be ruled out. The Commission recovered many of such items' containers from the cabin section of the wreckage. It should be noted, however, that these items may have been either ejected or moved during the rescue operations. The Commission also spotted hydraulic fluid spread on the floor of the burnt-down cabin of the aircraft at the wreckage site. Figure 11 shows the wreckage at marker '5' and some of the fluid containers recovered from the cabin and cargo section.

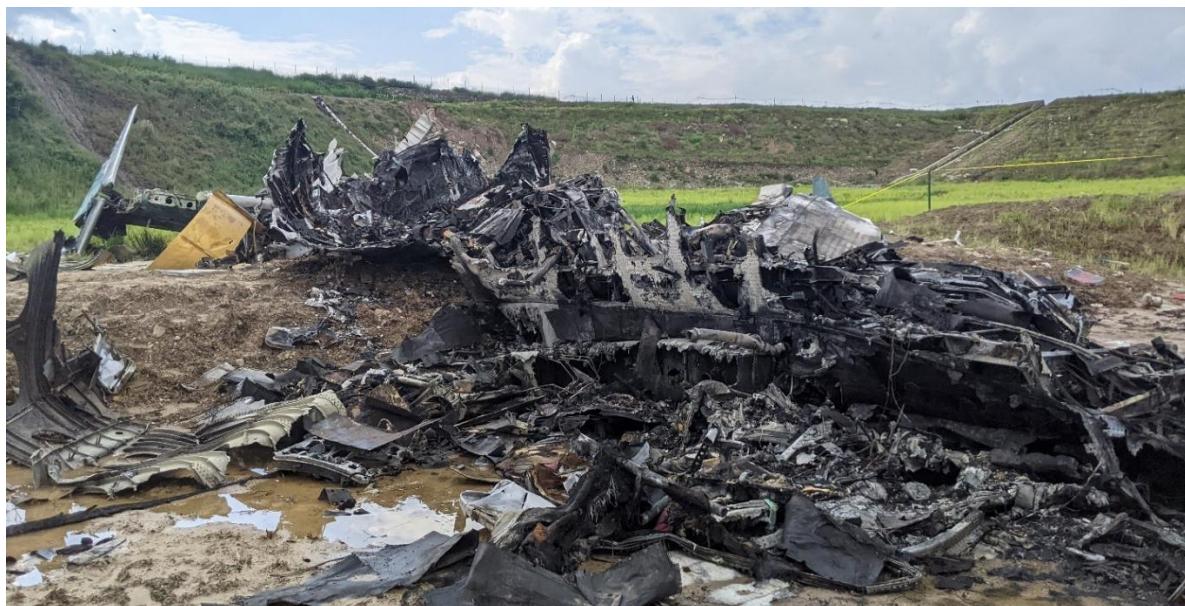
A particular scenario observed at the wreckage at '5' was the nature of destruction of the entire front fuselage section. Aft until the empennage, the fuselage was burnt down to the cabin floor, as shown in Figure 12. Few parts from the fuselage outer structure were found at the wreckage site, for e.g., the skin panel seen near the center upper-half of Figure 11. This indicates the possibility of several simultaneous factors:

3. The RFF effort was not swift enough to control the fire from engulfing the cabin wreckage at '5'. While some of the fuselage structure was taken apart during the rescue efforts, the wreckage shows fire damage of an extensive nature, indicating that the fire in the cabin had been burning long enough to cause the extensive damage seen in Figure 12.

4. The presence of flammable items onboard exacerbated the fire situation in the cabin.

**Figure 12:** Fuselage wreckage at marker '5' as seen from the front of the cabin

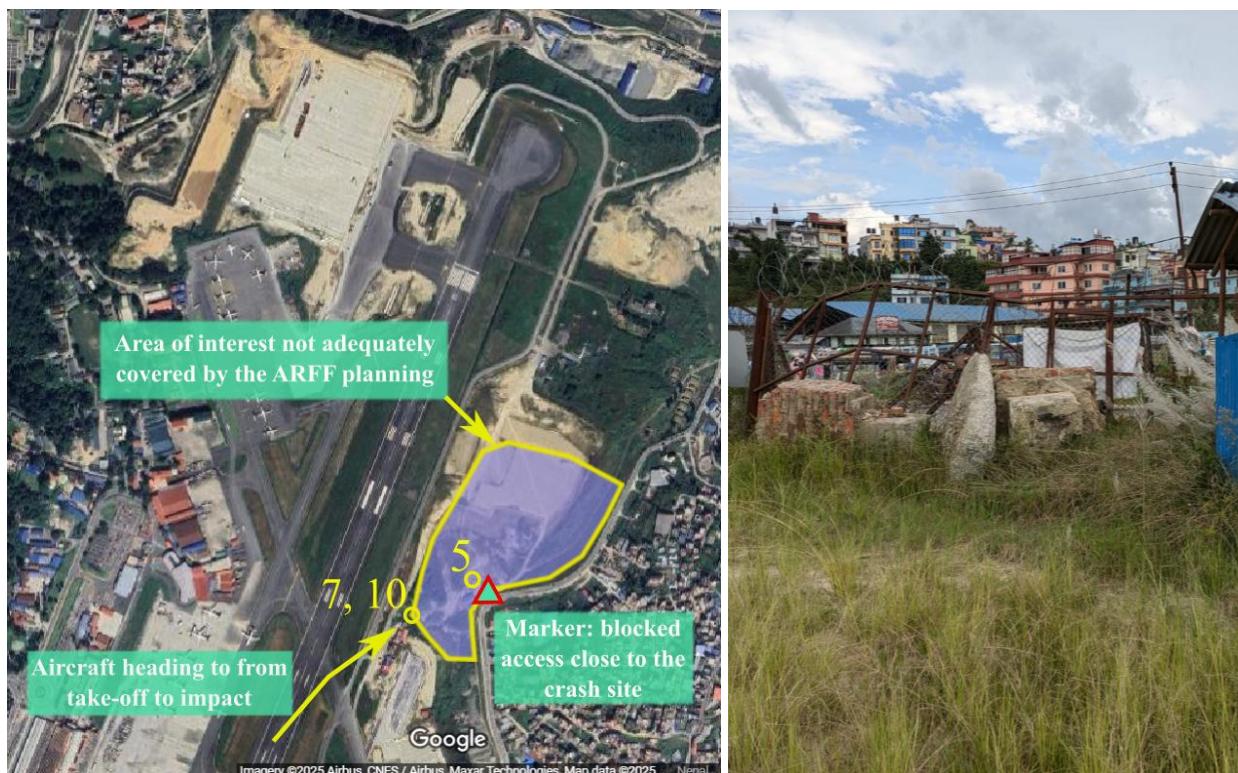
One of the emergency access gates closest to the crash site was found closed and obstructed by construction materials and debris. No Safety Risk Analysis or Management of Change process was completed for this area, contributing to deficiencies in the rescue operation. The blocked-off emergency gate can be seen in Figure 13, and among the site images provided in Appendix 7.

No Task Resource Analysis was conducted for equipment and manpower resources as per ICAO Service Manual 9137 - Part 1 and the TIA Airport Services Manual to provide a Category-IX airport firefighting service. It was noted that there is a lack of training in the Safety Management System within the Airport Rescue and Fire Fighting unit of TIA. In particular, blind regions were found in the coverage of the airport area. The assessment of the crash site by the Commission revealed that, despite being within the airport premises, the crash site was difficult to access on foot and via ground vehicle. These details are shown in Figure 13.

**Figure 13:** Blind region in the area of interest that hindered effective rescue and firefighting efforts. The markers 5, 7 and 10 are as listed in Figure 9. The blocked access marked near 5 is shown on the right.

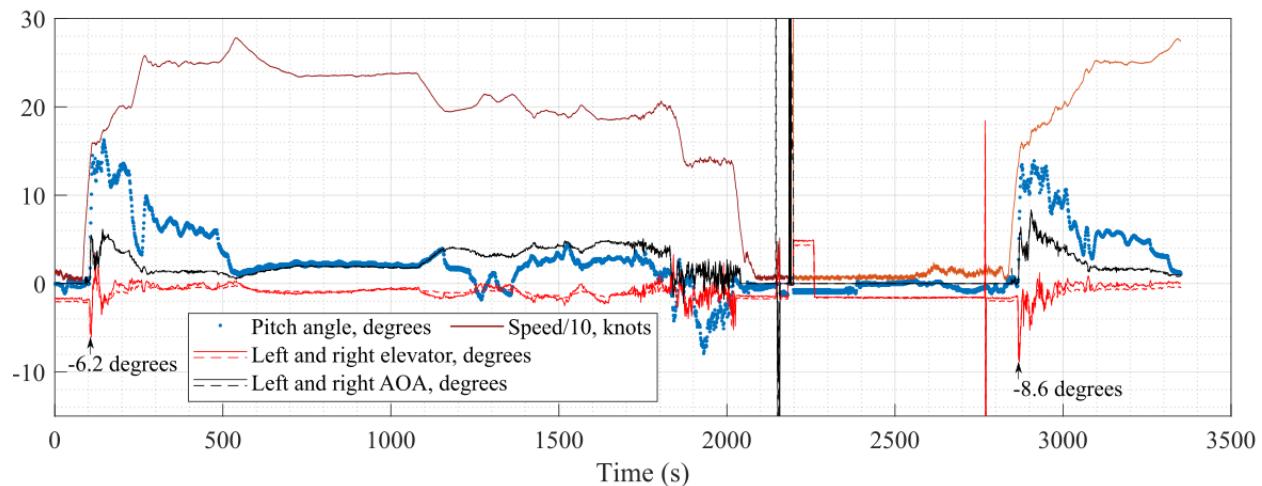
Typical flight parameters of two different flights, from February 20, 2024, are shown in Figure 14. The data presented in the figure was plotted in the same sequence as they were retrieved in the FDR, without clipping the time on the ground. The data presented is among the volume of historical flight data from the Saurya Airlines fleet that was analyzed as part of this investigation.

The rotation rates (pitch rates) in the cases presented in Figure 14 are within a nominal range of 3 degrees-per-second. The required elevator deflection for rotation ranged approximately between 6° to 10°, and the angle of attack increases approximately by up to 8°. As shown, during a typical take-off, the share of flight path angle gradually increases in the value of pitch angle, as the angle of attack should be limited within a safe range below stall margin. As the aircraft begins the climb, the pitch angle is increased to a target pitch angle, and the take-off sequence is completed. These sequences can also be interpreted from the data presented in Figure 14.

**Figure 14:** Flight parameters of typical flights (first flight from 0 s to ~2100 s and second flight from ~2800 s onwards), showing nominal elevator commands required and angle of attack and pitch angle responses during take-off and climb.

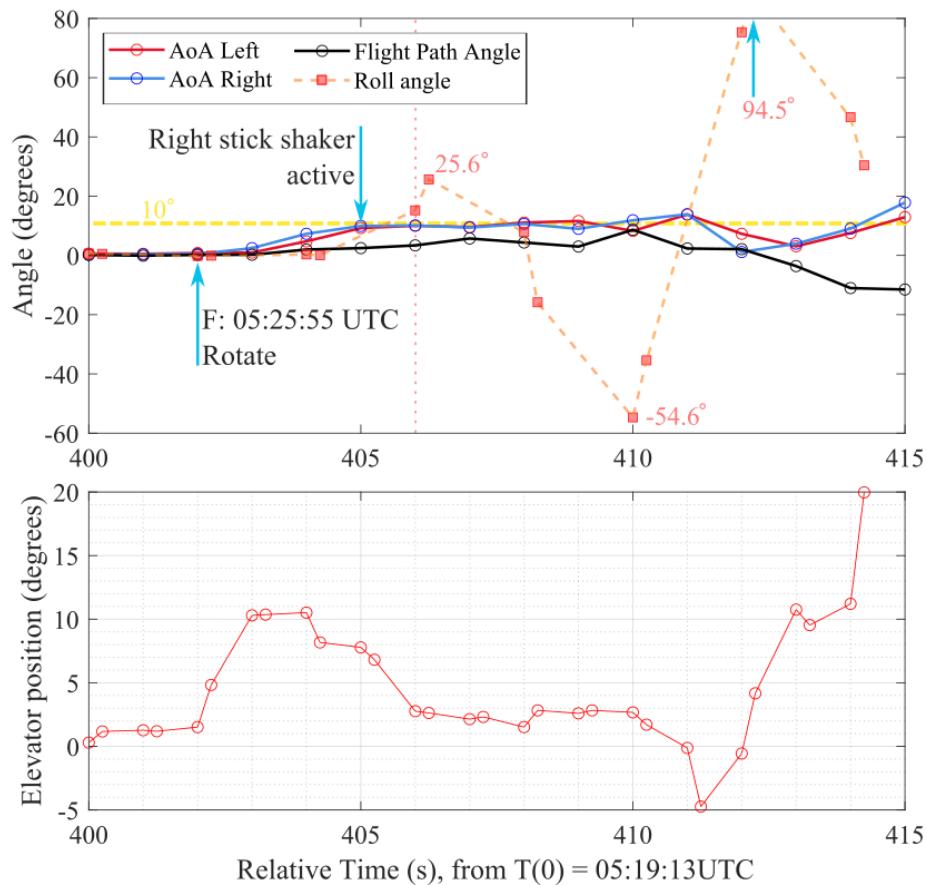
**Figure 16: Flight angles and left elevator (up) position**

The aircraft rotated for take-off near 120 knots. This speed fell short from required rotation speed stated in Tables 15 and 16. The elevator deflection (up) for take-off went from around  $1.5^\circ$  to  $10^\circ$  within 1 second. Two seconds after the elevator deflection to  $\sim 10^\circ$ , the angle of attack of both wings reached around  $10^\circ$ . At this instance, the aircraft started undergoing a right-low roll motion and the right stick shaker became active. Both stick shakers became active 1 second later, while the right-low bank angle reached  $25^\circ$ . This sequence is shown in the Figure 16. The instance where both stick-shakers became active is at 406 s in the figure, marked by a vertical dotted line.

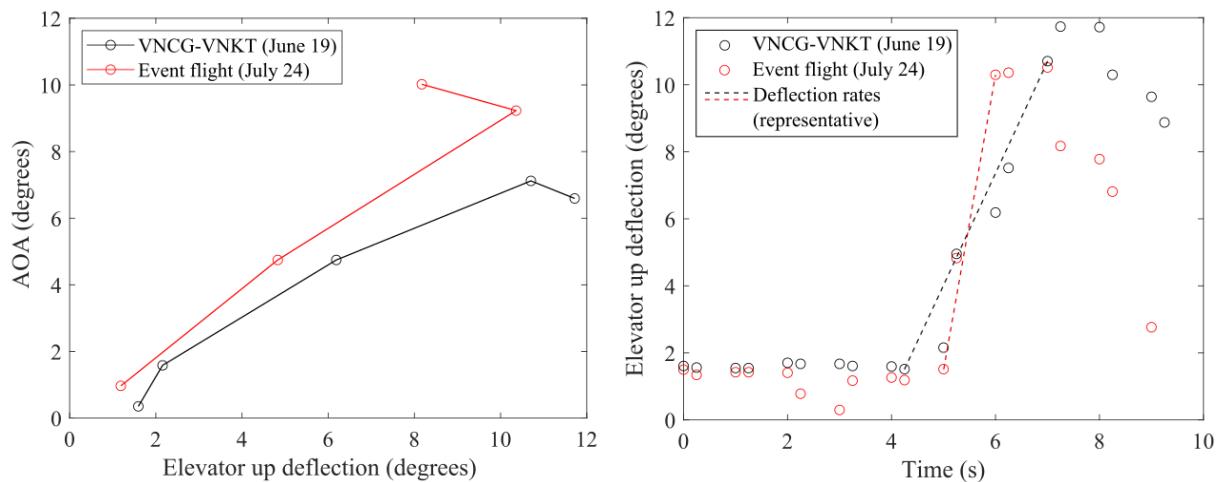
The response of the aircraft's rotation for take-off with respect to elevator deflection is analysed in Figure 17. In the responses shown, the angle of attack is taken 2 seconds from the corresponding elevator deflection. Response for the event flight shows that although the elevator deflection was decreased at an angle of attack of near 10°, the angle of attack continued to increase. This is unlike the comparison case, indicating that the longitudinal (pitch) control had been lost within 3 seconds after rotation.

**Figure 17:** Elevator and airplane pitch responses. The angle of attack is for the left wing.

The reason for a rapid increase of pitch angle (mainly the angle of attack component for the first few seconds) can be attributed directly to the rapid rate of elevator deflection, as shown in Figure 17. During the rotation for take-off, the elevator deflection for nose pitch up attained a deflection angle of over 10° in 1 second. Discounting the approximately two-seconds time lag in the aircraft response, the left-wing angle of attack increased linearly from approximately 1° to 10° within 2 seconds. During this period, the right-wing angle of attack rose more rapidly than that of the left wing, as seen in Figure 16. Hence, the right stick shaker also activated first, followed by the left stick shaker becoming active after 1 second.

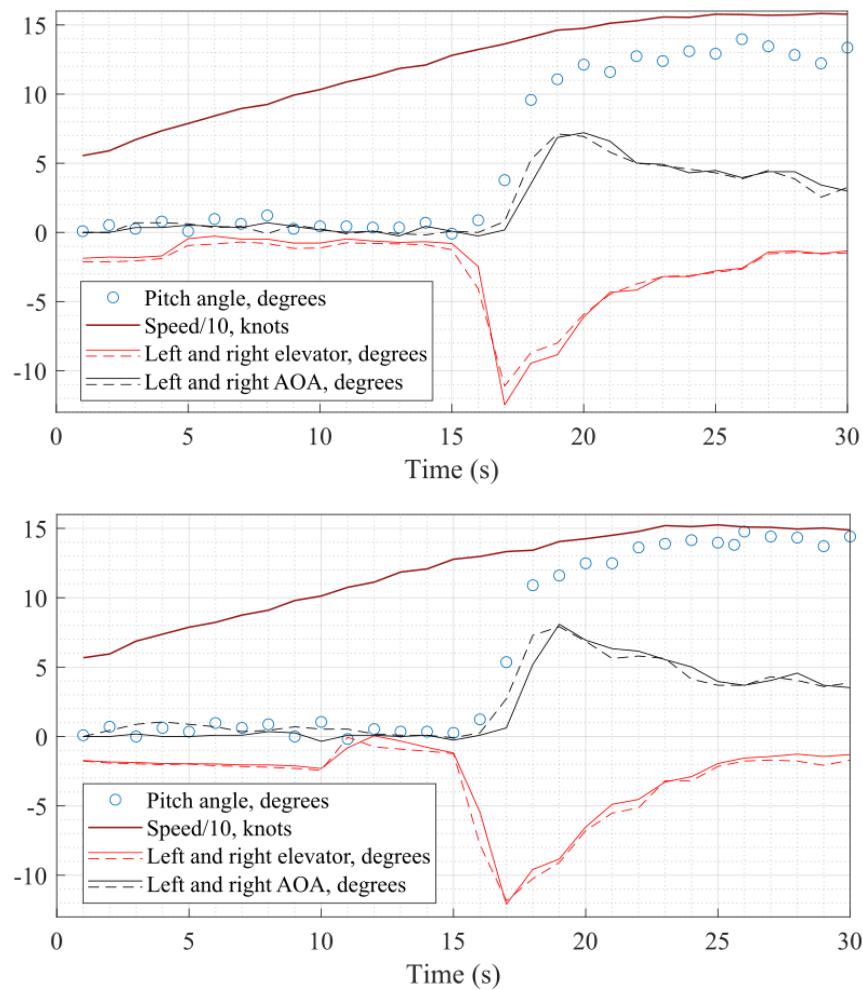
The worse of these cases for 9N-AME happened during flights on 11 January 2024 and 19 March 2024, with the rotation rates as per the above criterion respectively as (5.8° /s, 4.35° /s) and (5.5° /s, 4.8° /s). The plots showing these rotation rates versus time, along with the elevator deflections, AOA and speed are shown in Figure 18. During the flight on January 11, the elevator deflection was commanded by around 8 degrees within 1 second, because of which a rapid pitch rate of 5.8° /s was achieved between 17 to 18 seconds in the figure. While on March 19, the elevator deflection was commanded by 11 degrees in 2 seconds that resulted in a maximum rotation rate of 5.5° /s. Rotation for the flights were performed at 132.25 knots and 127.75 knots computed airspeeds, respectively. The corresponding required rotation speeds were 130 knots and 127 knots. Unlike in the case of the event flight, the above cases rotated at sufficient rotation speeds.

**Figure 18:** Take-off rotation data for 9N-AME flights on January 11, 2024 (top) and March 19, 2024 (bottom) that show excessive rotation rates during take-off

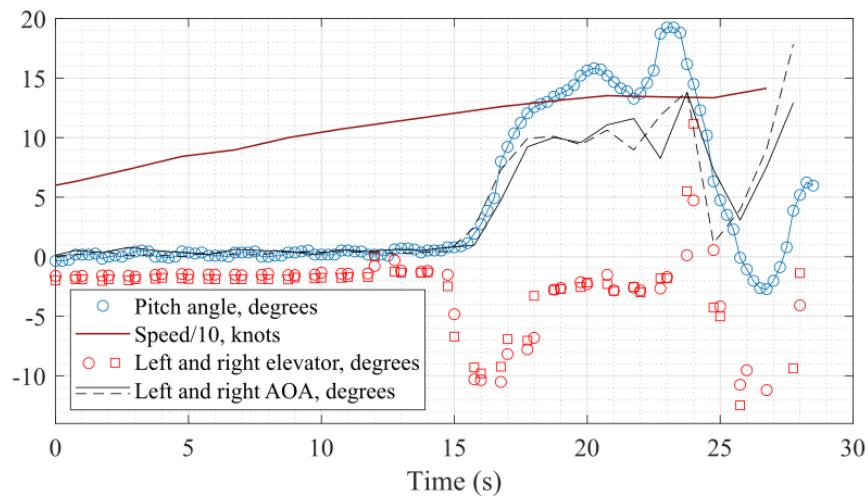
**Figure 19:** Take-off rotation data for the event flight, shown in comparison to Figure 18

For comparison, the elevator deflections for the event flight are shown in Figure 19. Elevator up is recorded as negative value in FDR. The rates for the event flight are abnormally high- even in comparison to the cases presented in Figure 18. In the event flight, the elevator deflection was commanded from  $\sim 1^\circ$  to  $\sim 10^\circ$  distinctly within a second, which is made clearer by the marker symbols in the plot style. This rate of pitch up response commanded was higher than any cases studied under this analysis, at  $(6.5^\circ/\text{s}, 4.2^\circ/\text{s})$  based on the above criterion.
