## **FINAL REPORT**

## **ACCIDENT INVESTIGATION**

### **ATR 72-500 Aircraft, registration 9N-AMF**

(Runway Excursion at Chandragadhi Airport, Jhapa, Nepal)

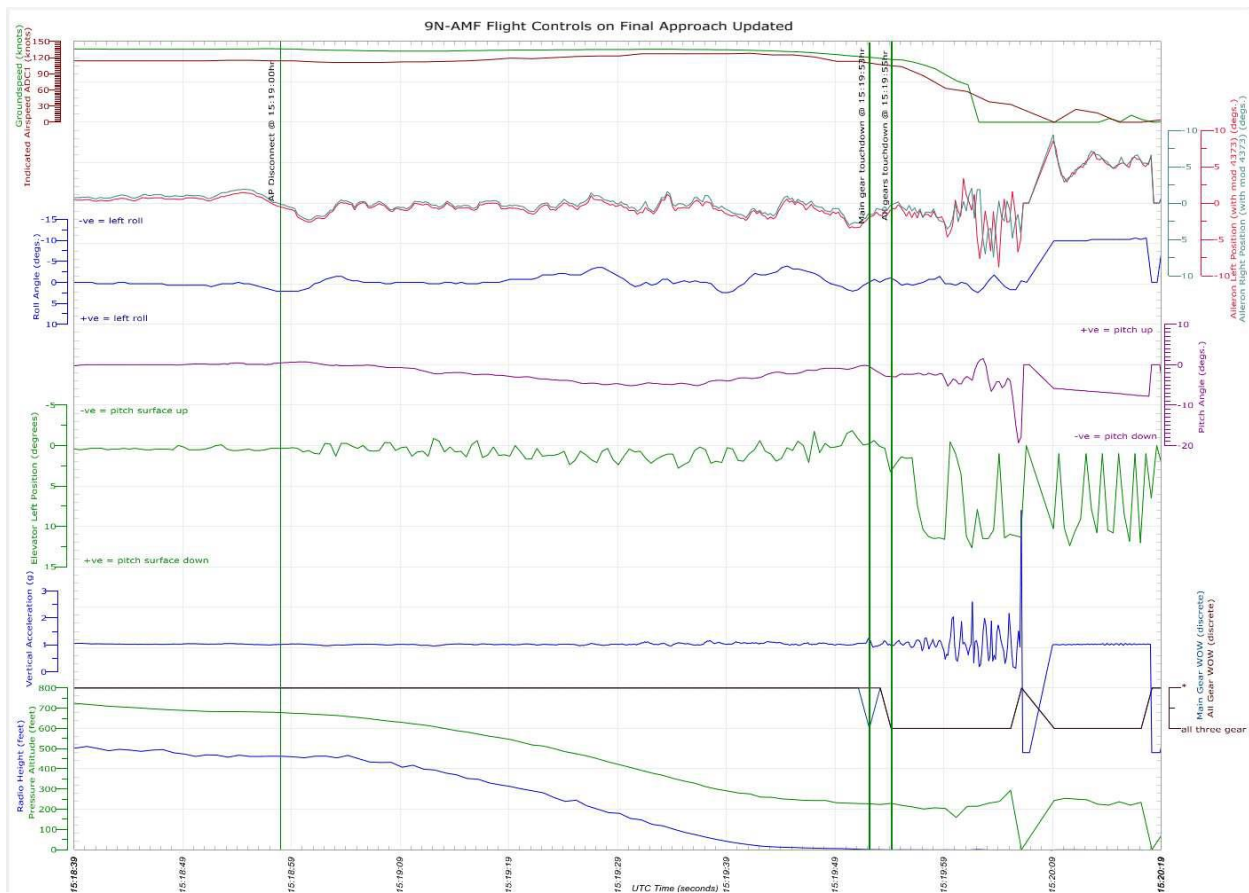
Over the next 53 sec, prior to the aircraft touching down on the runway, it was observed that there was movement on the ailerons and the roll angle varied between -4 to +2 degrees (See Figure 2). The pitch attitude gradually decreased to a larger nose down attitude where the maximum pitch angle was -5 degrees (nose down) before the pitch angle was increased to close to 0 degrees just before touchdown. During this period, there were corresponding changes to the left elevator position varying between -2 degrees (pitch surface up) and +3 degrees (pitch surface down).

Figure 2 Flight controls on final approach

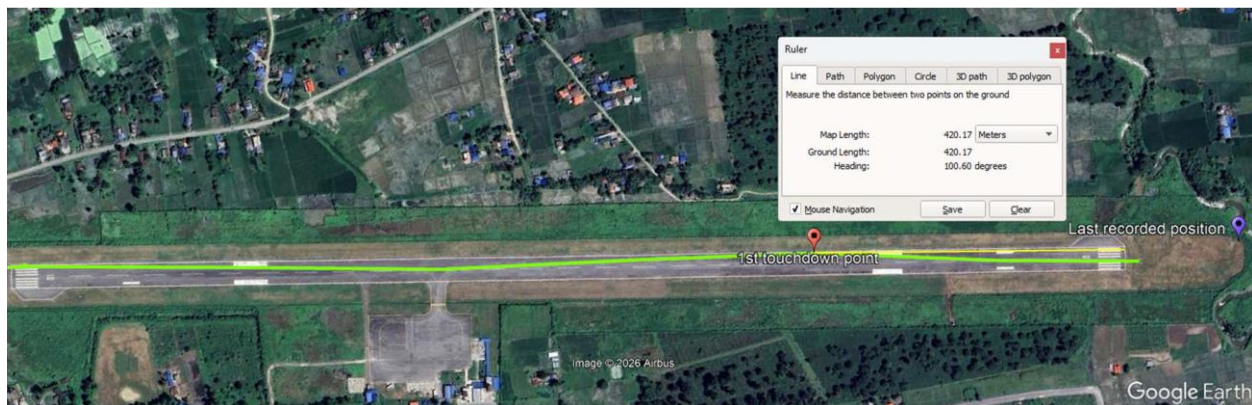
Following the touchdown the aircraft experienced a runway excursion. The aircraft exited the runway end, veered slightly to the left, and broke the perimeter fence before coming to a halt over a small stream. Following this, fifteen seconds later, VNCG tower gave taxi clearance to holding point to another aircraft waiting to enter the runway.

Figure 3 Floating path and touchdown location of the aircraft

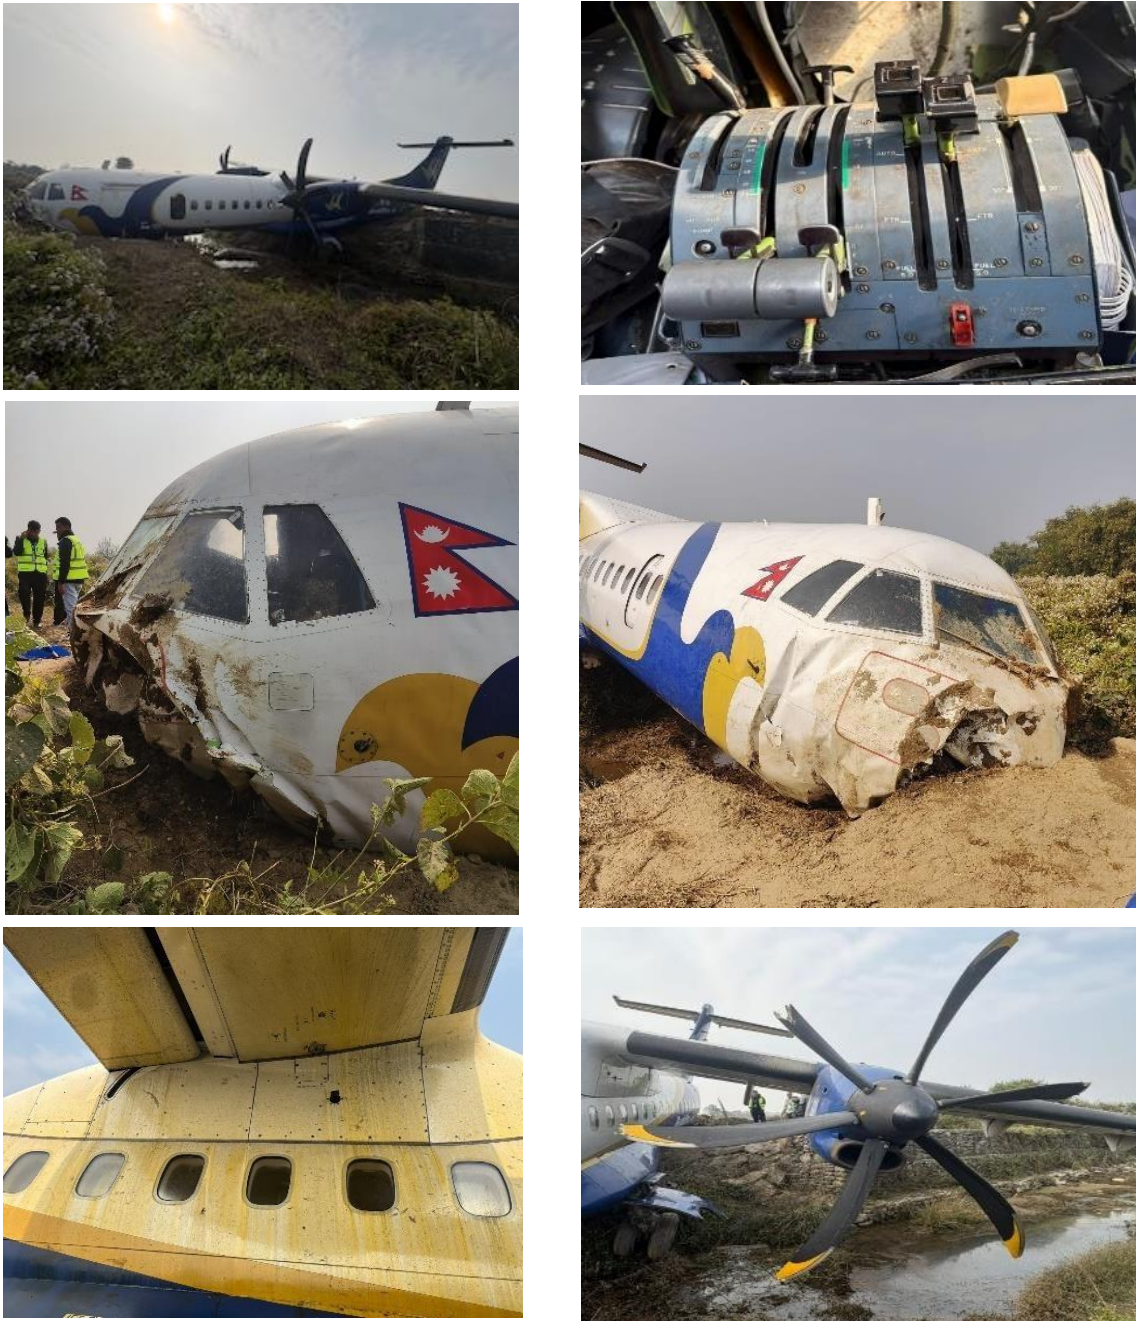
The aircraft sustained substantial damage. The aircraft's nose landing gear broke and collapsed into the landing gear bay after the aircraft overran the runway and impacted the creek beyond the eastern end of the runway. The impact caused significant damage to the lower section of the nose fuselage.

the impact. Although the propeller assemblies remained attached to the engines, nearly all composite propeller blades were fractured or severely damaged.

The cockpit flight instrument panel was heavily damaged and rotated by 90°, facing the ceiling instead of the flight crew. The central pedestal showed mechanical deformation. The overhead panel and the breaker shelves were found intact.

Figure 4: Wreckage of the event aircraft at VNCG, showing in situ condition of the exterior of the aircraft at the wreckage site and the position of the power (in reverse) and condition (between auto and 100% OVRD) levers

The exhaust cones of both engines were displaced because of the propeller strikes and landing impact. A significant oil splash was observed on the lower right-hand fuselage area beneath the wing, likely to originate from the propeller hub following the propeller strike. Additionally, several wrinkles were noted on the fuselage skin below the wing leading edge, indicating structural deformation from the impact forces.

In summary, the aircraft sustained substantial structural damage, particularly in the nose section, due to the high-energy impact, rendering the aircraft beyond economical repair (BER).

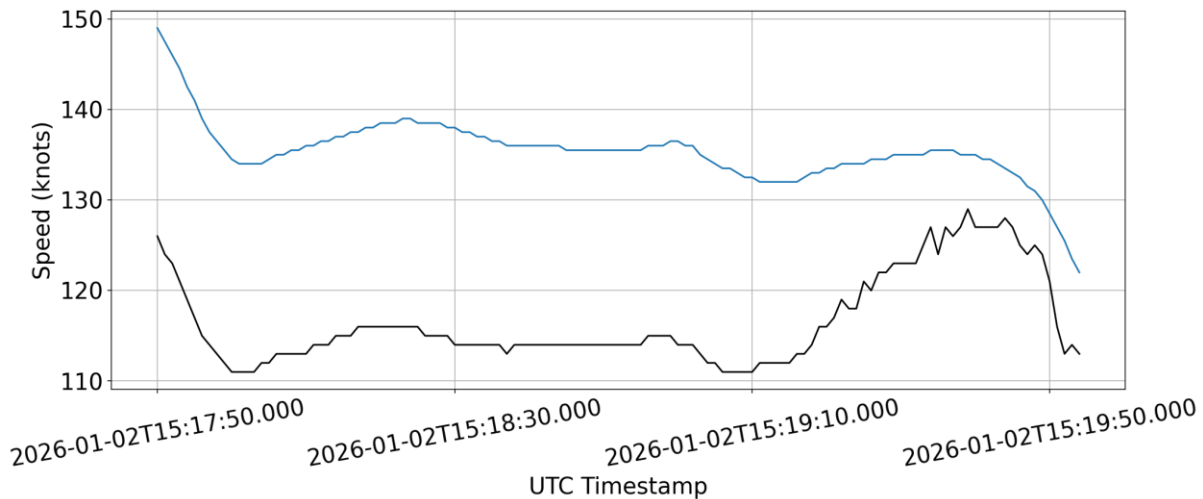
- The heading of the aircraft over the runway changed from approximately 103° near threshold at around 15:19:41, to 105° at around 15:19:55, and then to 98° at around 15:19:59. The heading at the end of the recorded data was approximately 79°. The aircraft overran the runway threshold at approximately 80 kts.

Figure 5: Ground speed (blue) and IAS (black) during final approach and landing phases of the event flight

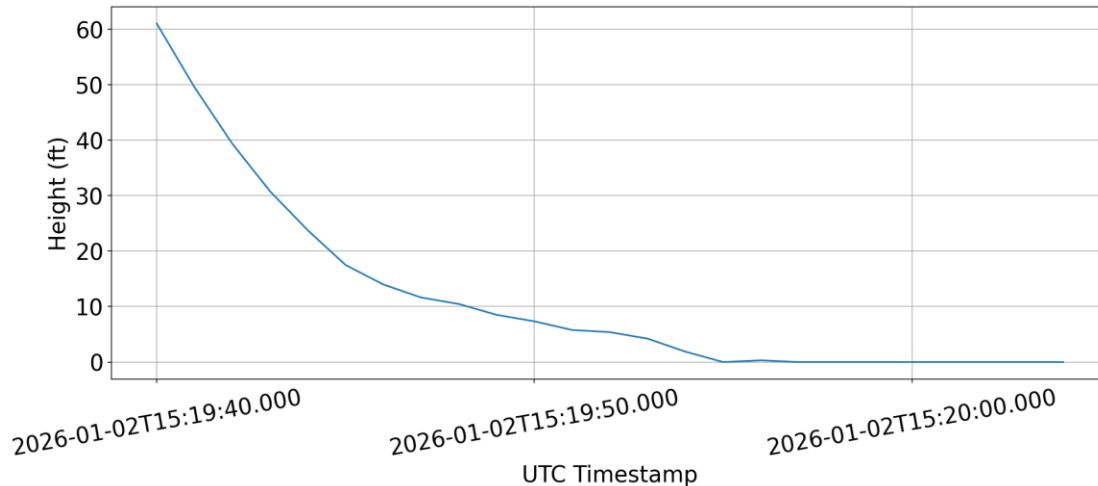
Figure 6: Radio height during the landing phase of the event flight

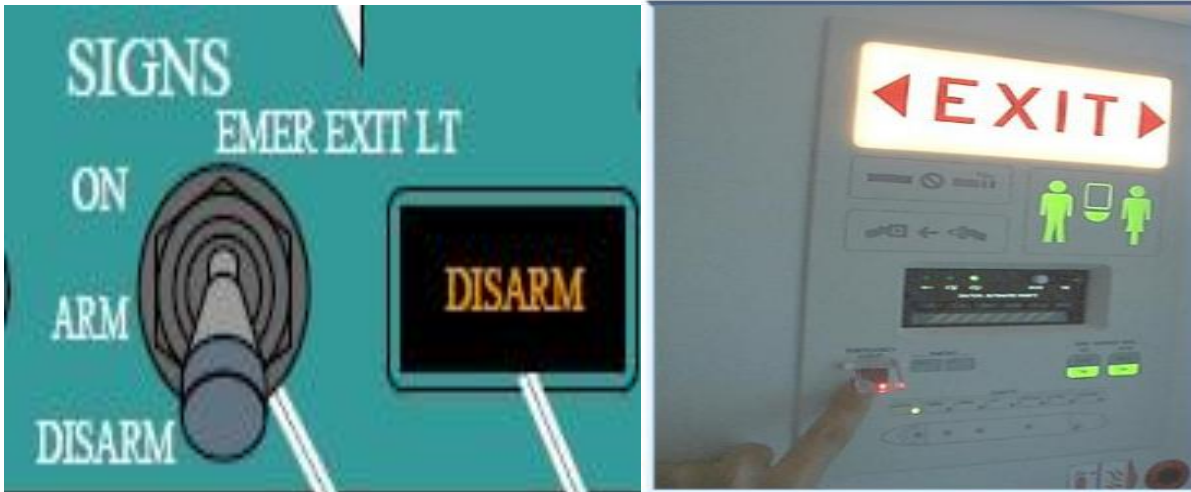
Figure 7 Emergency exit light selector in cockpit overhead panel and flight attendant panel

Examination of the cockpit overhead panel revealed that the EMER EXIT LT selector switch was found in the DISARM position instead of the normal ARM position required for flight operations. According to the Aircraft Flight Crew Operating Manual (FCOM), when the selector is in the ARM position, the emergency lighting system automatically illuminates whenever the DC Standby Bus voltage decreases below 18 V or both generators are lost. Conversely, selection of DISARM electrically isolates the emergency lighting system and prevents automatic activation following loss of aircraft electrical power.

The available evidence indicates that the absence of emergency lighting was not attributable to a system hardware malfunction but resulted from the emergency lighting system having been left in the DISARM position before the occurrence. Consequently, when normal aircraft electrical power was lost following the accident, the automatic activation logic was inhibited and the emergency lights did not illuminate. The failure to manually activate the system from the cabin attendant panel represented a lost opportunity to restore emergency illumination during the evacuation.

The investigation determined that the emergency lighting system failed to illuminate because the cockpit EMER EXIT LT selector had been positioned to DISARM, which inhibited automatic activation following the loss of aircraft electrical power. Electrical continuity checks found no evidence of wiring defects, and the discharged condition of the emergency batteries observed during post-accident examination could not be considered representative of their condition at the time of the occurrence because the examination was conducted approximately three and a half months later. The cabin attendant did not utilize the available manual override function during the evacuation, further contributing to the absence of emergency lighting.

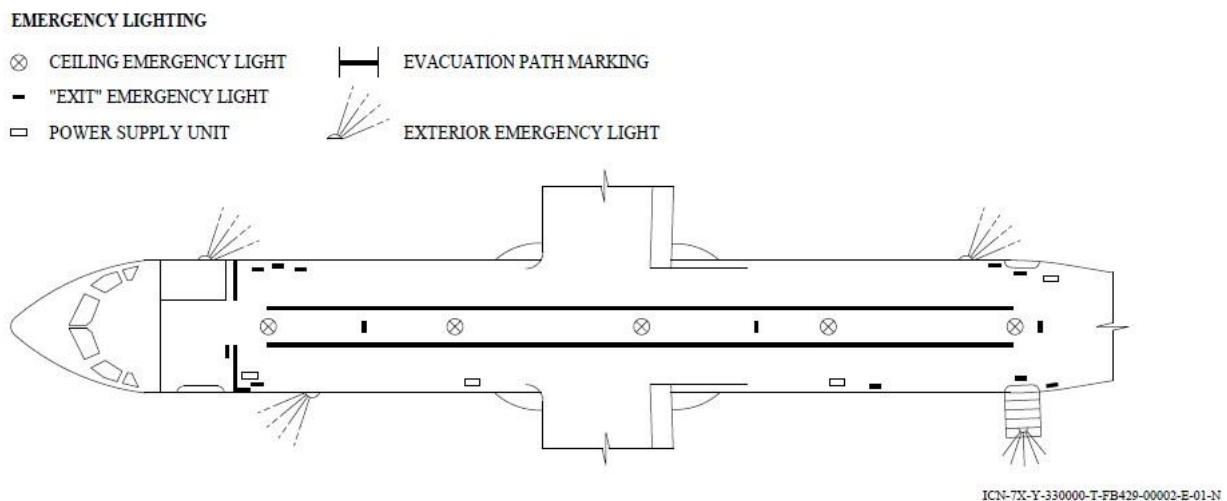
To determine whether the lighting failure resulted from an electrical malfunction, continuity checks were conducted on the wiring between the Flight Attendant Panel, the overhead anti-icing/de-icing/signs panel, and the associated terminal block. All inspected circuits demonstrated satisfactory continuity, indicating that no wiring discontinuity or open circuit existed that could have prevented system operation.

Figure 8 Emergency lights system in the ATR aircraft

The investigation also considered the possibility of failure of the Emergency Power Supply Units (EPSUs). Functional examination performed approximately 3.5 months after the occurrence found that all EPSU batteries were fully discharged. However, this condition was considered an expected consequence of the elapsed time following the accident and therefore could not be used to determine the battery state immediately after the occurrence. Consequently, no conclusion could be drawn that battery failure existed at the time of the accident. The battery condition observed during the examination should therefore not be considered a causal factor.

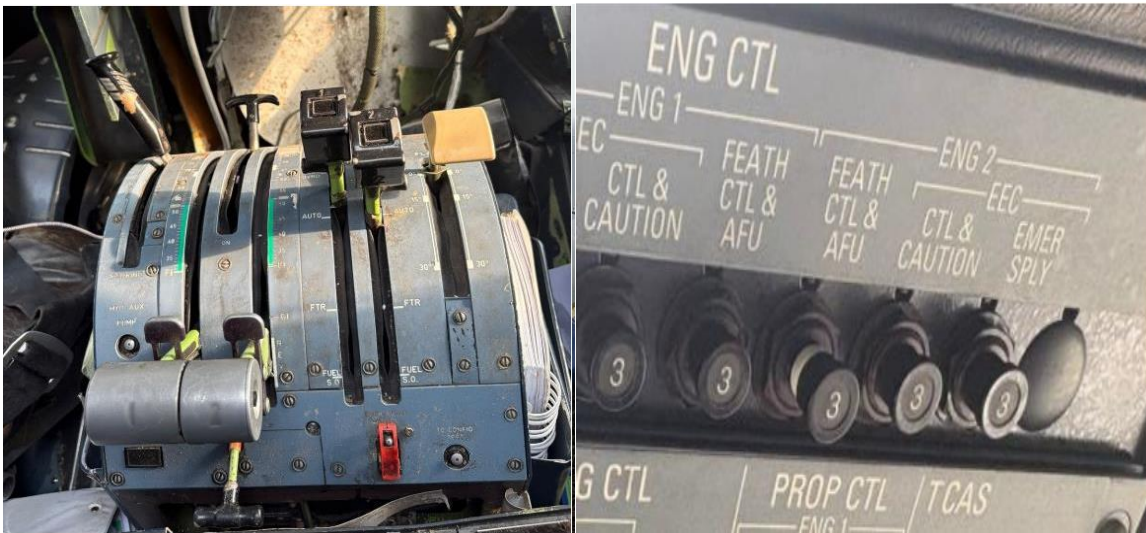
Figure 9 Indicative components for engine power and other engine control functions

Physical examination of the cockpit control revealed that both Condition Levers were jammed and locked tightly in the **AUTO** position. The crushing forces sustained by the lower cockpit structure during the runway overrun severely deformed the internal mechanical control beneath the cockpit floor. This structural binding physically prevented the flight crew from retarding the Condition Levers to the **FUEL SO** position, completely disabling the primary mechanical method of engine shutdown.

Visual inspection of the Engine 2 LP fuel shutoff valve assembly revealed that the valve mechanism was seized at an intermediate, mid-transit position. The mechanical position indicator was found resting between the fully Open ('O') and fully Closed ('F') markings, confirming the valve failed to complete its required angular travel.
