MAPPING HAZARDS IN NEPAL'S MELAMCHI RIVER

CATCHMENT TO ENHANCE
KATHMANDU'S WATER SECURITY

NOVEMBER 2023

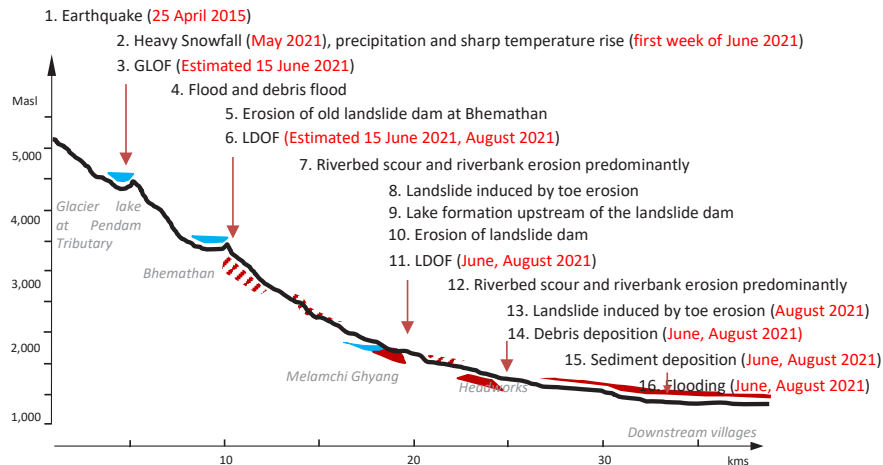
Figure 1: Events Leading Up to the 2021 Melamchi Basin Floods

Toe erosion caused by the flows from Bhemathan, coupled with prolonged rainfall in the catchment, triggered a major landslide further downstream that dammed the river. Breaching of this natural dam generated outburst floods from the lake that formed behind it, and this, in turn, created new natural dams whose breach caused additional outburst floods. Cumulatively, the outbursts eroded the riverbanks between Bhemathan and the headworks area, and deposited sediments in the headworks area and further downstream. Toe erosion due to these floods and increased soil saturation due to prolonged rainfall also aggravated an existing landslide on the left bank of the headworks.

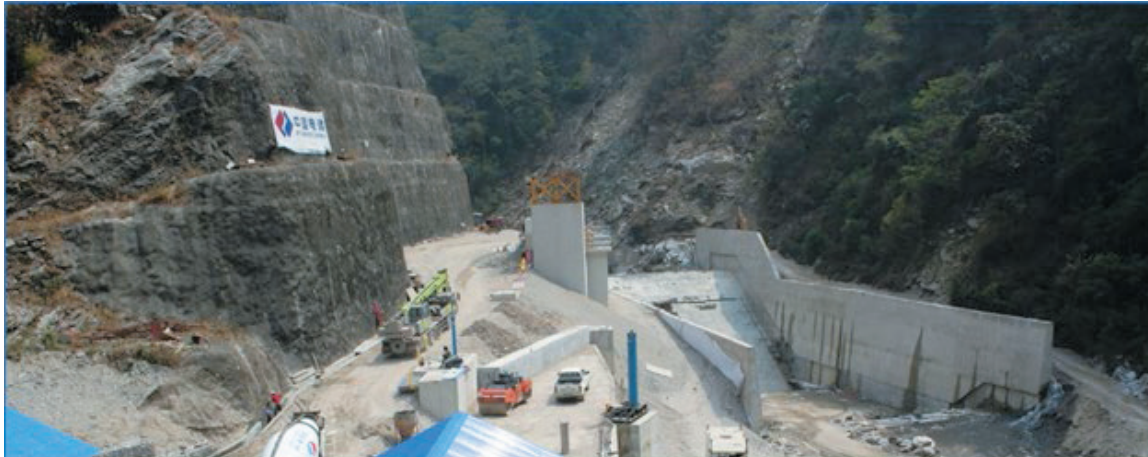
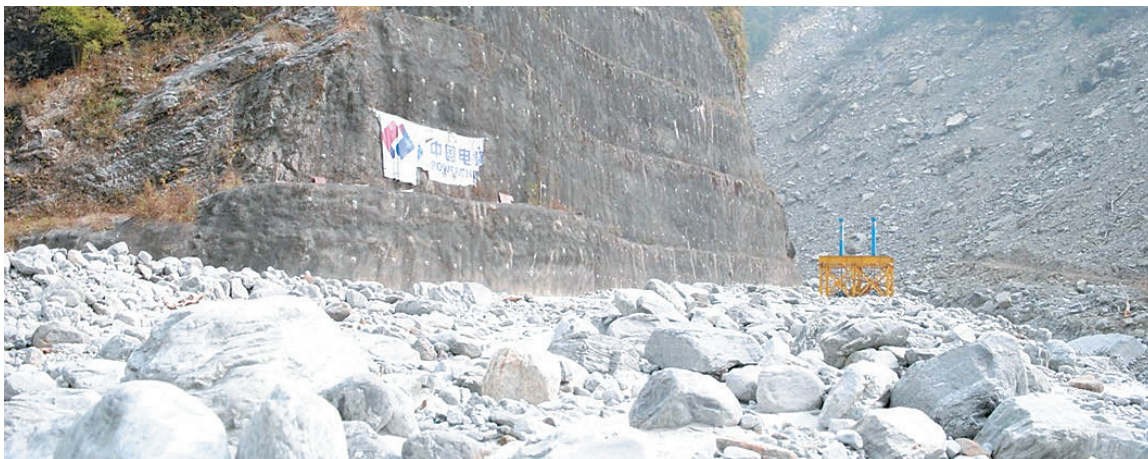
Pre-disaster (above) and post-disaster condition (below) of Melamchi headworks (photo by TA team)

The second event also caused heavy erosion along the river channel, with extensive collapse of the V-shaped channel walls. In addition, it severely damaged roads, bridges, and public and private property in the downstream reaches of the river.

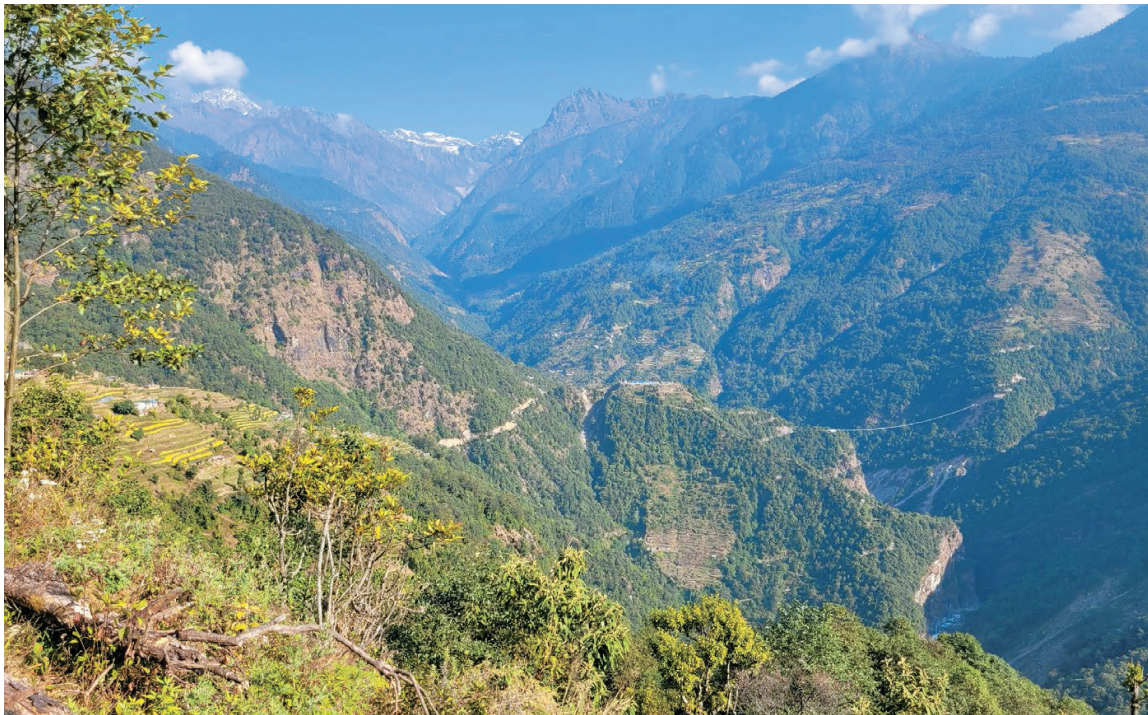
View of the Melamchi River gorge with headworks in lower right corner (photo by TA team).

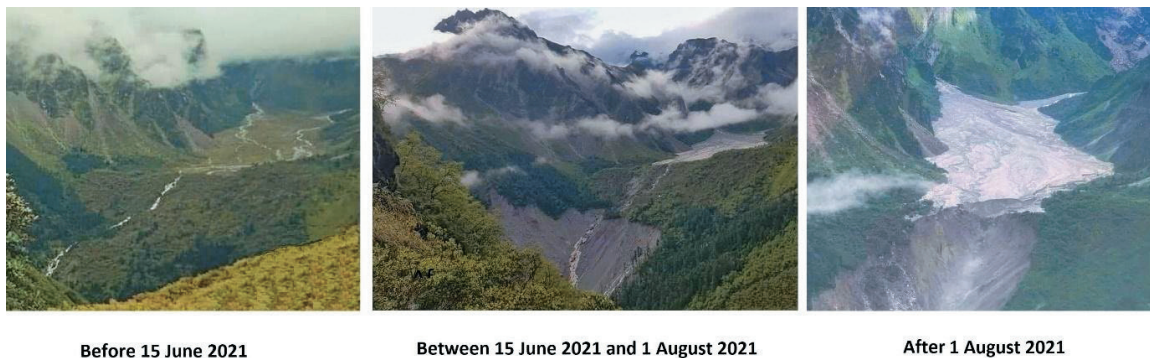
Figure 2: Aerial Images of Flood Impacts at the Bhemathan Deposit

Before 15 June 2021

Between 15 June 2021 and 1 August 2021

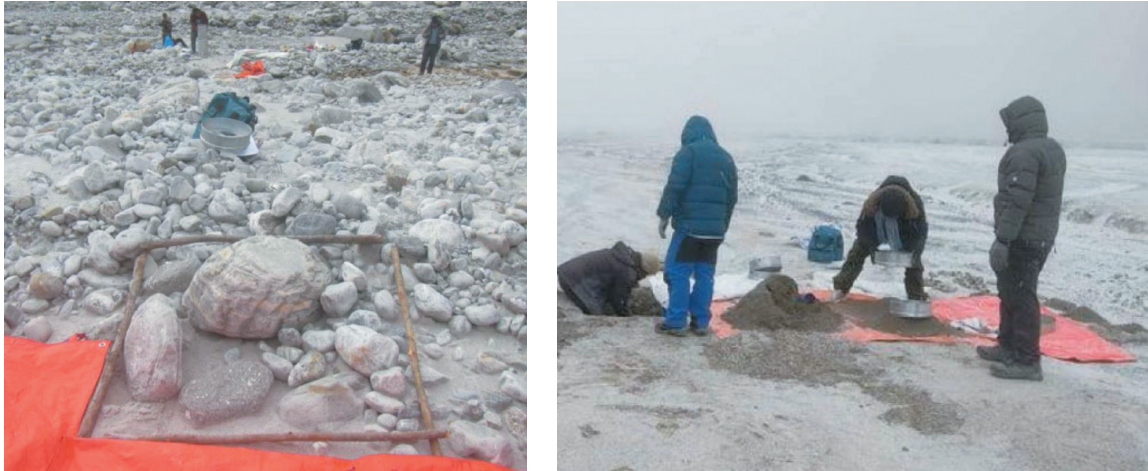
Bed sediment sampling in plots (left) and at Bhemathan (right) (photos by Clean Energy Consultants Pvt. Ltd.)

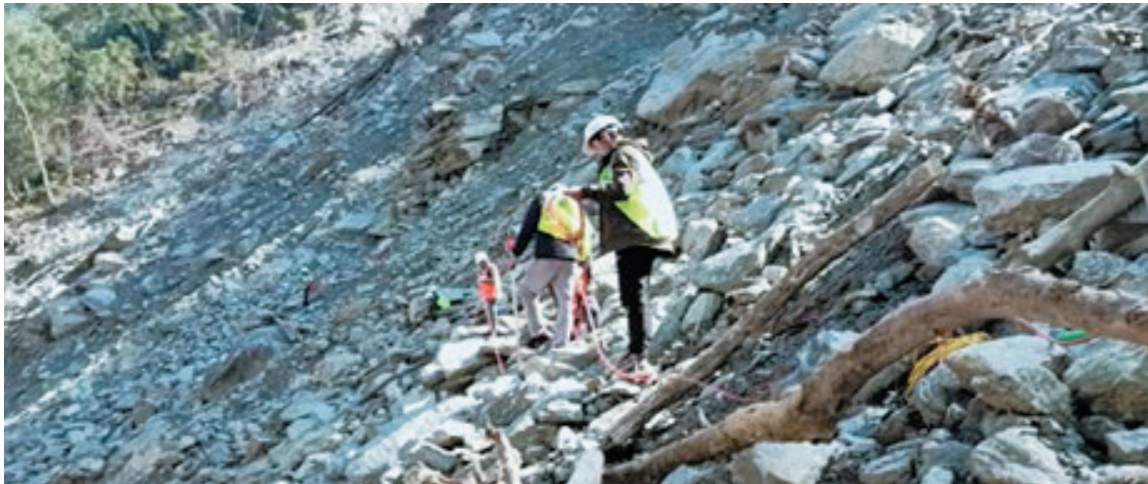
Geophysical surveys at Bhemathan and the headworks landslide were carried out to establish their subsurface conditions, estimate the quantity of erodible sediments at Bhemathan, and assess the risk of their erosion. The surveys consisted of two-dimensional electrical resistivity tomography (ERT) and seismic refraction tomography (SRT) along selected profile lines. At Bhemathan, eight ERT and 36 SRT profiles, with aggregated lengths of 3.82 km and 3.45 km, respectively, were carried out. However, three ERT profiles totaling about 1 km produced data errors because of cable faults caused by snow cover and low temperatures. At the headworks landslide, five ERT profiles and six SRT profiles, totaling 1,865 m and 690 m, respectively, were surveyed.

Geophysical sampling preparation on the landslide slope near the Melamchi headworks, February 2022 (photo by Explorer Geophysical Consultants, Pvt. Ltd.).

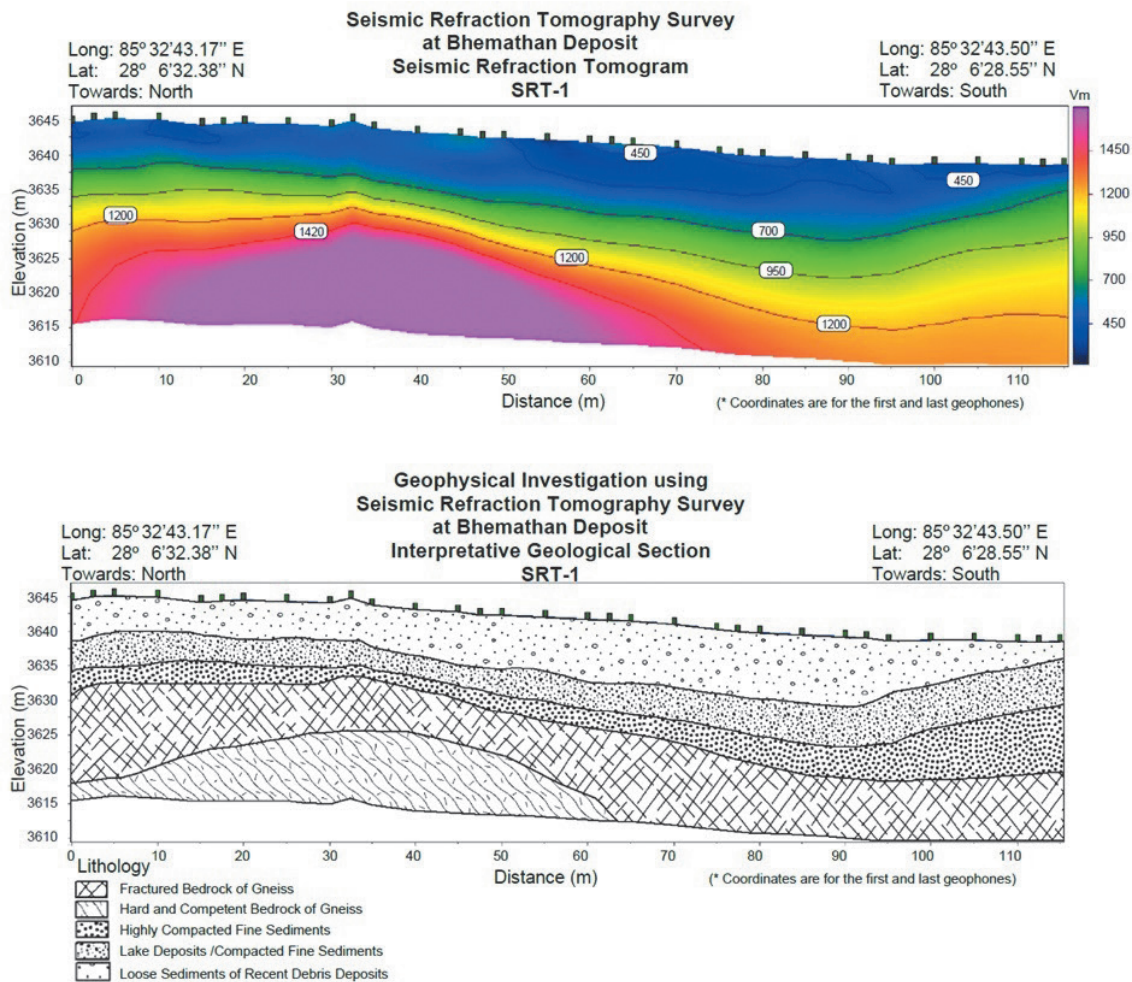
Figure 4: Seismic Refraction Tomography Survey in Bhemathan

m = meter, SRT = seismic refraction tomography, vm = velocity model.

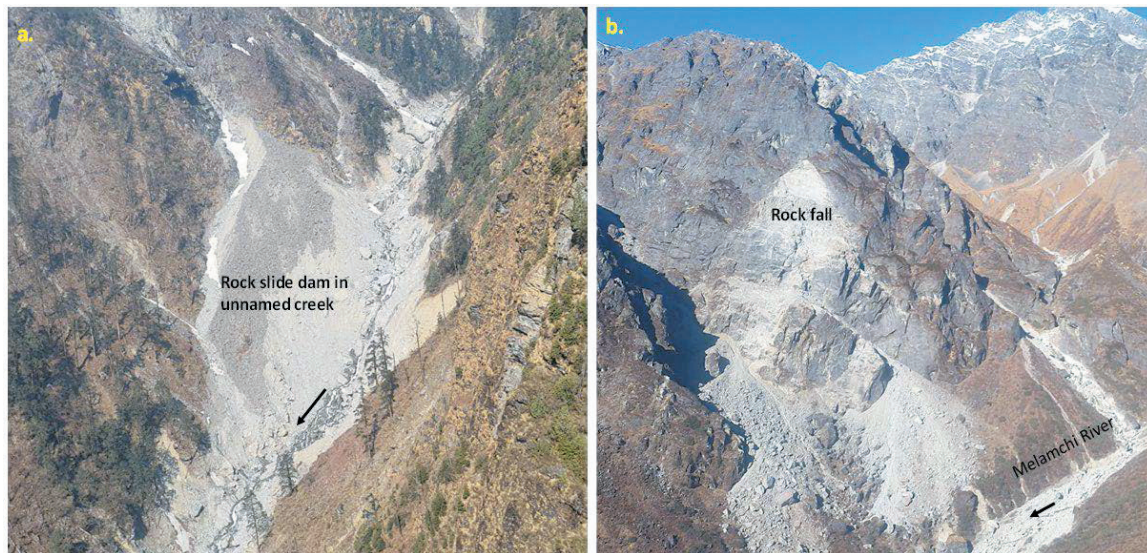
Rockfall and Rockslides are shown in an unnamed creek between Namsan Creek and Bhemathan. Arrow shows debris flow direction (photo by TA team).

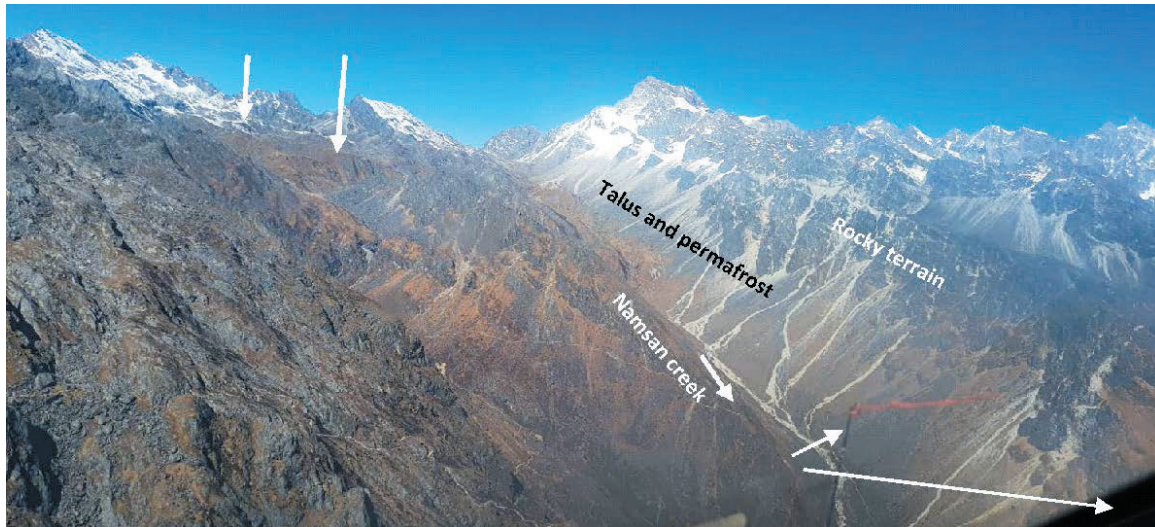
Another serious issue of headward erosion and possible GLOF-related flash floods is noticed in the areas around glacial lakes upstream of Namsan Creek. The creek itself has many erosion areas and has rockfall scree with talus deposits²³ on the left bank above the deglaciated valley and permafrost.

Fragile geomorphological settings of Namsan Creek (photo by TA team).

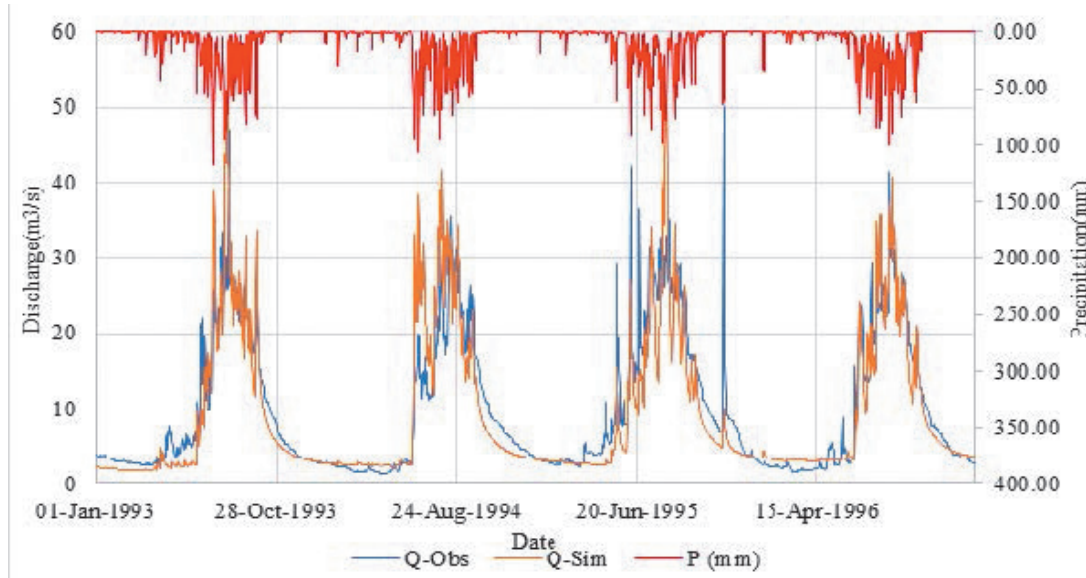
Figure 17: Observed and Simulated Hydrograph, Daily Averaged Values, 1993-1996

m³/s = cubic meter per second, mm = millimeters, p = precipitation, Q-Obs = observed discharge, Q-Sim = simulated discharge.

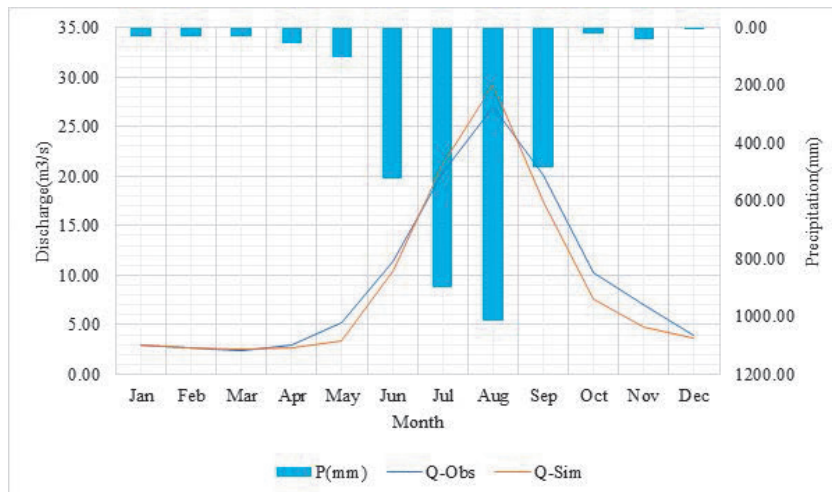
Figure 18: Observed and Simulated Hydrograph, Monthly Averaged Values, 1993-1996

m³/s = cubic meter per second, mm = millimeters, p = precipitation, Q-Obs = observed discharge, Q-Sim = simulated discharge.

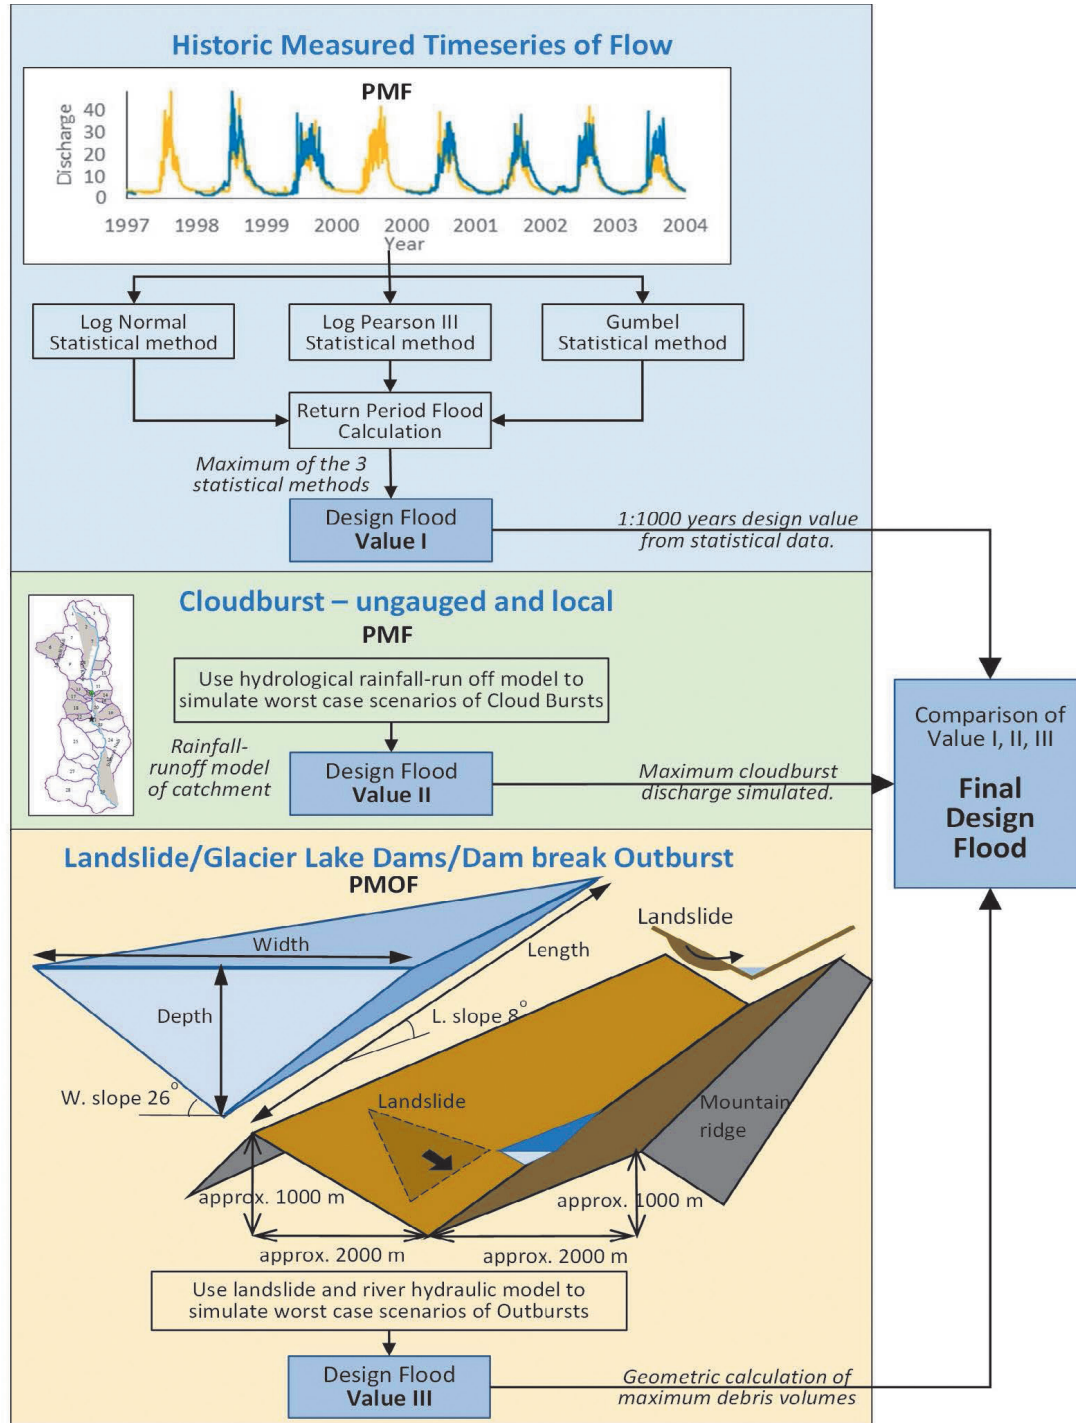
Figure 21: Proposed PMOF Approach for Estimating Maximum Discharge

Exceeding the design flood highlighted the need for incorporating climate change impacts in estimation of maximum floods by including various processes in geology, geomorphology, hydrology, etc., that influence multi-hazards. Accordingly, the concept of probable maximum outburst flood (PMOF) was introduced in this study. This concept involves estimations of GLOF, LDOF, cloudburst⁴ floods, and probable maximum flood (PMF) for the catchment and the selection of the peak flood discharge based on a rational combination and comparison of the various floods.

Application of the PMOF approach to the Melamchi catchment yielded a maximum flood value of 3,500 m³/s. Given the various possible scenarios of multi-hazard combinations in the catchment, the uncertainty in the PMOF estimate thus derived can be very high.

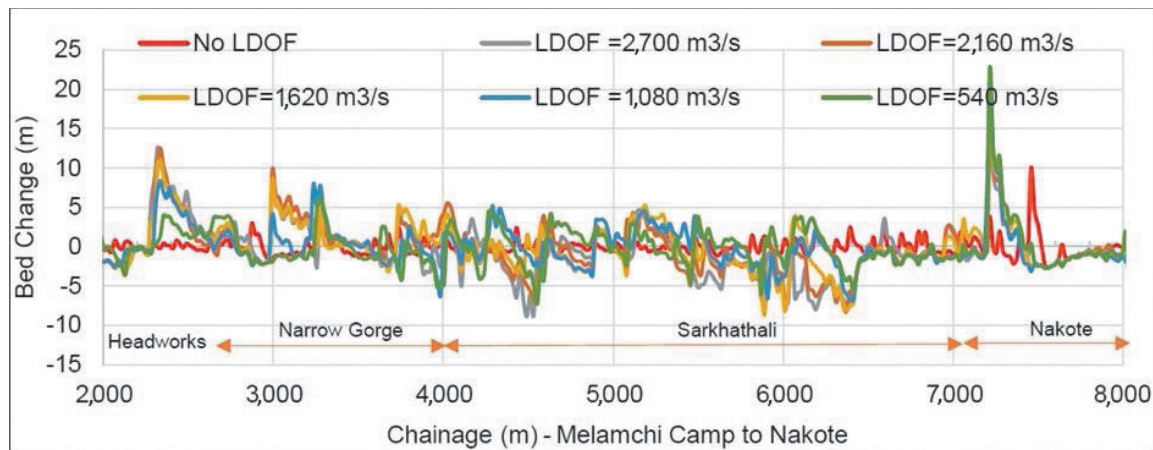
Figure 31: Headworks-Nakote Bed-Level Change with Different Discharge Scenarios

m = meter, LDOF = landslide dam outburst flood
Note: Chainage from 2,100 m to 2,800 m is the headworks area
Source: Authors.

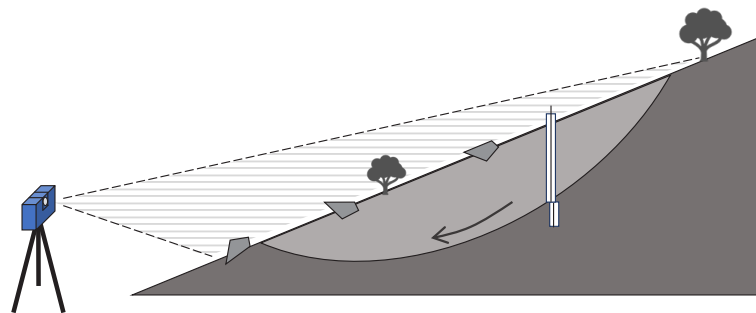
Figure 43: Using a Long-Range Light Detection and Ranging (LIDAR) Scanner and Inclinometer to Detect Motion

Note: Image shows long-range 3D LIDAR scanner on the left, inclinometer on the right.
