Department of Forests and Soil Conservation

**Bathymetric Survey and Sedimentation  
Assessment of Begnas and Rupa Lakes, Pokhara Valley  
(Final Report)**

**Submitted By**  
**Geo Three D Modelling Pvt. Ltd**  
Kageshwori Manohara-9  
[www.geo3dmodelling.com.np](http://www.geo3dmodelling.com.np)  
+977-9842520354

*June 2026*

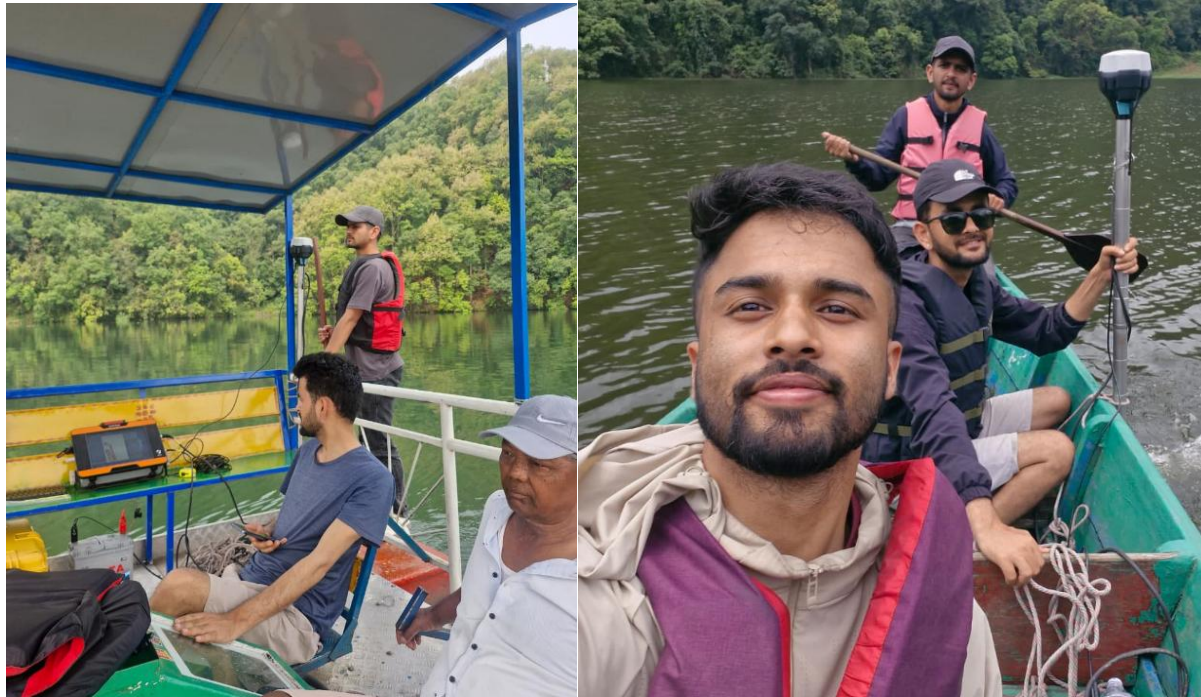
Field operations were conducted from an inflated survey boat crewed by a boatman, two survey team member, and one field assistant. The survey team was responsible for confirming each measurement location, recording three-dimensional positional data comprising depth, latitude, and longitude.

*Figure 6: Showing echo-sounder device being mounted on the paddle and rowing boat*

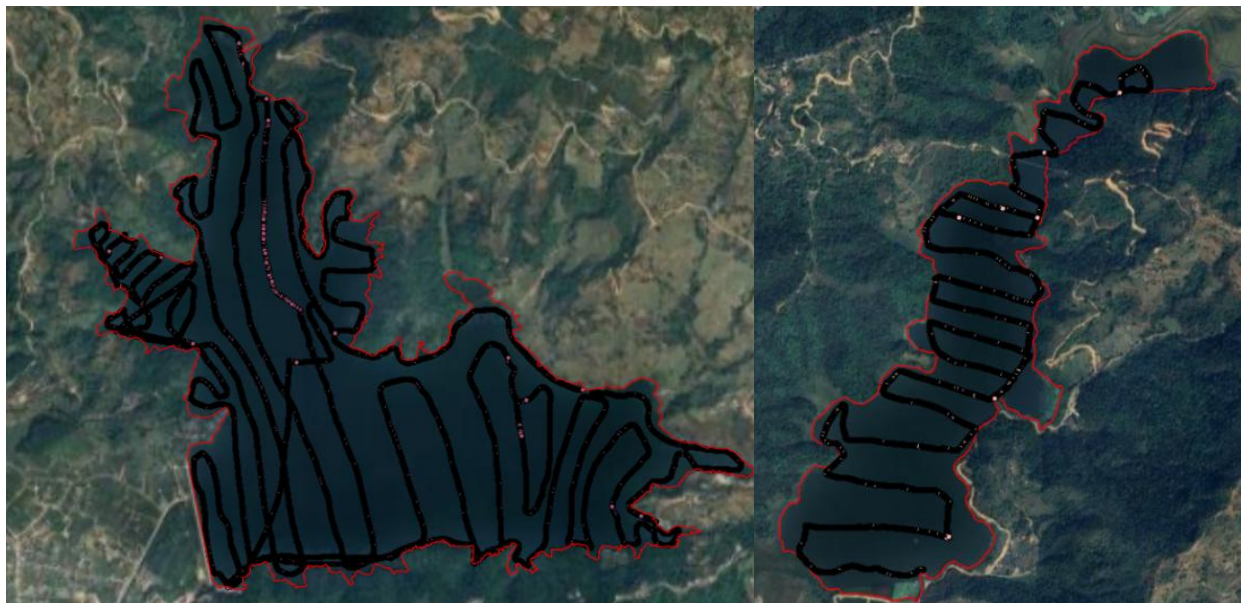
*Figure 7: Showing the actual line transects for Begnas (left) and Rupa (right) Lake*

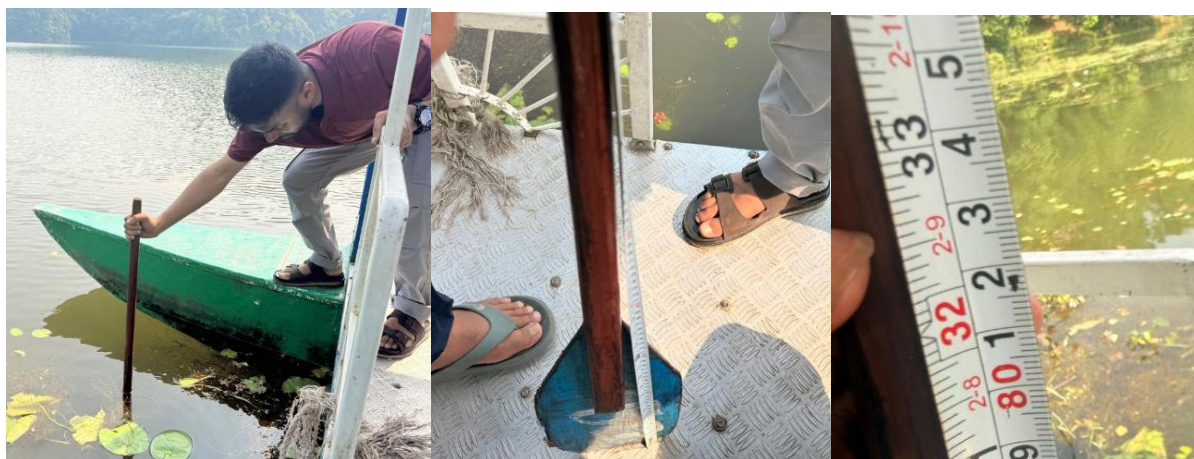
Before the survey echo-sounder was calibrated using tape measure as shown in the figure below where wooden stick was dipped into the water and tape measure was used to measure the water depth and again echo-sounder was used at the same location to measure the depth, It was found the error with within plus minus 3 cm. Calibration checks were repeated periodically throughout the survey campaign, particularly following equipment transportation, battery replacement, or abrupt changes in environmental conditions.

*Figure 8: Showing the Calibration of echo-sounder in the field*
