Government of Nepal Ministry of Urban Development National Research Center for Building Technology (NRCBT) Babarmahal, Kathmandu

AN ASSESSMENT TO OCCUPATIONAL HEALTH AND SAFETY PRACTICES IN BUILDING AND URBAN ROAD CONSTRUCTION SITES

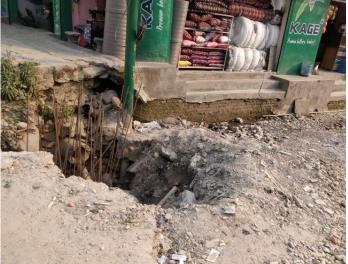
Overhead electrical cables posing risk in urban road construction site

- **Site 11:** Box Culvert and Disaster Management Work site had mainly traffic hazards, dust hazards, heat stress, lack of proper PPEs and failure to use PPEs consistently, lack of proper signs etc. Overhead power cables were also posing risk.
