# BUDHIGANGA HYDROPOWER PROJECT

## REPORT from DAILY SITE MONITORING SYSTEM

Reporting Period: August 2026

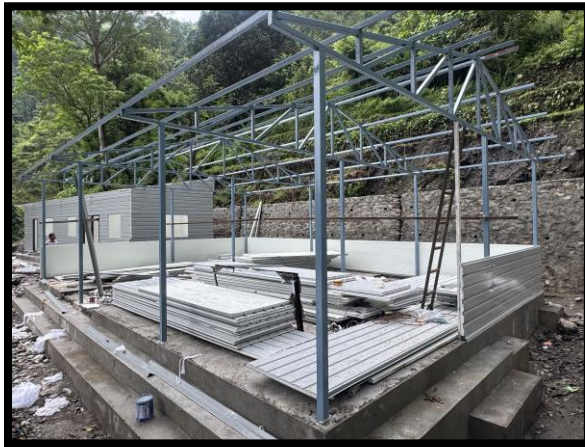
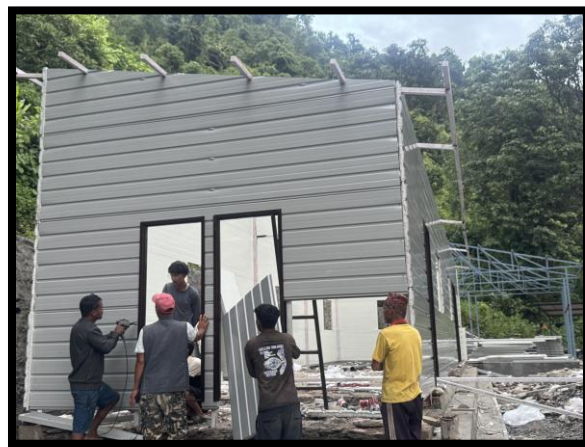
## Guest House

Contractor Camp developments centered on structural cladding and interior division. For the Executive Guest House, 25 square meters of SY sandwich panel boards were installed on August 23, and exterior wall cladding was finalized. This was followed on September 1 by the assembly of internal partition walls and truss color coatings. Meeting Hall truss installation and horizontal frame connections were fully completed. Additional site preparation and layout plans for the Contractor's Engineer Camp were completed on September 1.

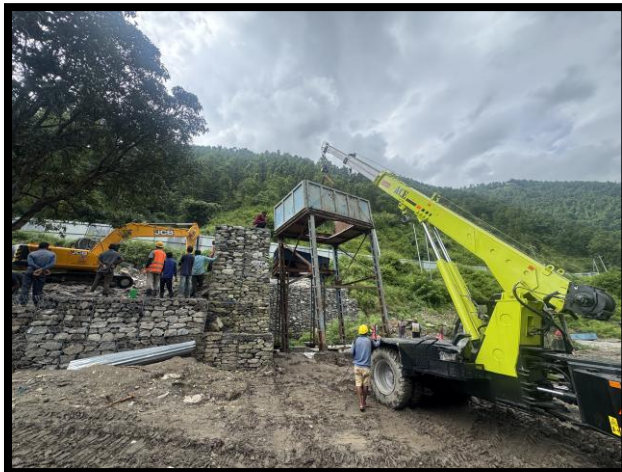
## Crusher Plant

Industrial installation at the Crusher Plant moved rapidly. Fencing operations progressed through vertical post installations and horizontal frame welding, reaching 100% completion on August 8. Heavy civil foundation bases for processing equipment were poured, with PCC work for the screen crusher completed. Mechanical assembly commenced immediately with the successful installation of the crusher unit hopper. The Storage House area was leveled and completed with structural soling on August 23, with steel fabrication and 50% of the GI roofing sheets installed. For local utilities, sanitary and plumbing lines for the toilet building were completed and excavation of the toilet foundations proceeded on August 4.
