Spring Inventory and Mapping

A Report of Baruwa Watershed, Triyuga, Udayapur, Nepal

Basin Management Center,
Koshi Gaighat, Udayapur

June 2022 (Jeth, 2079 B.S)

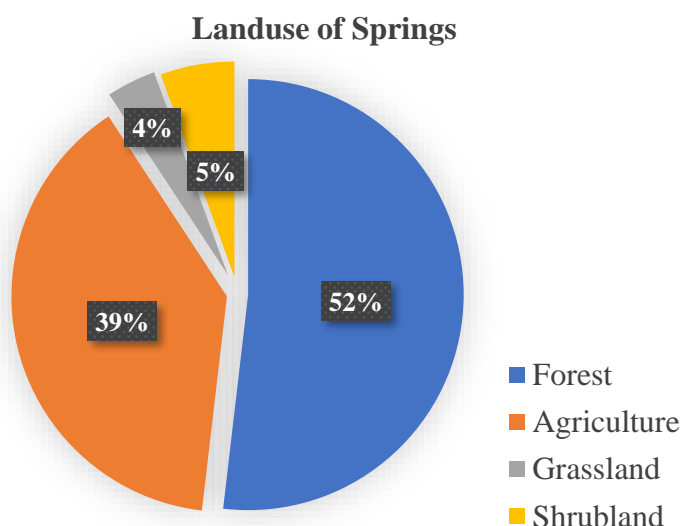
The landuse map prepared from the DEM produced by the Department of Survey. Seven landuse classes have been identified in that area: agriculture land, forest, grassland, shrubland, built-up area, water body, and barren land. A total of 52% of spring is located in the forest, 39% in Agriculture land, 4% in grassland, and 5% in Shrubland (Figure 4.3).

Figure 4.3: Pie diagram showing the percentage covered by Forest, Agriculture, Grassland, and Shrubland in the study area.

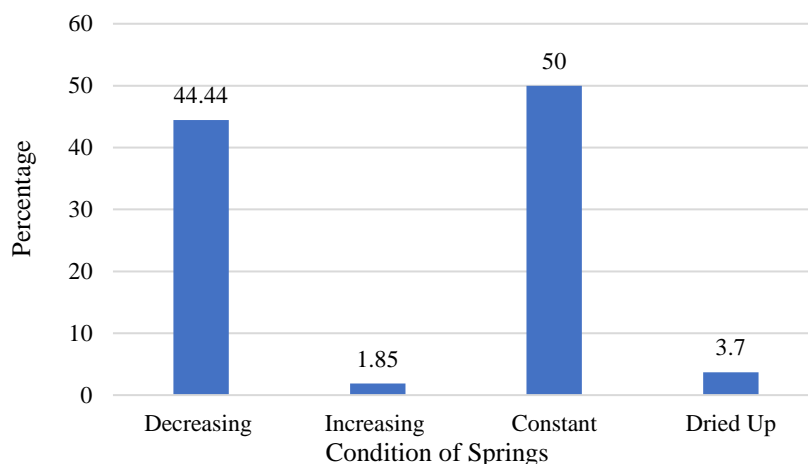
Figure 4.6: Historical trend of Spring in the Baruwa watershed

As depicted in Figure 4.6, the flow from many springs has lessened. The findings revealed that the flow from approximately 44.44% of springs has reduced. 3.7% are completely dried, 50% remain constant, and 1.85% increase.

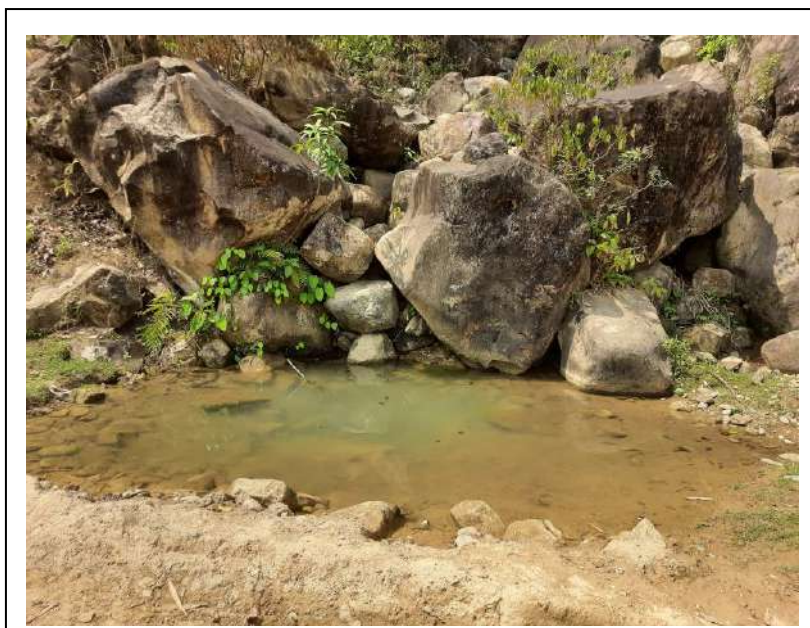
Photograph of Spring

Type of Spring	Depression: √	Contact:	Fracture:	Fault:	Karst:
Water Available:		Annually: √	6 months:		3 months:
Current Condition:		Flowing: √	Drying up:		Dried Up:
Spring water History trend:		Increasing:	Constant: √		Decreasing:
Infrastructure to conserved Spring		Not Built

Discharge		9.6 L/M			
Spring Located	Ridge and Gulley: ✓	Rocky terrain:	Agriculture land:	Forest:	River Bank:
Types of Deposit		Residual			
Related Hazard		No			
Possible Useful		Drinking for small community.			
Outlet of Spring		From a flowing stream.

- Details of any damage to the Spring: Road Construction led to a damaged Spring.
- Local-level/ local people use the the procedure to conserved Spring. Not used any measured.

The Spring holds good storage capacity for the small community. The surrounding area is hazard less. Water Awareness programs can be conducted for the community for their good water preservation. Water Boundary and storage tank should be made to sound water and good water quality.

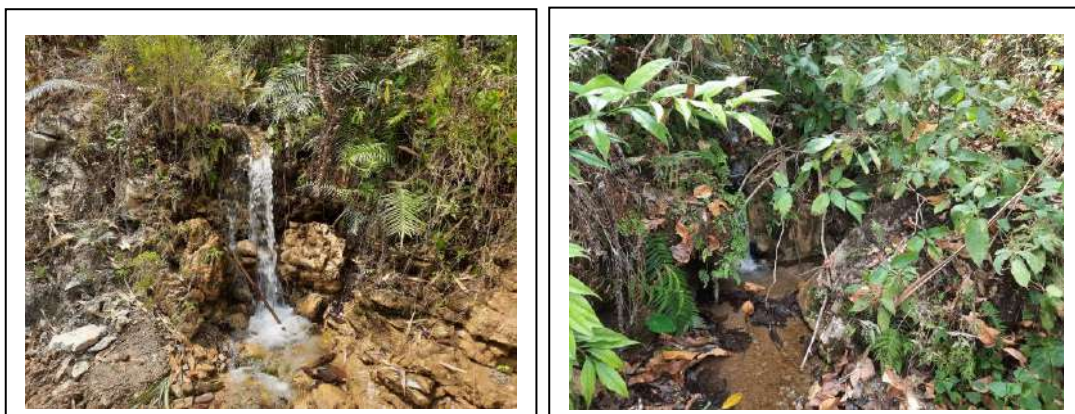
Photograph of Spring

The area is composed of Dolomitic terrain. The Spring contains a very good storage capacity for a large community. Water Awareness programs can be conducted for the community for their good water preservation. Water Boundary and storage tank should be made to sound water and good water quality.

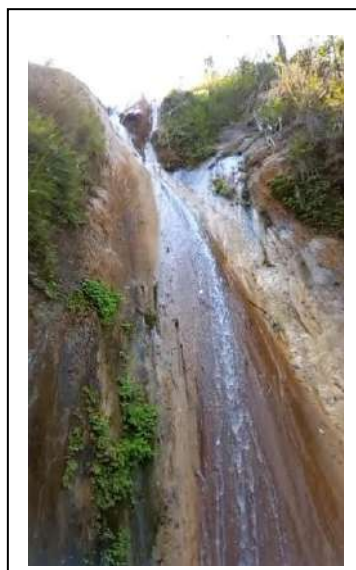
Photograph of Spring

The Spring holds a good storage capacity for the small community. Clear vegetation above the head of the spring. Local-level Water Awareness programs can be conducted for the community for their good water preservation. Fence the area around the spring tank to prevent pollution by children or livestock.

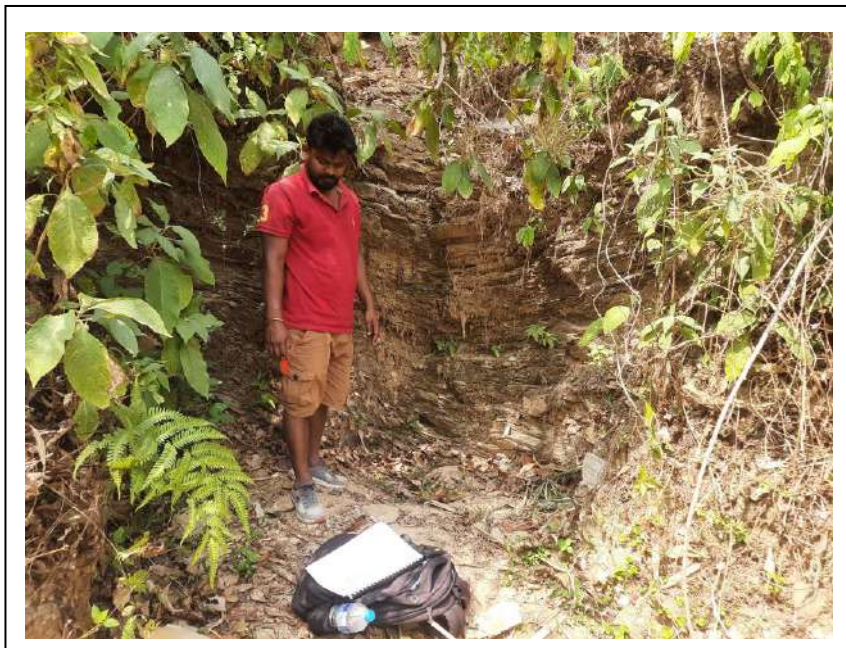
Photograph of Spring

There are Problems related to water in this village. They travel Some distance to collect water. They brought water using a tube but that was not sufficient. The water from this spring can provide only for three months during the monsoon. Fence the area around the spring tank to prevent pollution by children or livestock. Clear vegetation above the head of the spring to make it bacteria-free.

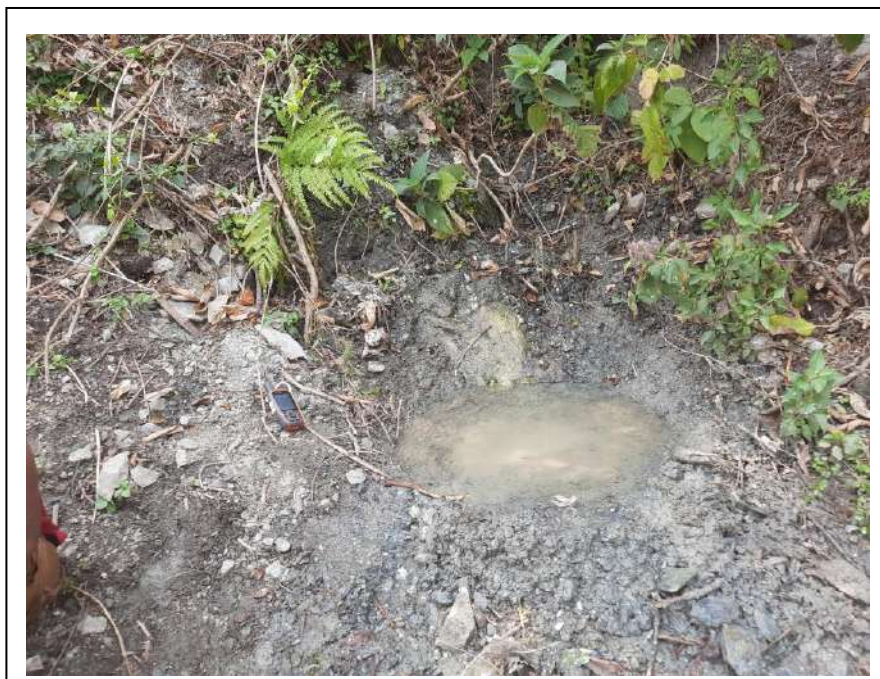
Photograph of Spring

The Spring storage capacity is very low. Water Awareness programs can be conducted for the community for their good water preservation. Fence the area around the spring tank to prevent pollution by children or livestock. Water boundaries and water collection tanks can be a useful measure to store good water.

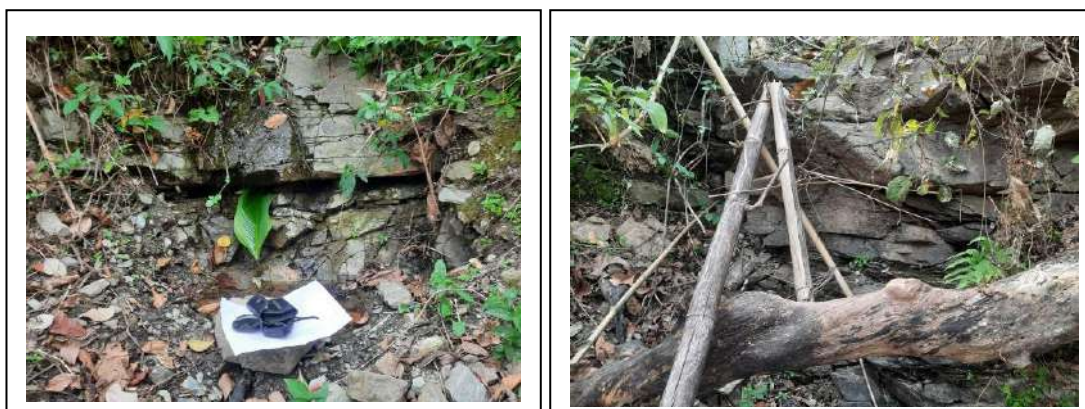
Photograph of Spring

The Spring can hold storage capacity for a small community. Important water Awareness programs can be conducted for the community for their good water preservation and waste management. Fence the area around the spring tank to prevent pollution by children or livestock. Rock Slope stability measures to be applied to conserved water.

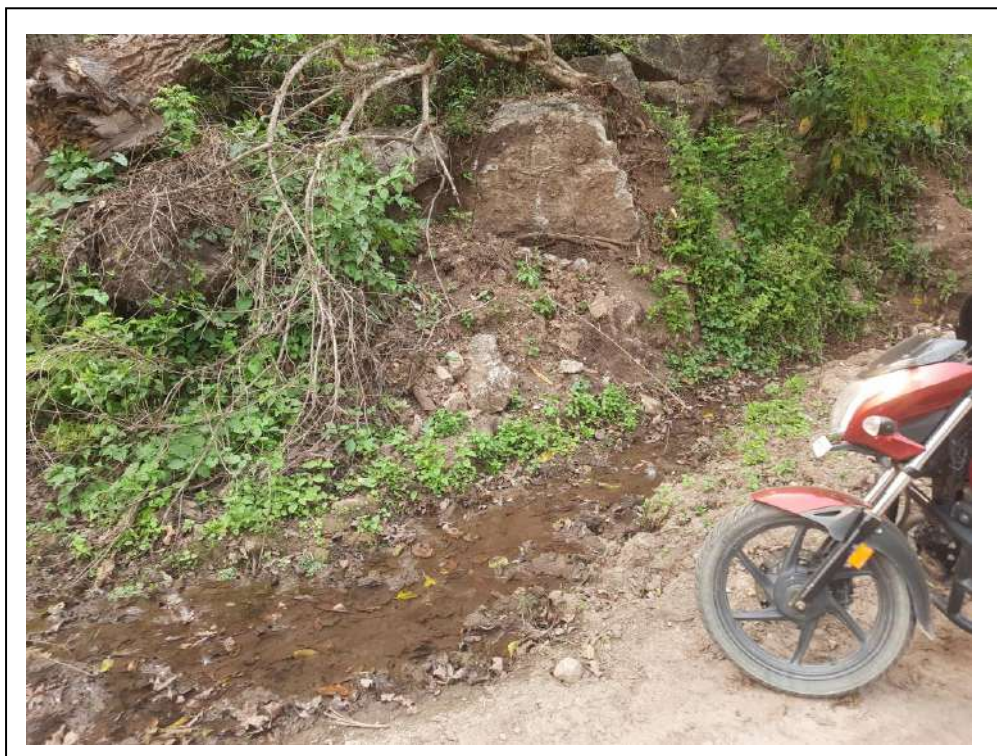
Photograph of Spring

Water Awareness programs can be conducted for the community for their good water preservation. Fence the area around the spring tank to prevent pollution by children or livestock. A Water Storage tank is necessary to collect the water.

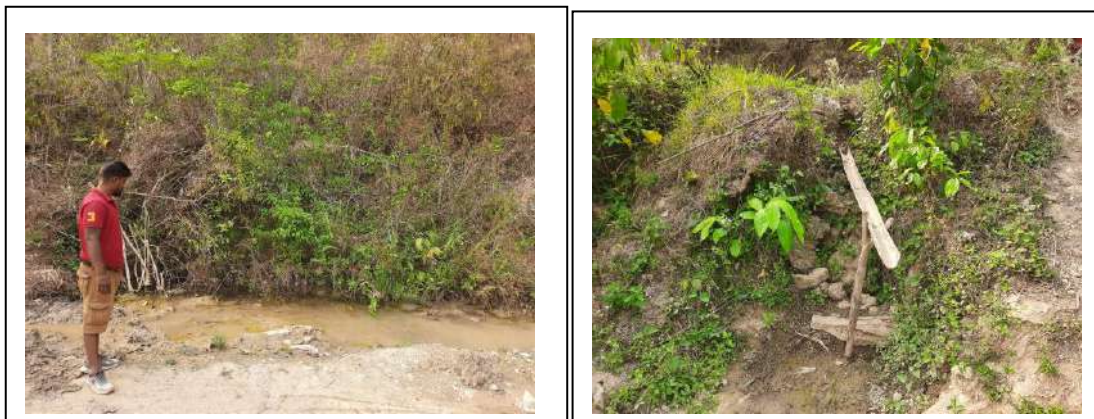
Photograph of Spring

Water Awareness programs can be conducted for the community for their good water preservation. Fence the area around the spring tank to prevent pollution by children or livestock.

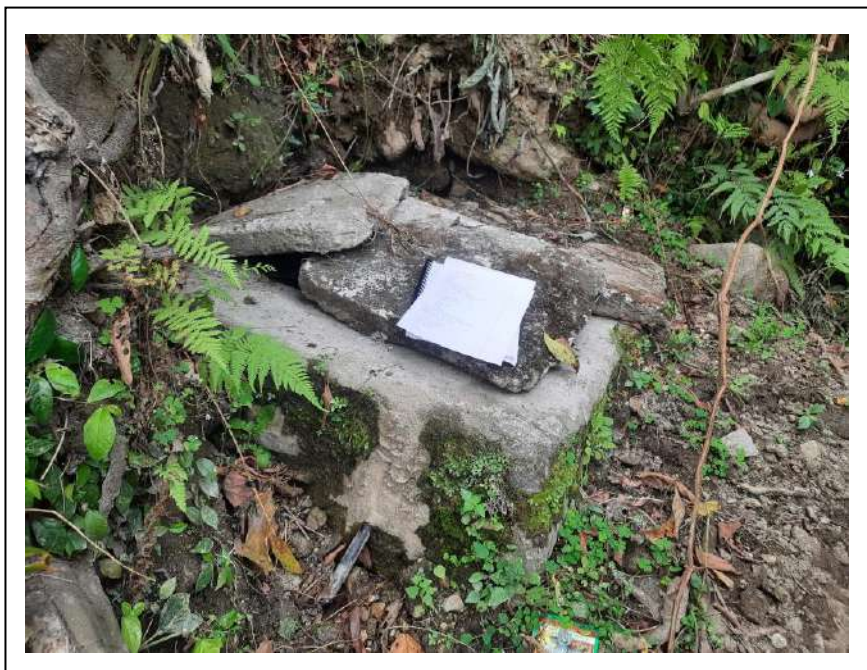
Photograph of Spring

The Spring holds a very good storage capacity for a large community. Clear vegetation above the head of the spring to make it bacteria-free. Many other communities use water using the tube from storage. Water Awareness programs can be conducted for the community for their good water preservation. Fence the area around the spring tank to prevent pollution by children or livestock.

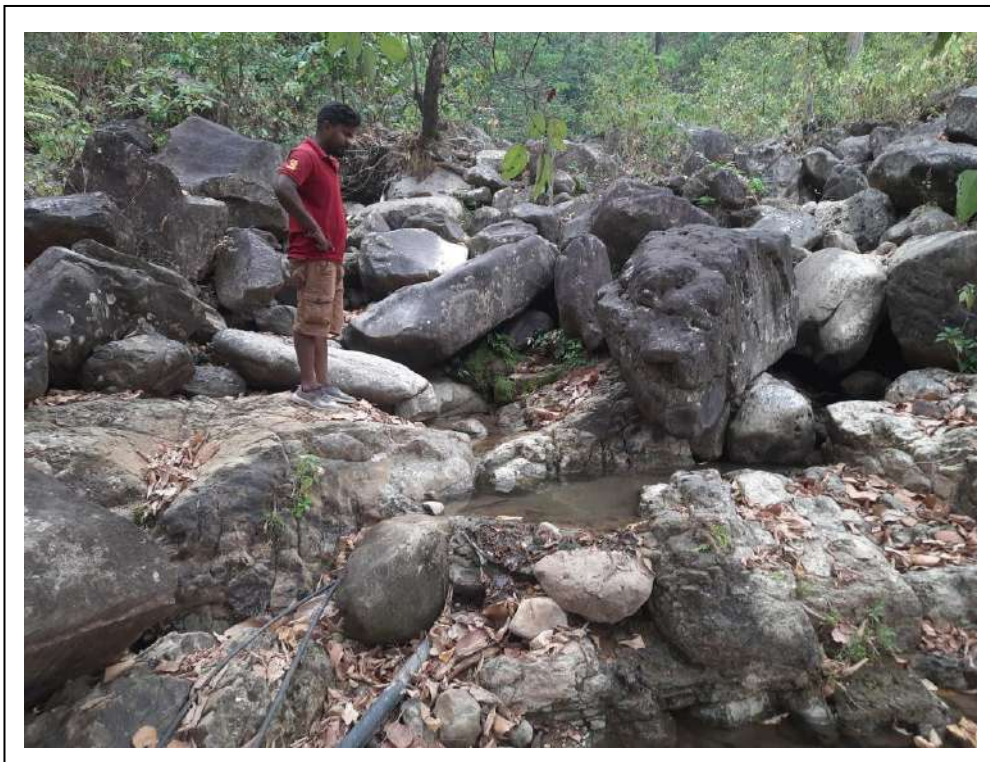
Photograph of Spring

The Spring holds a good storage capacity for a large communities. Water Awareness programs can be conducted for the community for their good water preservation. Fence the area around the spring tank to prevent pollution by children or livestock. Clear vegetation above the head of the spring to make it bacteria-free.

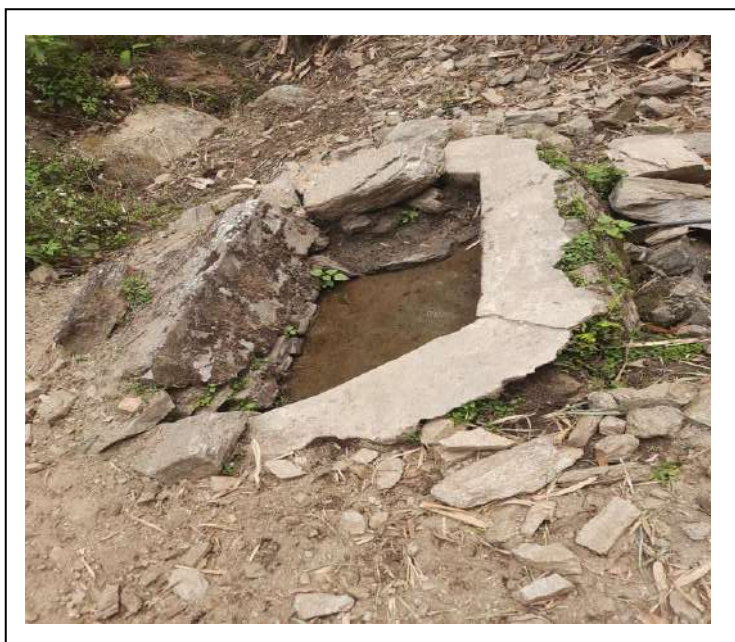
Photograph of Spring

The Spring hold good storage capacity for small community. Water Awareness programs can be conducted for the community for their excellent water preservation. Fence the area around the spring tank and cover the tank from up to prevent pollution by children or livestock. Clear vegetation above the head of the spring to make bacteria free.

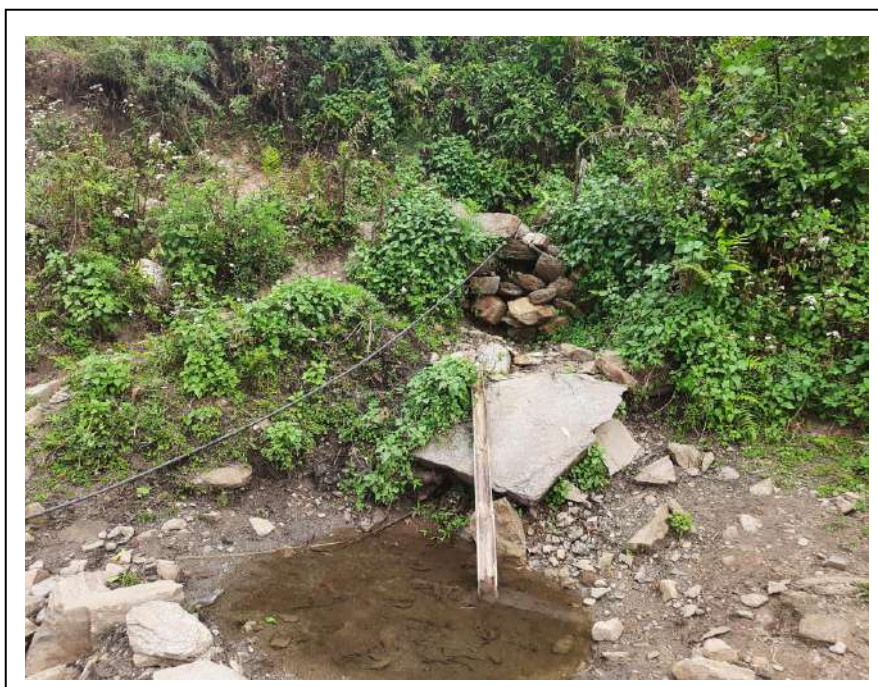
Photograph of Spring

Water Awareness programs can be conducted for the community for their good water preservation. Fence the area around the spring tank to prevent pollution by children or livestock. Clear vegetation above the head of the spring to make it bacteria-free.

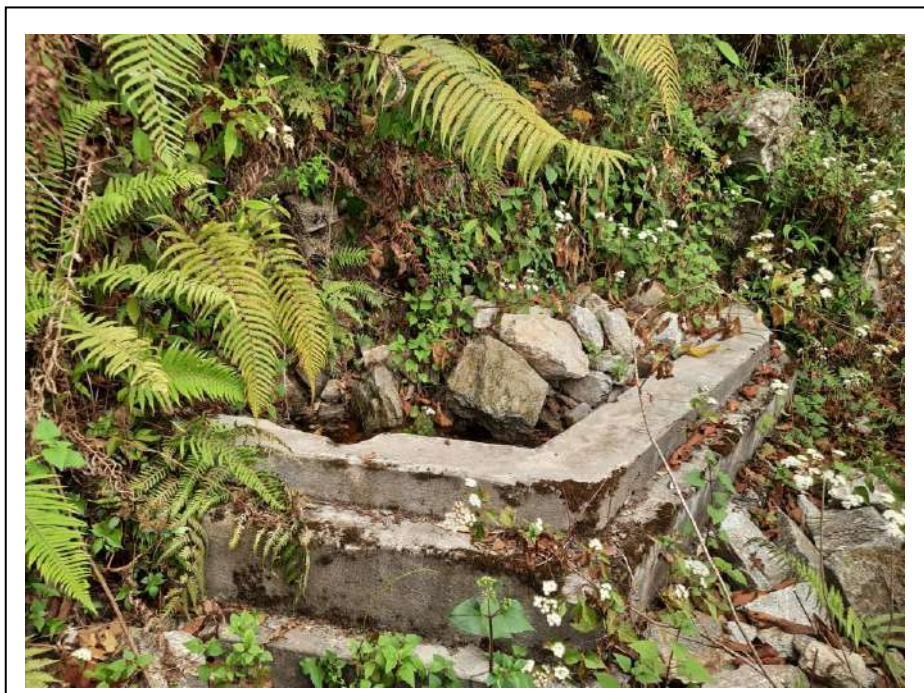
Photograph of Spring

Water Awareness programs can be conducted for the community for their good water preservation. Fence the area around the spring tank to prevent pollution by children or livestock. They use a water boundary tank to collect water and supplied to the house using the tube.

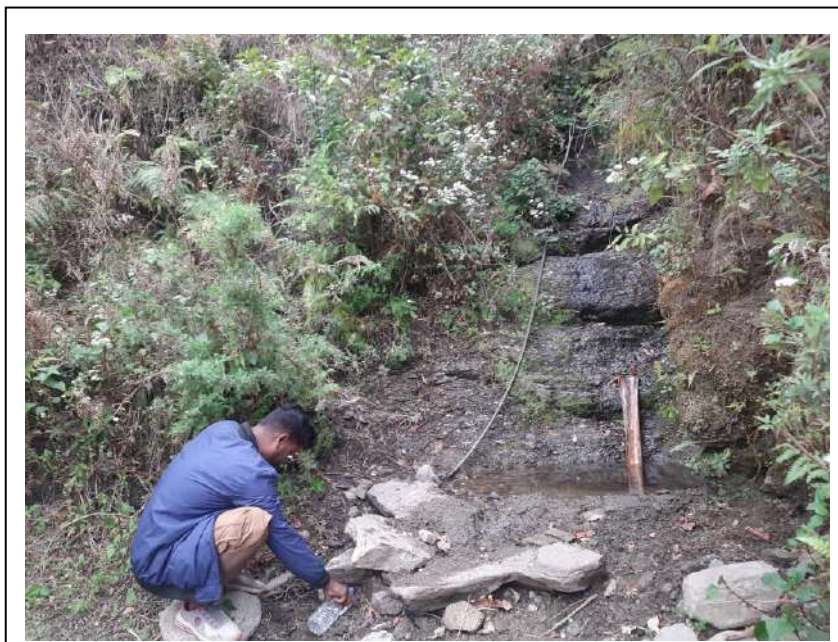
Photograph of Spring

The Spring can supply storage capacity for small community for current time. Water Awareness programs can be conducted for the community for their good water preservation. Fence the area around the spring tank to prevent pollution by children or livestock. Construct the water storage tank to collect and supply using tube.

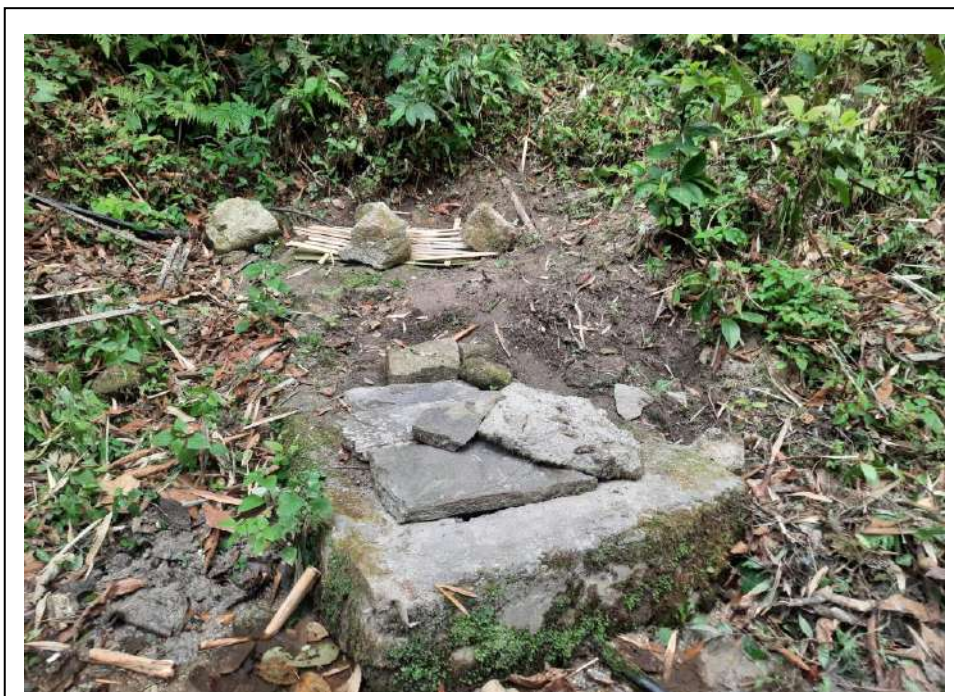
Photograph of Spring

The Spring holds a good storage capacity for the small community. Water Awareness programs can be conducted for the community for their good water preservation. Fence the area around the spring tank to prevent pollution by children or livestock. Cover the tank to make free from any impurities.

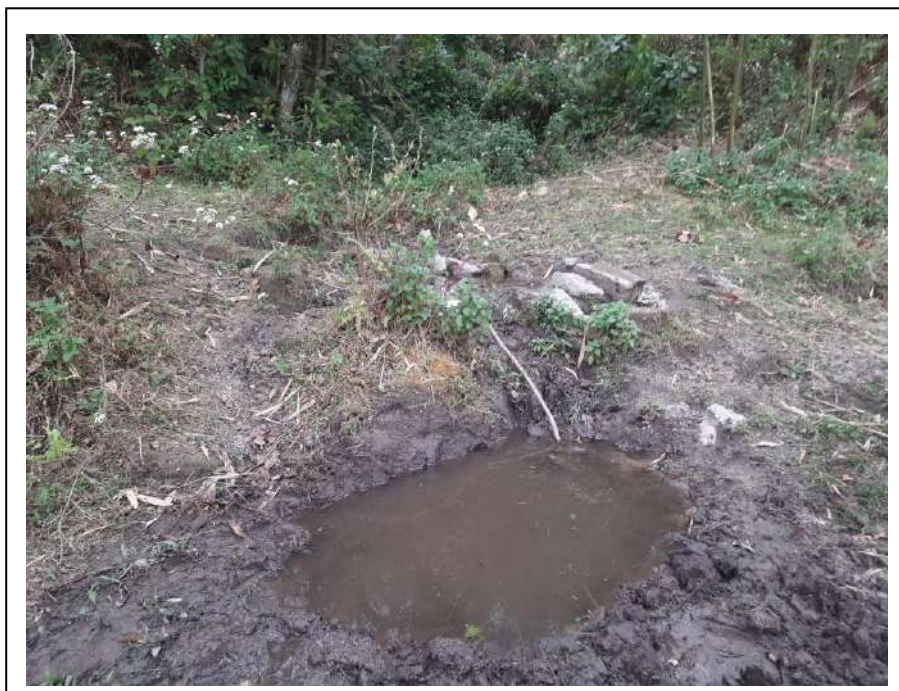
Photograph of Spring

The Spring water contain high impurities. Water Awareness programs can be conducted for the community for their good water preservation. Fence the area around the spring tank to prevent pollution by children or livestock. Water preservation and collection tank should be made.

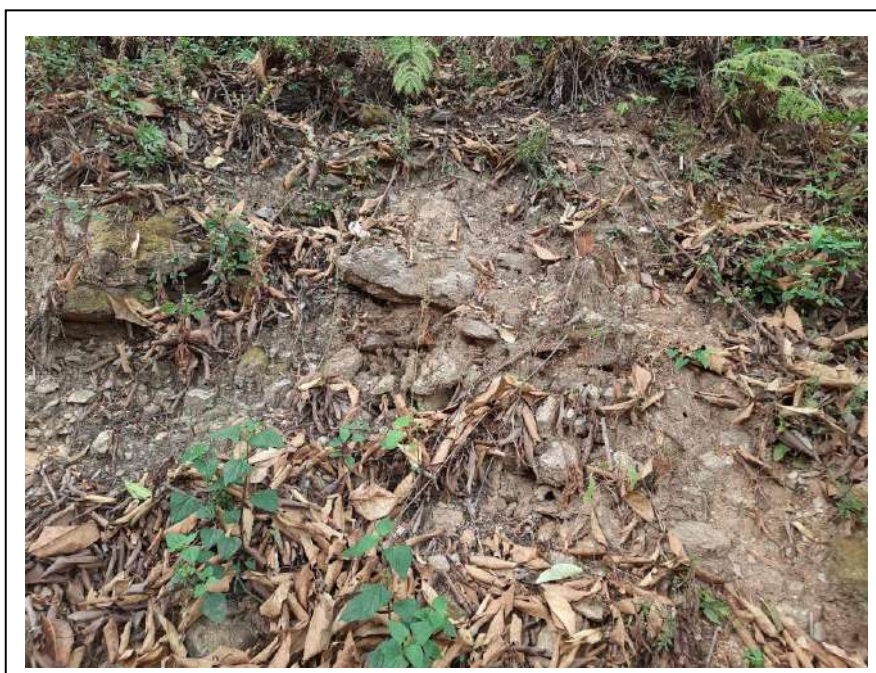
Photograph of Spring

The Spring hold good storage capacity for a small community but it is dried now

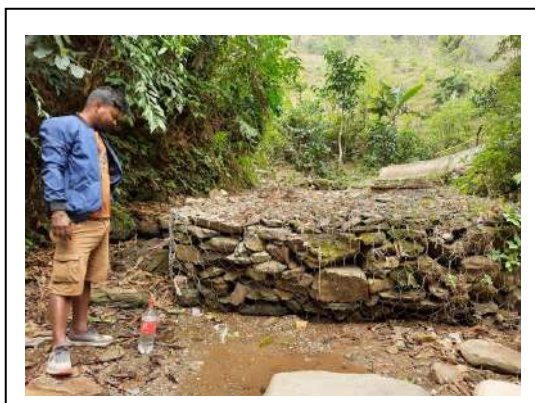
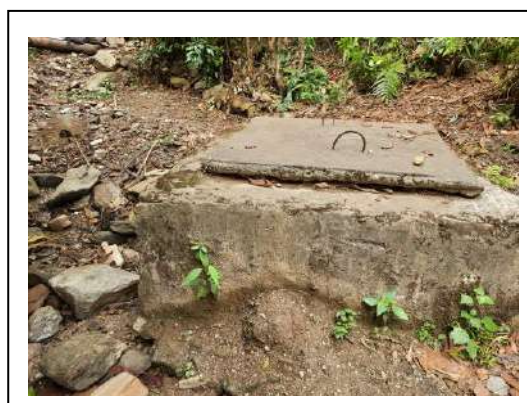
Photograph of Spring

The Spring holds a good storage capacity for Large communities. Water Awareness programs can be conducted for the community for their good water preservation. Fence the area around the spring tank to prevent pollution by children or livestock.

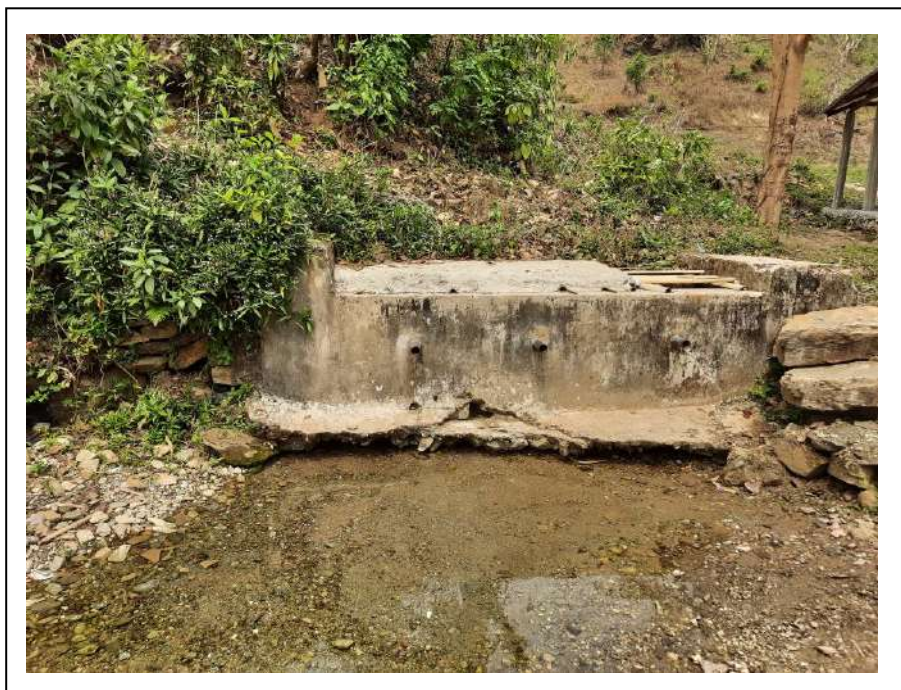
Photograph of Spring

The Spring holds a good storage capacity of water for the small community. Water Awareness programs can be conducted for the community for their good water preservation. Fence the area around the spring tank to prevent pollution by children or livestock.

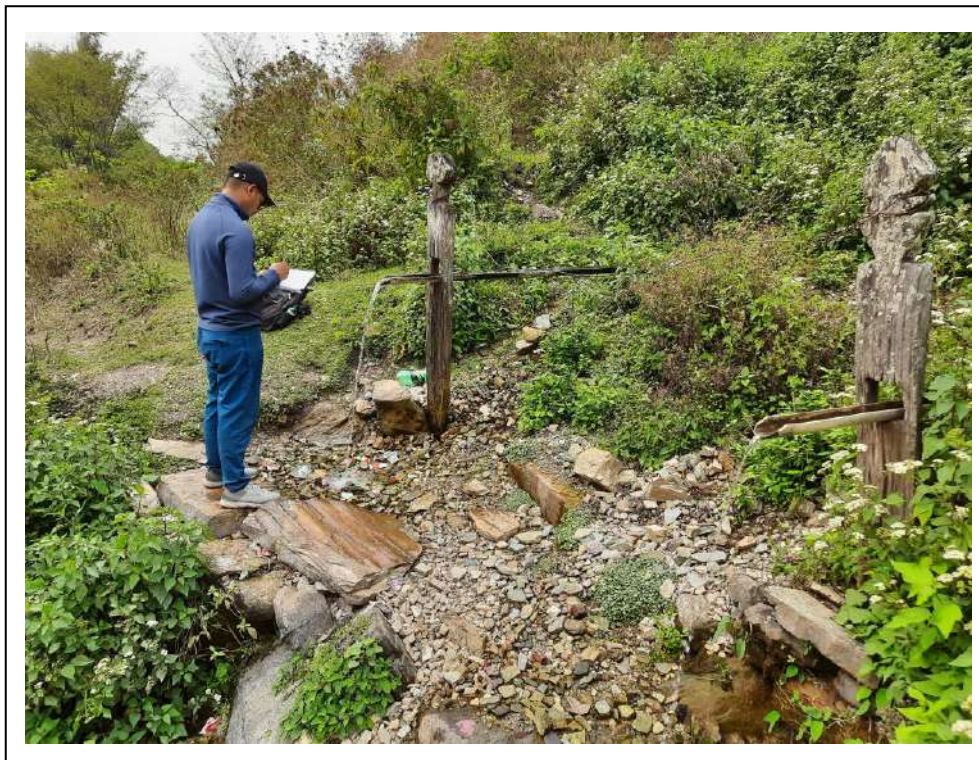
Photograph of Spring

The Spring holds a good storage capacity of water for the community. Water Awareness programs can be conducted for the community for their good water preservation. Fence the area around the spring tank to prevent pollution by children or livestock. Clear small shrubs and grass to clear water and make it free of pollutants.

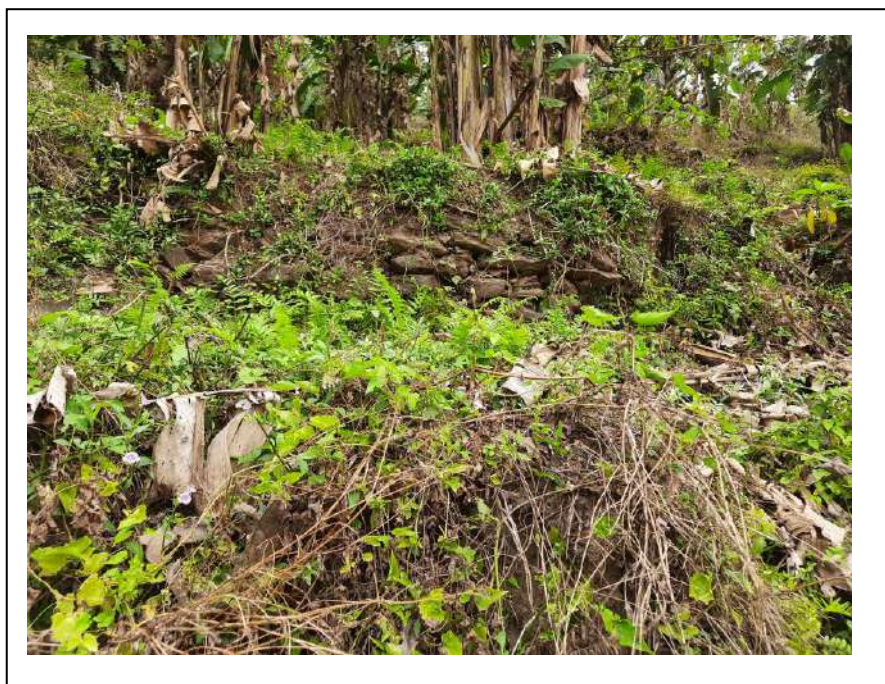
Photograph of Spring

The Spring holds a good storage capacity for a small communities. Water Awareness programs can be conducted for the community for their good water preservation. Fence the area around the spring tank to prevent pollution by children or livestock.

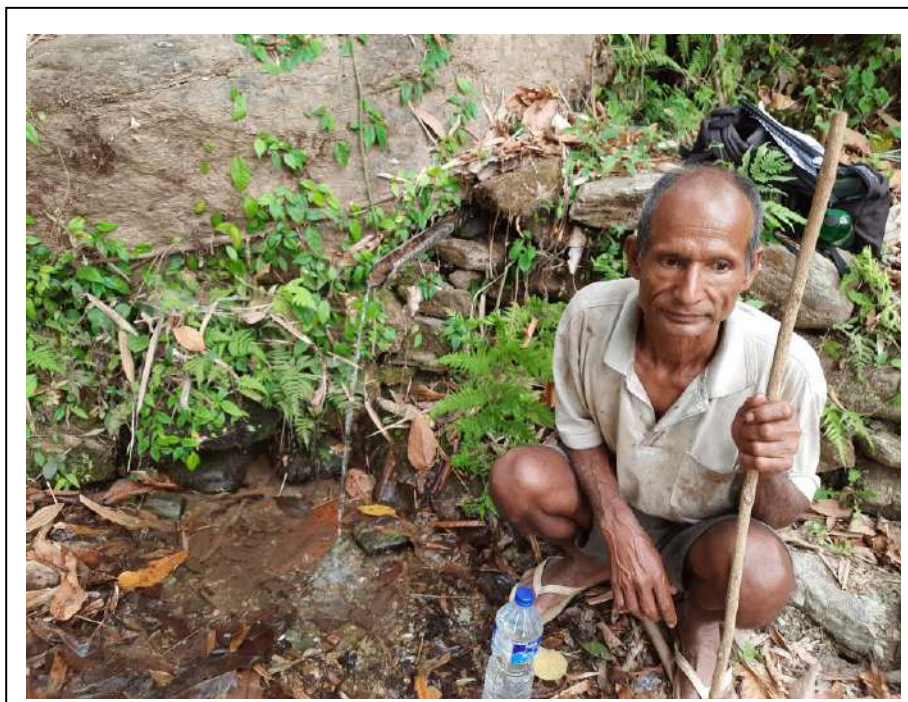
Photograph of Spring

Water Awareness programs can be conducted for the community for their good water preservation. Fence the area around the spring tank to prevent pollution by children or livestock.

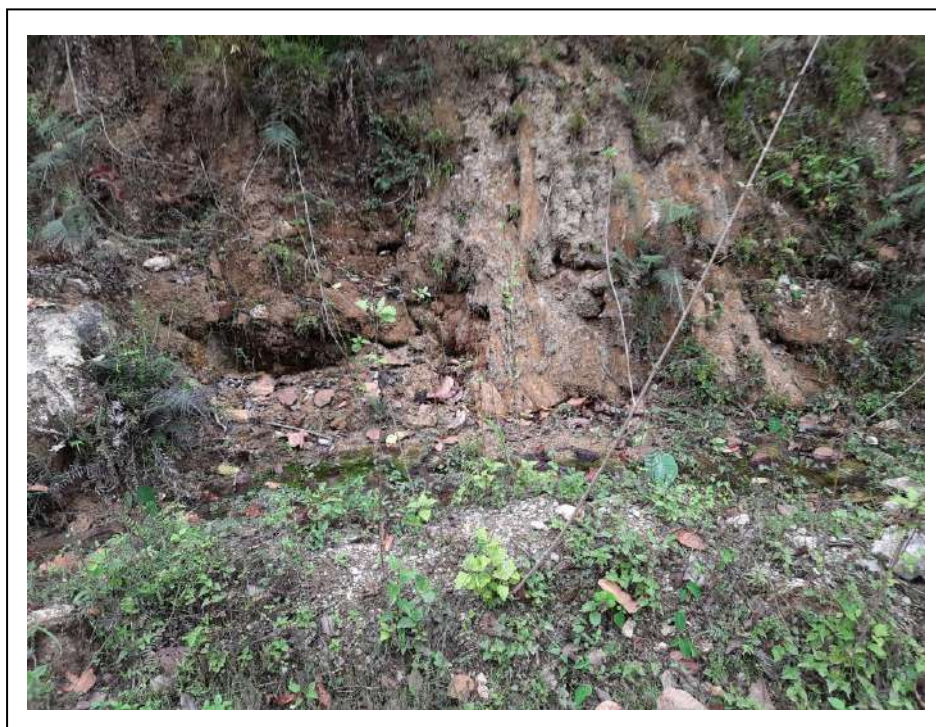
Photograph of Spring

Water Awareness programs can be conducted for the community for their good water preservation. Fence the area around the spring tank to prevent pollution by children or livestock. A water storage tank is very useful to collect the water.

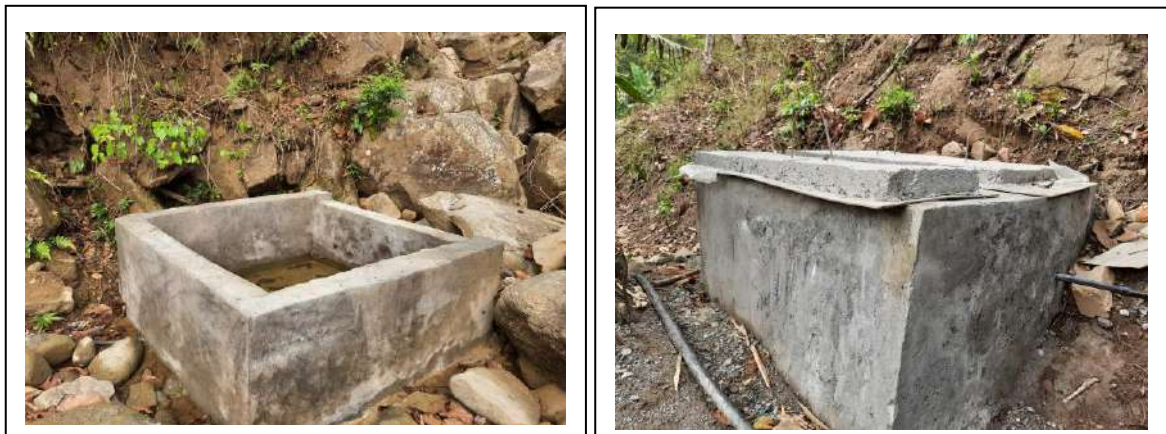
Photograph of Spring

The Spring is a good storage capacity of water for small communities. Water Awareness programs can be conducted for the community for their good water preservation. Fence the area around the spring tank to prevent pollution by children or livestock.

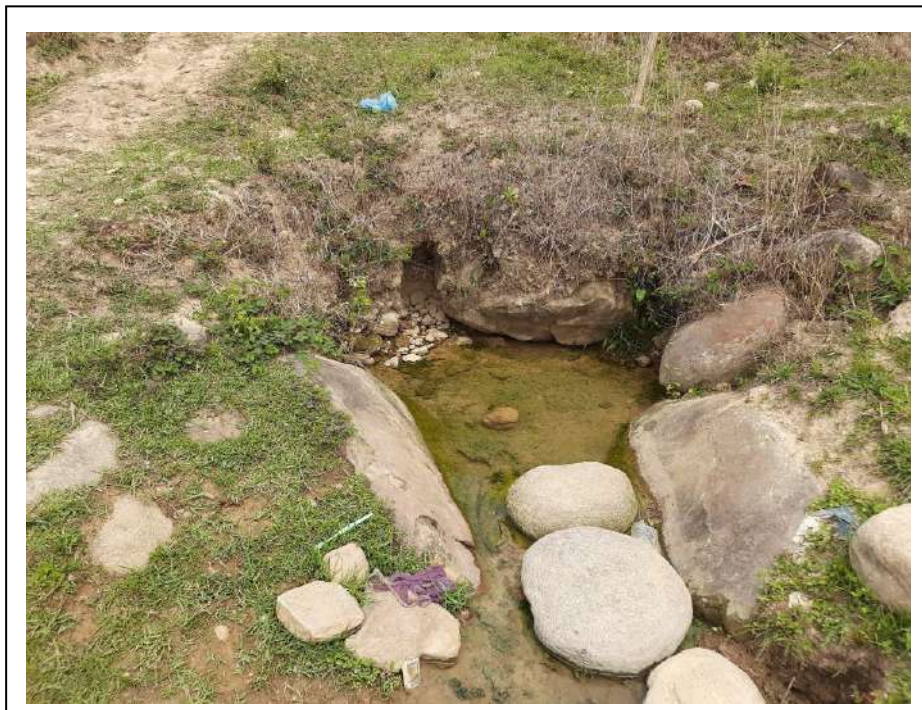
Photograph of Spring

Water Awareness programs can be conducted for the community for their good water preservation. Fence the area around the spring tank to prevent pollution by children or livestock.

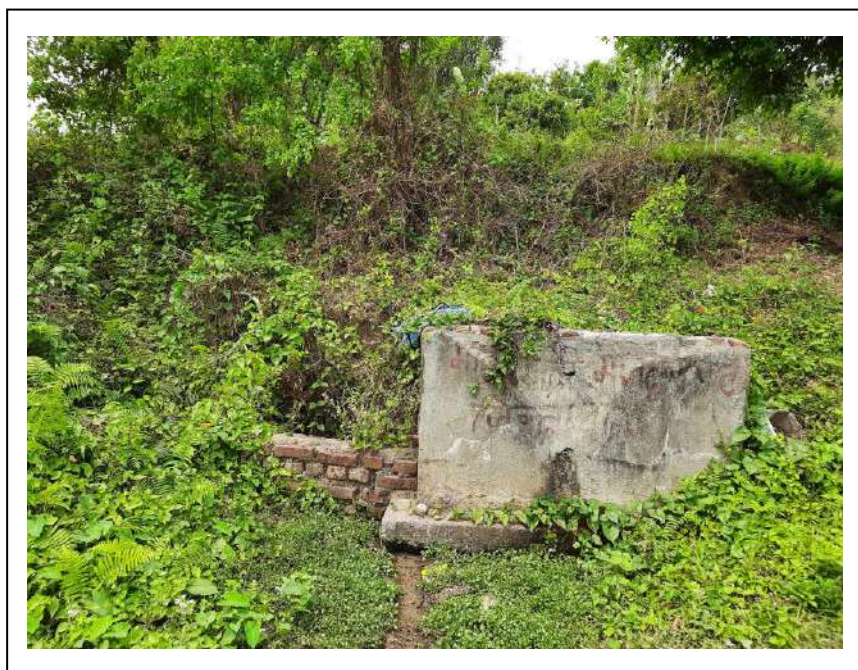
Photograph of Spring

A protective structure provides stability and may be made of concrete or masonry. A seal to prevent surface water from leaking in is usually made of puddle clay and sometimes plastic. Water Awareness programs can be conducted for the community for their good water preservation. Fence the area around the spring tank to prevent pollution by children or livestock.

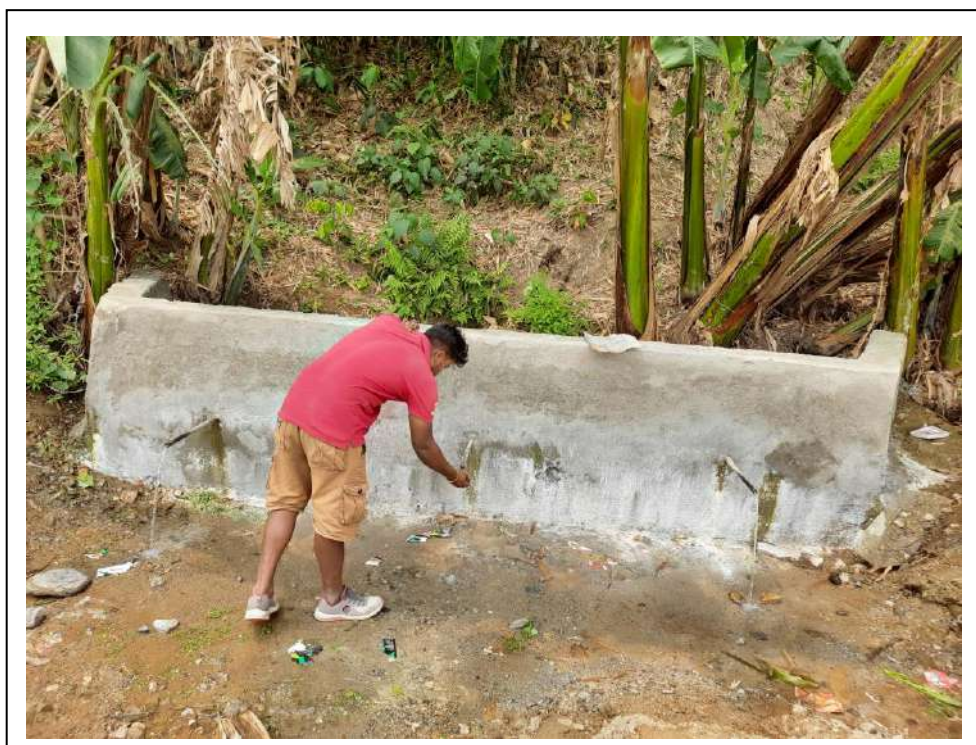
Photograph of Spring

The Spring hold good storage capacity for large community. A seal to prevent surface water from leaking in and is usually made of puddle clay and sometimes plastic. Water Awareness programs can be conducted for the community for their good water preservation. Fence the area around the spring tank to prevent pollution by children or livestock.

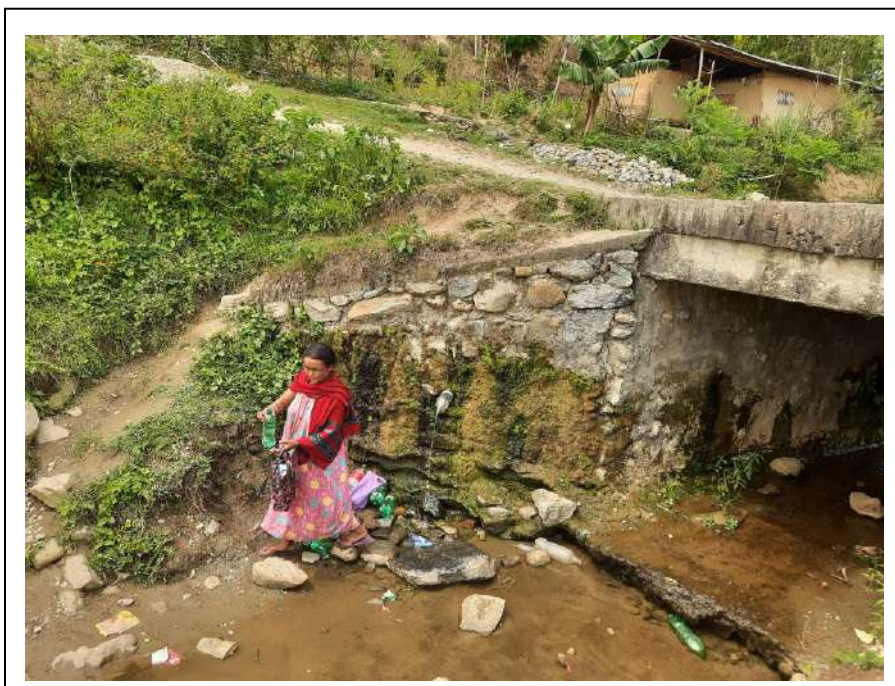
Photograph of Spring

A seal to prevent surface water from leaking in, and is usually made of puddle clay and sometimes plastic. Water Awareness programs can be conducted for the community for their good water preservation. Fence the area around the spring tank to prevent pollution by children or livestock.

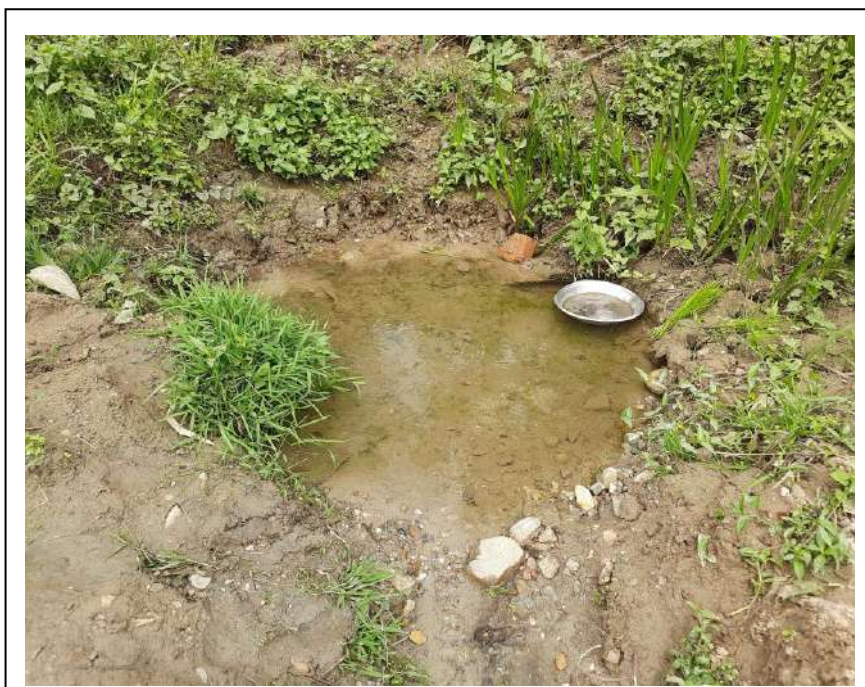
Photograph of Spring

The Spring holds good storage capacity for small communities. A protective structure provides stability and may be made of concrete or masonry. A seal to prevent surface water from leaking is usually made of puddle clay and sometimes plastic. Water Awareness programs can be conducted for the community for their good water preservation. Fence the area around the spring tank to prevent pollution by children or livestock.

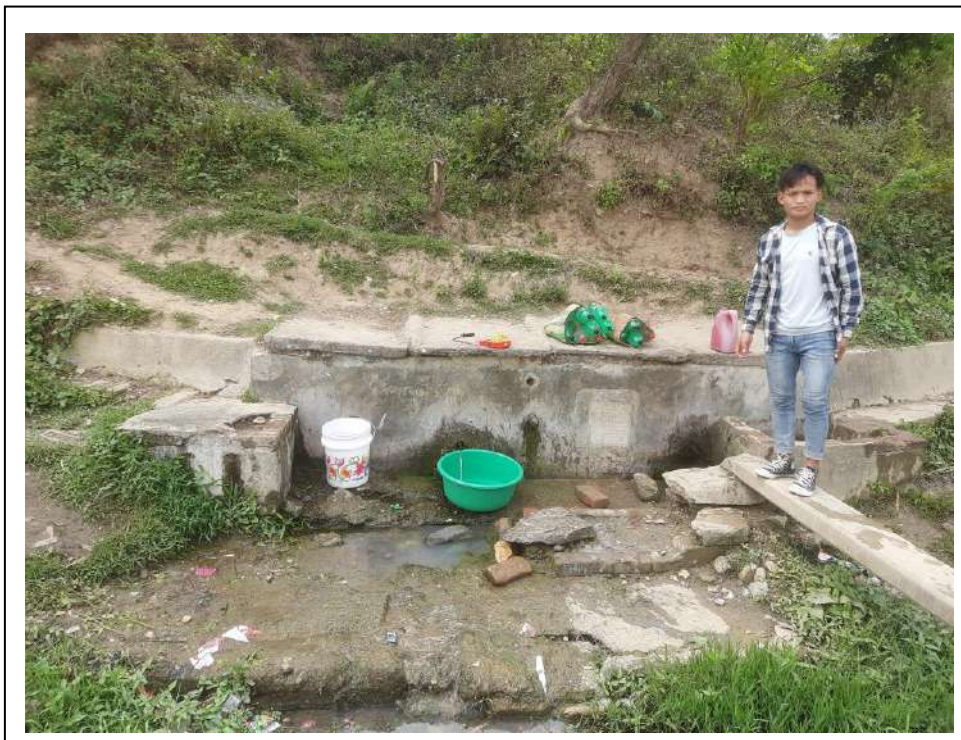
Photograph of Spring

The Spring hold very good discharge capacity. A seal to prevent surface water from leaking in and is usually made of puddle clay and sometimes plastic. Water Awareness programs can be conducted for the community for their good water preservation.

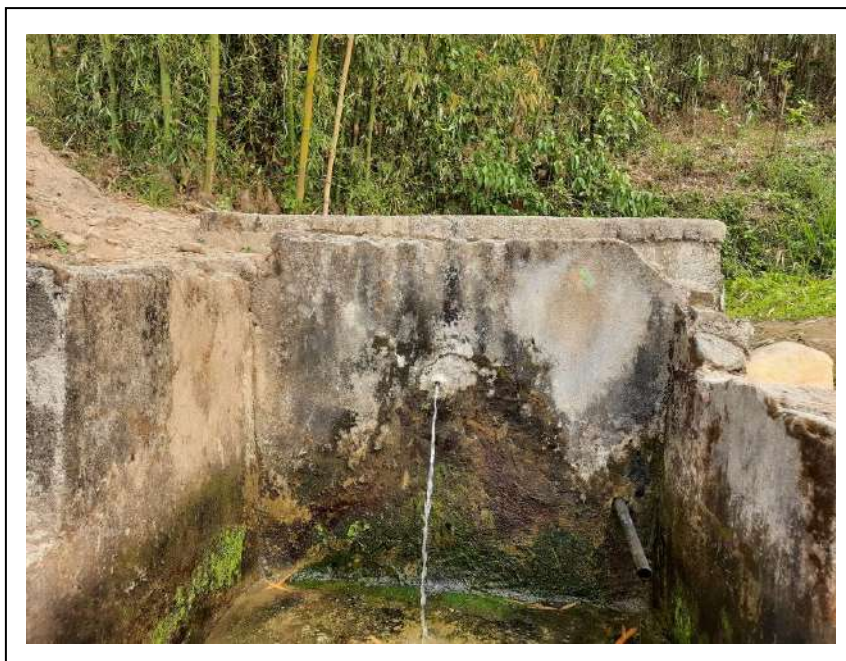
Photograph of Spring

The Spring has good water discharge. A seal to prevent surface water from leaking is usually made of puddle clay and sometimes plastic. Water Awareness programs can be conducted for the community for their good water preservation. Fence the area around the spring tank to prevent pollution by children or livestock

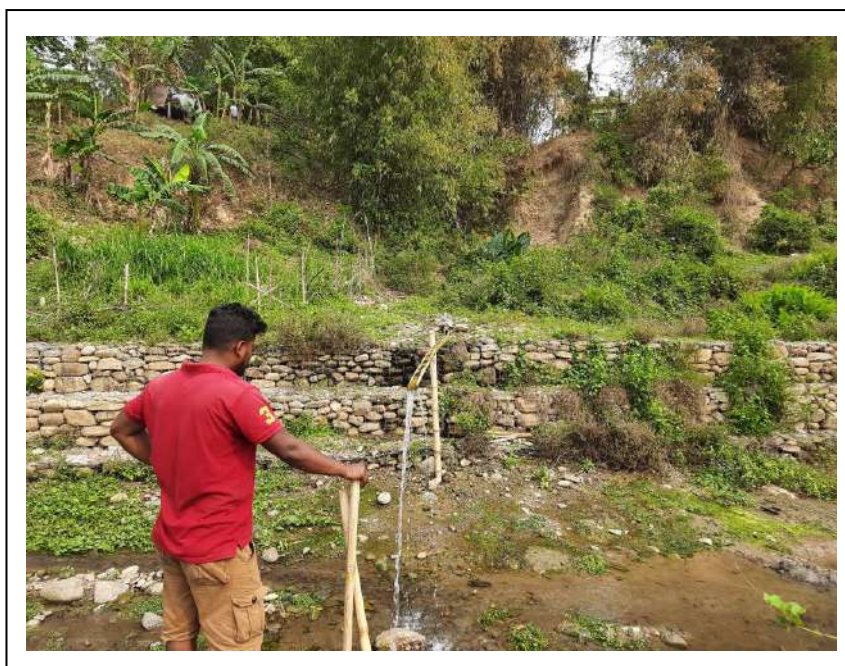
Photograph of Spring

The Spring holds good discharge capacity for the community. A protective structure provides stability and may be made of concrete or masonry. A seal to prevent surface water from leaking is usually made of puddle clay and sometimes plastic. Water Awareness programs can be conducted for the community for their good water preservation. Fence the area around the spring tank to prevent pollution by children or livestock.
