Spring Inventory and Mapping

A Report of Baruwa Watershed, Triyuga, Udayapur, Nepal

Basin Management Center,
Koshi Gaighat, Udayapur

June 2022 (Jeth, 2079 B.S)

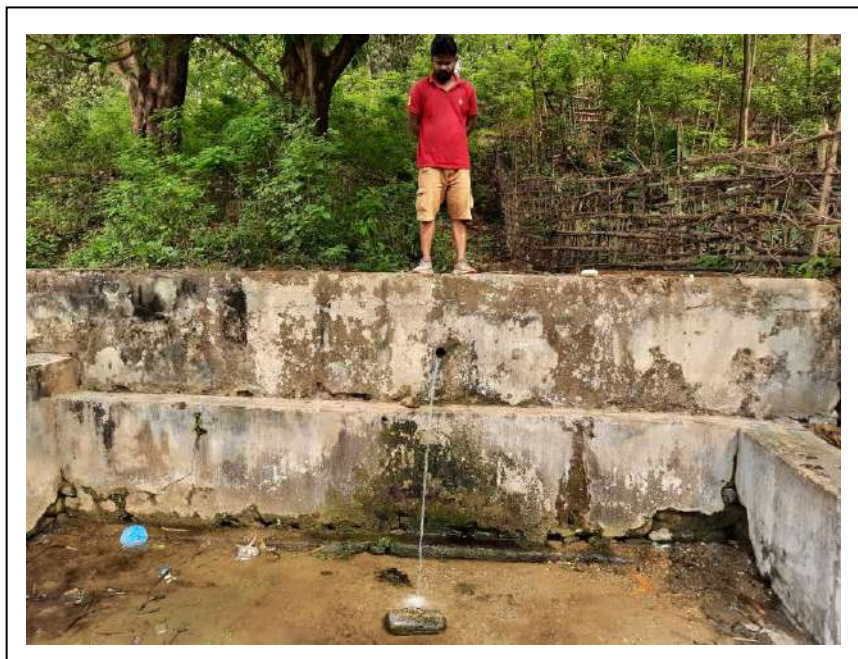
Photograph of Spring

The Spring holds good storage capacity and discharges water for the community. Water Awareness programs can be conducted for the community for their good water preservation. Fence the area around the spring tank to prevent pollution by children or livestock. Stop Sanitary landfills near the spring, which pollutes the water.

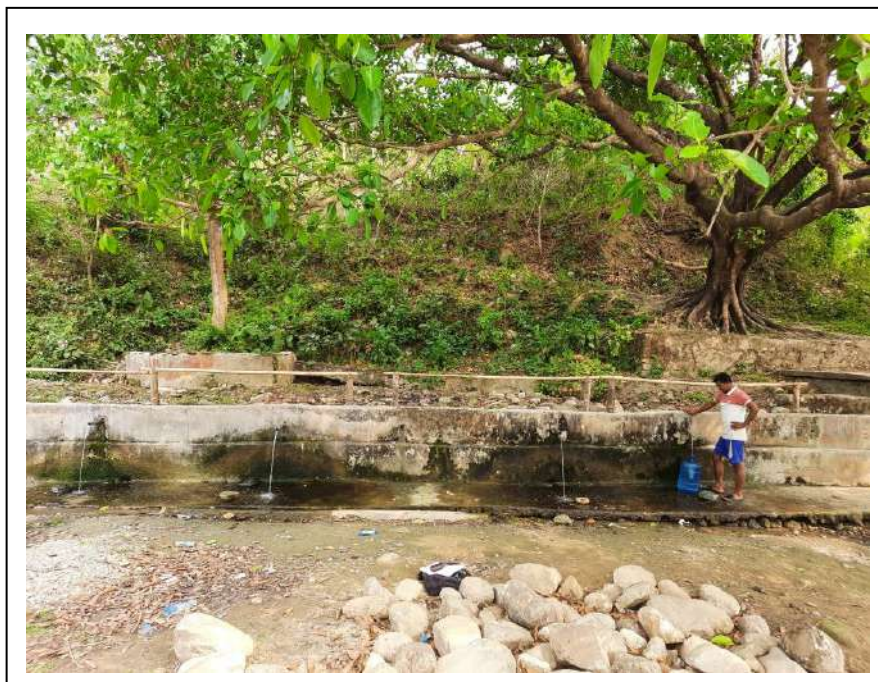
Photograph of Spring

The Spring holds a good storage capacity of water for a small community. Water Awareness programs can be conducted for the community for their good water preservation. Fence the area around the spring tank to prevent pollution by children or livestock.

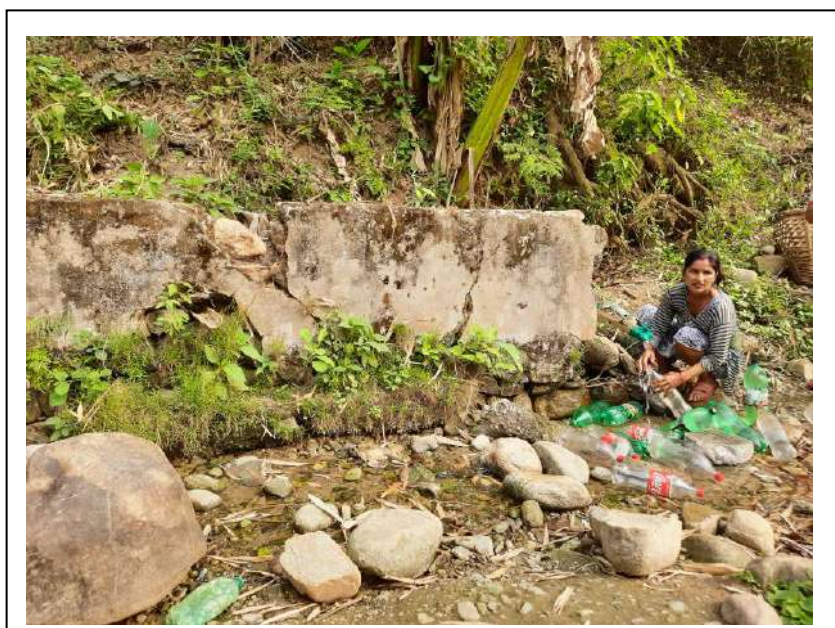
Photograph of Spring

Water Awareness programs can be conducted for the community for their good water preservation. Fence the area around the spring tank to prevent pollution by children or livestock.

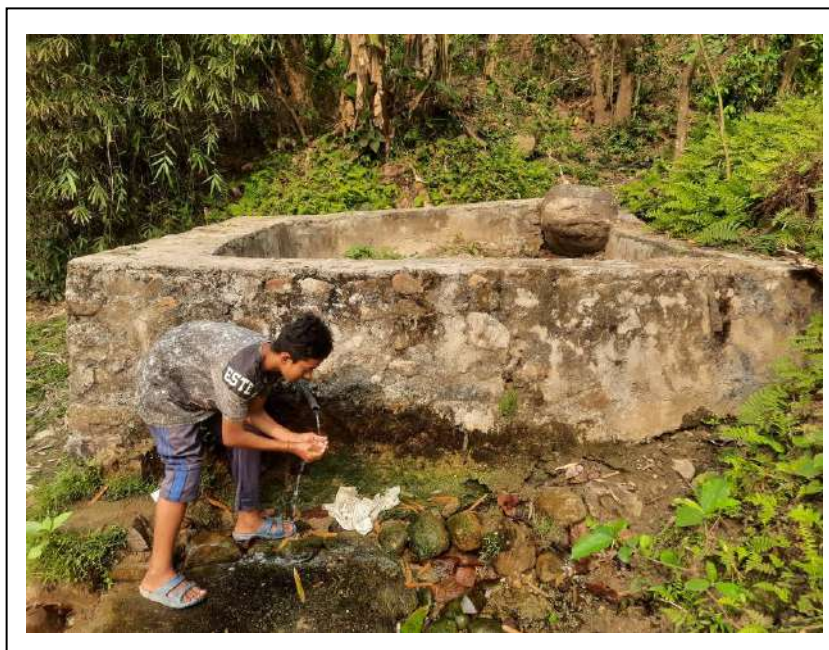
Photograph of Spring

Water Awareness programs can be conducted for the community for their good water preservation. Fence the area around the spring tank to prevent pollution by children or livestock. Stop Sanitary landfills near the spring, which pollutes the water.

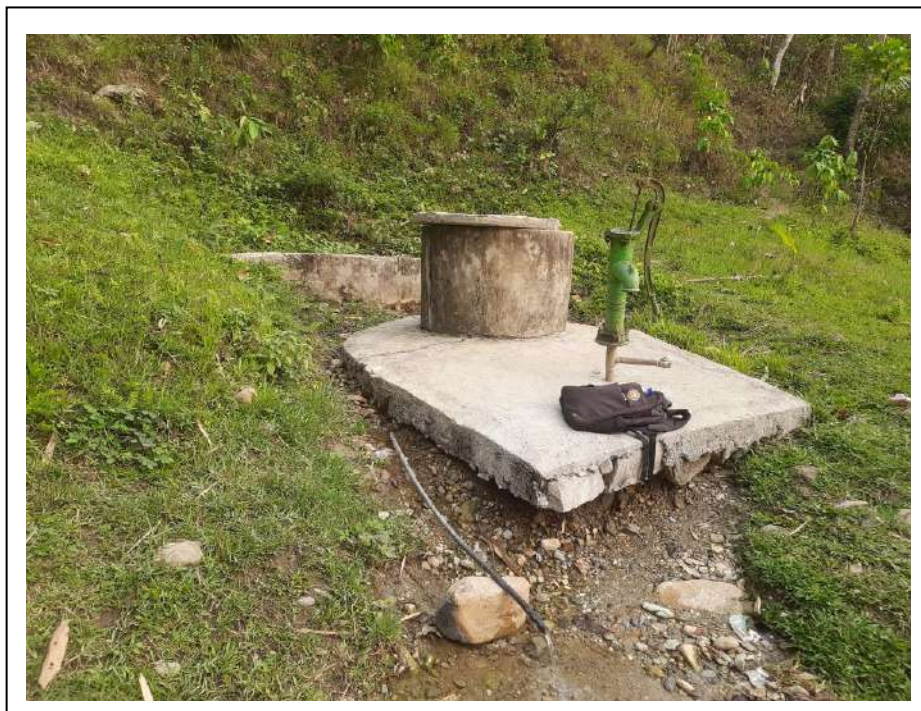
Photograph of Spring

The Spring holds a good storage capacity for a small community. Water Awareness programs can be conducted for the community for their good water preservation. Fence the area around the spring tank to prevent pollution by children or livestock.

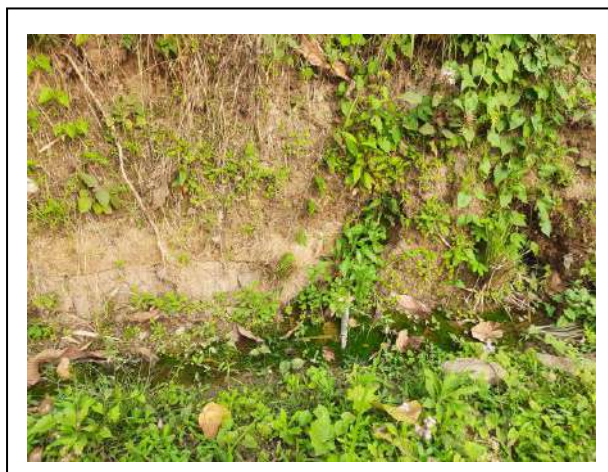
Photograph of Spring

The Spring hold good storage capacity for small community. Water Awareness programs can be conducted for the community for their good water preservation. Fence the area around the spring tank to prevent pollution by children or livestock.

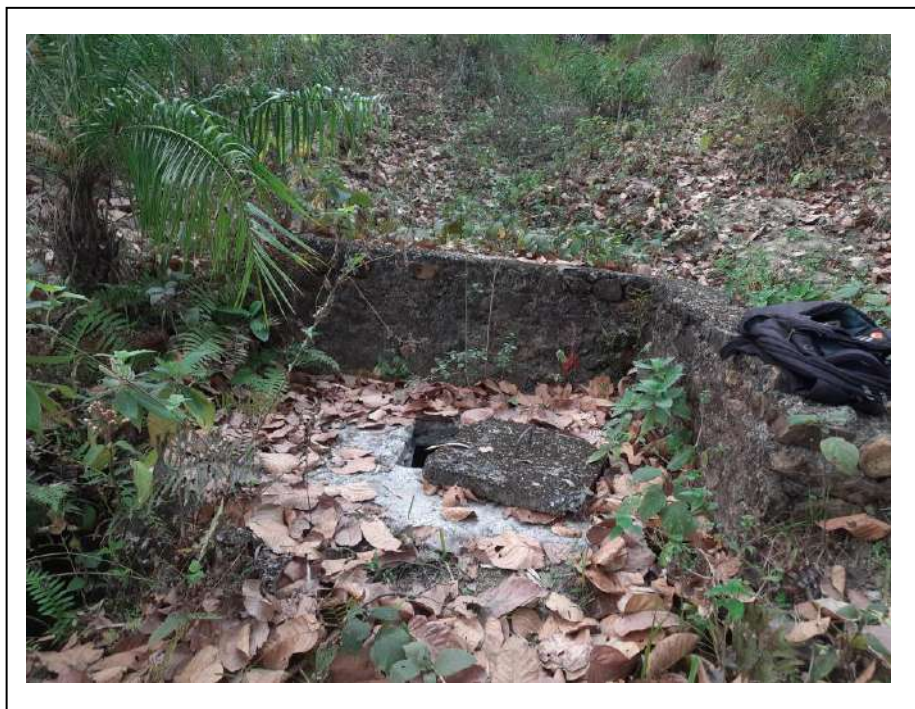
Photograph of Spring

Type of Spring	Depression: √	Contact:	Fracture:	Fault:	Karst:
Water Available:		Annually: √	6 months:		3 months:
Current Condition:		Flowing: √	Drying up:		Dried Up:
Spring water History trend:		Increasing:	Constant: √		Decreasing:
Infrastructure to conserved Spring	Newly construct tank

Discharge L/M		5.00			
Spring Located	Ridge:	Rocky terrain:	Agriculture land:	Forest: ✓	River Bank:
Types of Deposit		Residual deposits			
Related Hazard		No			
Possible Useful		Drinking			
Outlet of Spring		Using pipe

a. Details of any damage to the Spring: No.

Fence the area around the spring tank to prevent pollution by children or livestock. Stop Sanitary landfills near to the spring, which pollutes the water.

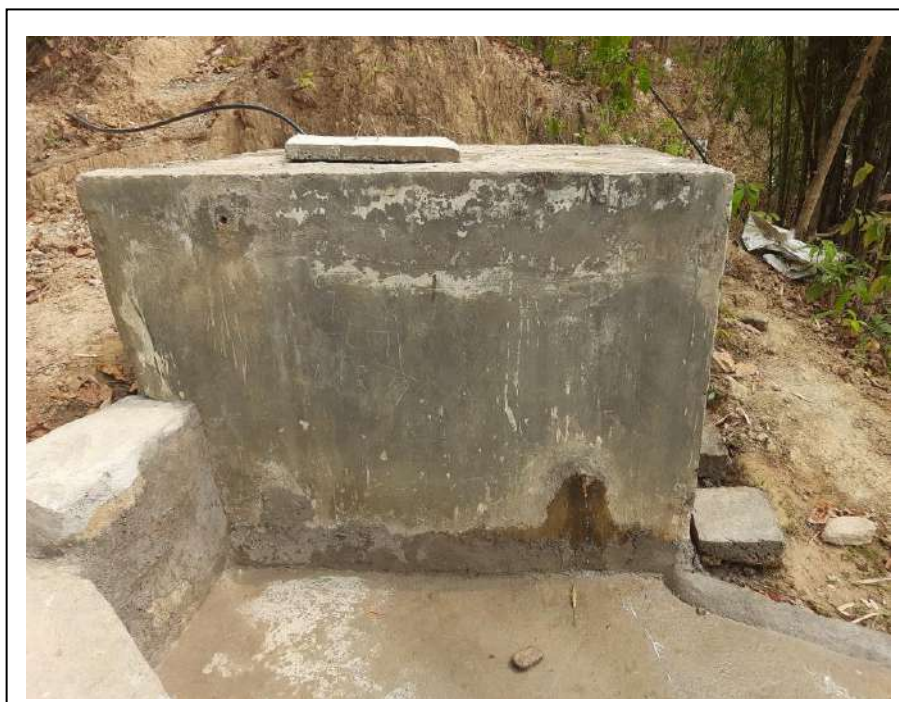
Photograph of Spring

Type of Spring	Depression: √	Contact:	Fracture:	Fault:	Karst:
Water Available:	Annually: √	6 months:	3 months:		
Current Condition:	Flowing:	Drying up: √	Dried Up:		
Spring water History trend:	Increasing:	Constant:	Decreasing: √		
Infrastructure to conserved Spring	Not Built

Discharge L/M		4.00			
Spring Located	Ridge:	Rocky terrain:	Agriculture land:	Forest:	River Bank:
Types of Deposit		Lower Siwalik (Residual Deposits)			
Related Hazard		Sanitary Landfill from police station.			
Possible Useful		No			
Outlet of Spring		From a spring box

a. Details of any damage to the Spring: No.

Fence the area around the spring tank to prevent pollution by children or livestock.

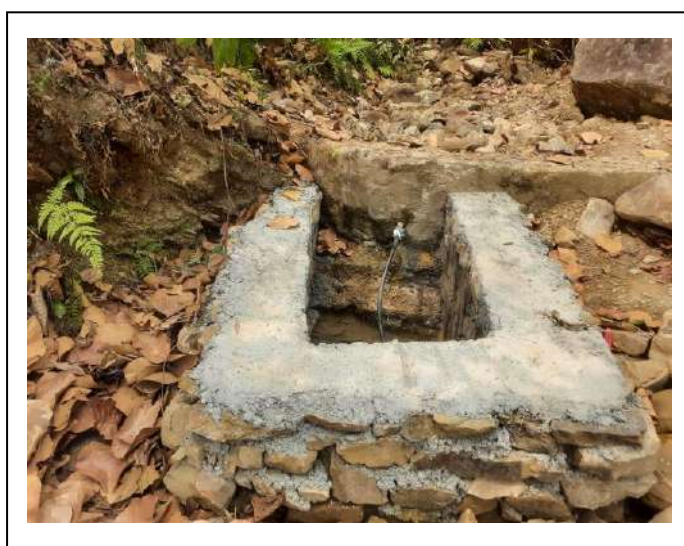
Photograph of Spring

Type of Spring	Depression: √	Contact:	Fracture:	Fault:	Karst:
Water Available:		Annually: √	6 months:		3 months:
Current Condition:		Flowing:	Drying up: √		Dried Up:
Spring water History trend:		Increasing:	Constant: √		Decreasing:
Infrastructure to conserved Spring	Small Storage tank

Discharge L/M		18.00			
Spring Located	Ridge:	Rocky terrain:	Agriculture land:	Forest:	River Bank:
Types of Deposit		Residual Deposits			
Related Hazard		No			
Possible Useful		Drinking, Agriculture			
Outlet of Spring		From a flowing stream

a. Details of any damage to the Spring: No.

Water Awareness programs can be conducted for the community for their good water preservation. A protective structure provides stability and may be made of concrete or masonry. A seal to prevent surface water from leaking in is usually made of puddle clay and sometimes plastic. Fence the area around the spring tank to prevent pollution by children or livestock

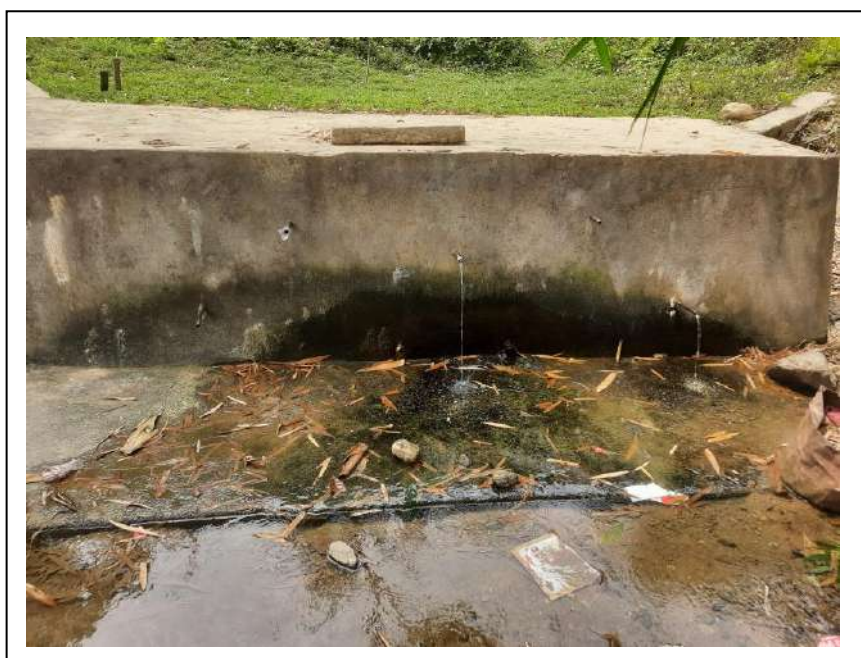
Photograph of Spring

Type of Spring	Depression: √	Contact:	Fracture:	Fault:	Karst:
Water Available:		Annually:	6 months:		3 months:
Current Condition:		Flowing: √	Drying up:		Dried Up:
Spring water History trend:		Increasing:	Constant: √		Decreasing:
Infrastructure to conserved Spring	Yes, Tank Built

Discharge L/M		15			
Spring Located	Ridge:	Rocky terrain:	Agriculture land:	Forest:	River Bank:✓
Types of Deposit		Alluvium Deposit			
Related Hazard		No			
Possible Useful		Drinking and agriculture			
Outlet of Spring		From a flowing stream

- Details of any damage to the Spring: Waste product from the Pig and human landfill near to 30m area of spring.
- Local-level/ local people use the procedure to conserved Spring. Not used any measured.

Water Awareness programs can be conducted for the community for their good water preservation. Fence the area around the spring tank to prevent pollution by children or livestock. Control sanitation landfills and waste products near to spring.

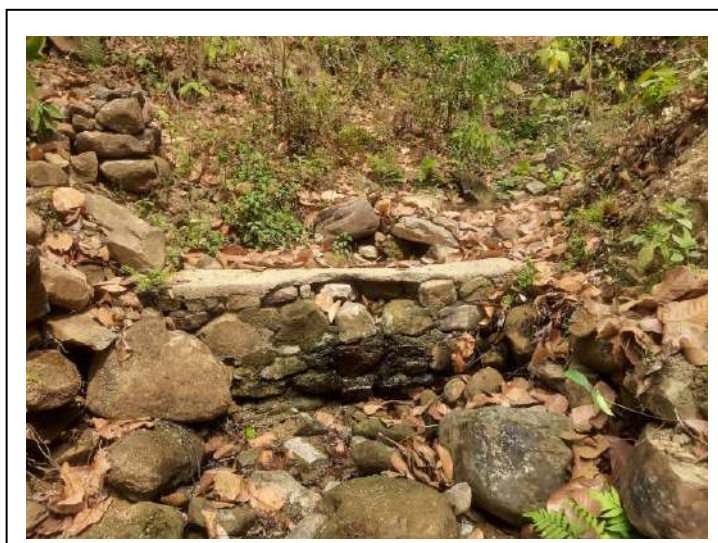
Photograph of Spring

Type of Spring	Depression: √	Contact:	Fracture:	Fault:	Karst:
Water Available:		Annually: √	6 months:		3 months:
Current Condition:		Flowing:	Drying up: √		Dried Up:
Spring water History trend:		Increasing:	Constant:		Decreasing:√
Infrastructure to conserved Spring	Check dam was built to collect the water

Discharge L/M		2.40			
Spring Located	Ridge:	Rocky terrain:	Agriculture land:	Forest: √	River Bank:
Types of Deposit		Alluvium Deposit			
Related Hazard		No. Water pollution from forest leaves and other activities			
Possible Useful		Drinking for small community			
Outlet of Spring		From a flowing stream

a. Details of any damage to the Spring: No

The Spring holds a good storage capacity for a small community. Water Awareness programs can be conducted for the community for their good water preservation. Fence the area around the spring tank to prevent pollution by children or livestock. Control waste products and cleanliness required in Spring for good water.

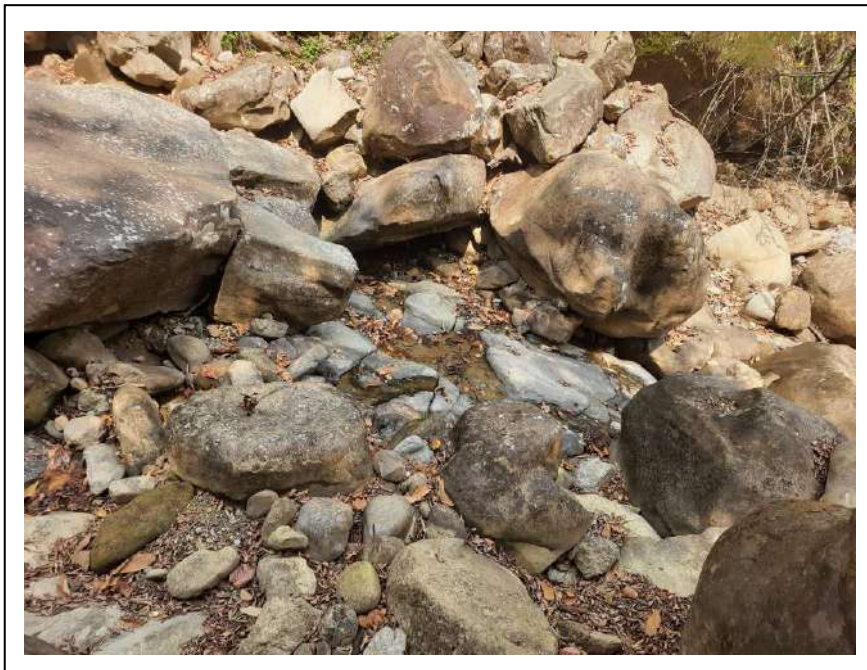
Photograph of Spring

Type of Spring	Depression: √	Contact:	Fracture:	Fault:	Karst:
Water Available:		Annually: √	6 months:		3 months:
Current Condition:		Flowing: √	Drying up:		Dried Up:
Spring water History trend:		Increasing:	Constant: √		Decreasing:
Infrastructure to conserved Spring	Not Built				
Discharge l/m	2.61				
Spring Located	Ridge and Gulley:	Rocky terrain: √	Agriculture land:	Forest:	River Bank:
Types of Deposit	Alluvium Deposit (Boulder, cobble gravel, sand silt)				
Related Hazard	No				
Possible Useful	Drinking for small Community				
Outlet of Spring	From a flowing stream.

i. Details of any damage to the Spring: No

The Spring capacity for small Households. The surrounding area is free of hazards. Important water Awareness programs can be conducted in the community for their good water preservation. Water is open, bacteria growth can harm if taken directly. Water Boundary and storage tank should be made to sound water and good water quality.

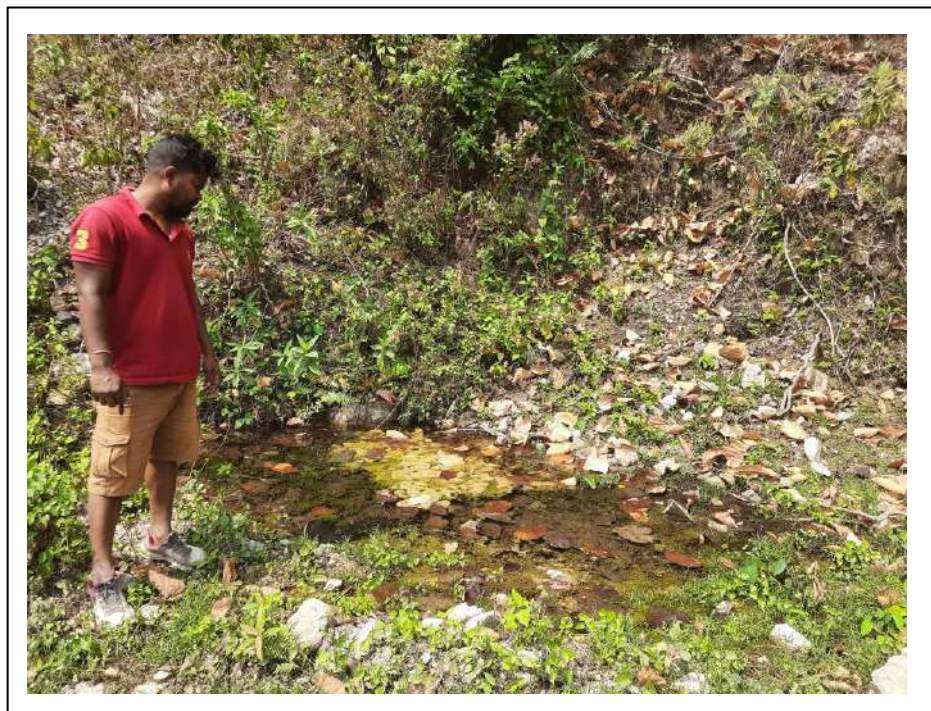
Photograph of Spring

Type of Spring	Depression: <input checked="" type="checkbox"/>	Contact:	Fracture:	Fault:	Karst:
Water Available:		Annually: <input checked="" type="checkbox"/>	6 months:		3 months:
Current Condition:		Flowing: <input checked="" type="checkbox"/>	Drying up:		Dried Up:
Spring water History trend:		Increasing:	Constant:		Decreasing:
Infrastructure to conserved Spring	Not Built				
Discharge L/M	Cannot measured				
Spring Located	Ridge and Gulley: <input checked="" type="checkbox"/>	Rocky terrain:	Agriculture land:	Forest:	River Bank:
Types of Deposit	Residual Deposits (Boulder, cobble, Pebble, sand)				
Sediment Thickness	10m				
Related Hazard	Landslide and flooding can occur.				
Possible Useful	Drinking				
Outlet of Spring	Spring Box

- a. Details of any damage to the Spring: Road Construction led to a damaged Spring.
- b. Local-level/ local people use the procedure to conserved Spring. Not used any measured.

The Spring can be used for small communities. Water Awareness programs can be conducted for the community for their good water preservation. Fence the area around the spring tank to prevent pollution by children or livestock. Clear vegetation above the head of the spring to make it bacteria-free.
